TECHNICAL SERVICE BULLETIN

EM22-007A

TURBOCHARGER REPLACEMENT PROCEDURE

APPLIED VEHICLES:
 2016-2022 Q50 (V37)

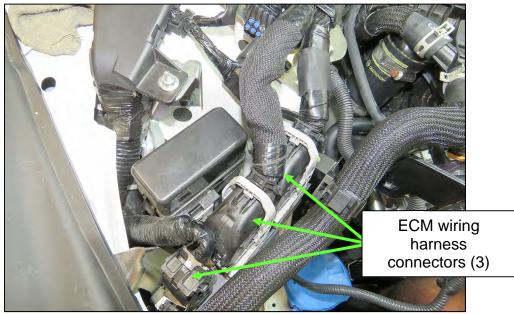
Figure 6

15. Disconnect the three (3) ECM wiring harness connectors.

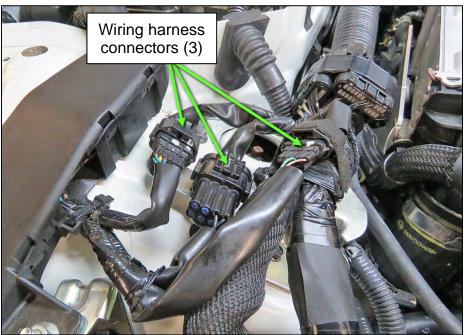
Figure 7

16. Disconnect the three (3) wiring harness connectors shown in Figure 7.

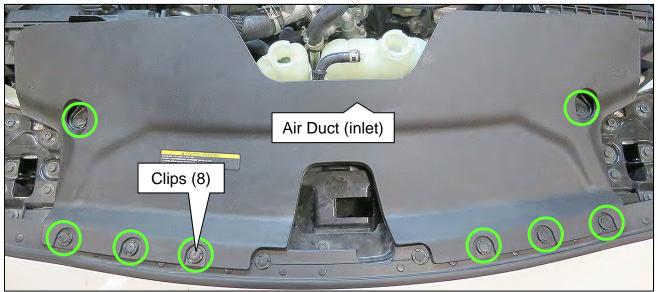
Figure 17

- 28. Remove the Air Duct (inlet), shown in Figure 17.
 - Eight (8) clips.

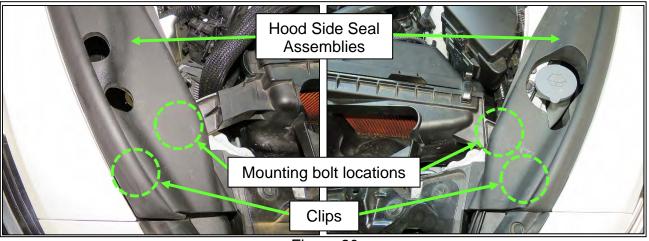
Figure 20

31. Unclip the first clip of the passenger (RH) side and the driver (LH) side Hood Side Seal Assemblies, to allow access to the Air Cleaner Body (bank 1) and Air Cleaner Body (bank 2) mounting bolts (Figure 20).

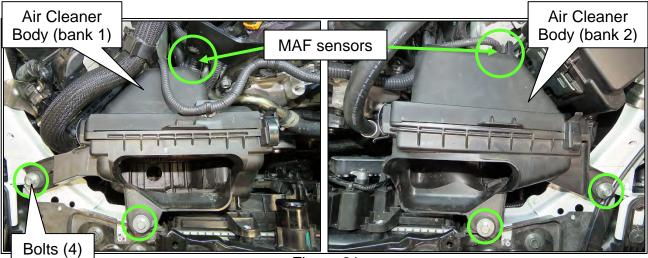
Figure 21

- 32. Disconnect both MAF sensor wiring harness connectors from the MAF sensors (Figure 21), located on the Air Cleaner Body (bank 1) and Air Cleaner Body (bank 2).
- 33. Unclip the MAF sensor wiring harnesses from Air Cleaner Body (bank 1) and Air Cleaner Body (bank 2).
- 34. Unbolt both Air Cleaner Body (bank 1) and Air Cleaner Body (bank 2); two (2) bolts each where shown in Figure 21.
- 35. Detach both Air Cleaner Body (bank 1) and Air Cleaner Body (bank 2) from Air Duct (bank 1) and Air Duct (bank 2), and then remove them from the vehicle.
 - Air Duct (bank 1) and Air Duct (bank 2) are located beneath Air Cleaner Body (bank 1) and Air Cleaner Body (bank 2).

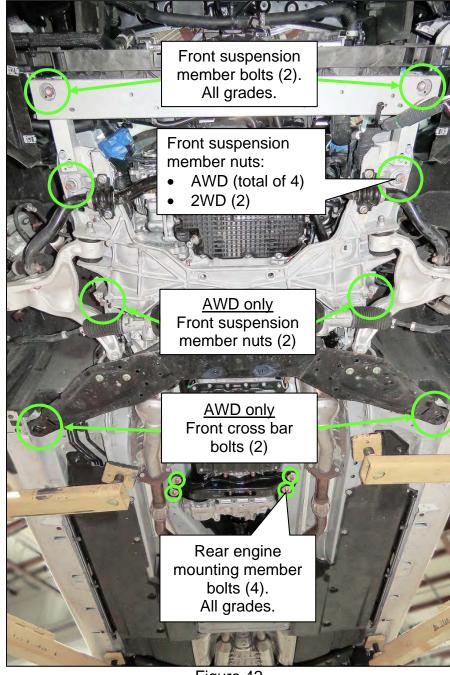
- 59. Remove the four (4) rear engine mounting member bolts (Figure 42).
- 60. Remove the front suspension member nuts and bolts indicated in Figure 42.
 - AWD has a total of four (4) front suspension member nuts.
 - 2WD has two (2) front suspension member nuts.
 - Two (2) front suspension member bolts (both AWD and 2WD).
 - <u>AWD only</u>: Two (2) front cross bar bolts.

HINT: Figure 42 is of an AWD vehicle. Nut and bolt locations are similar for 2WD.

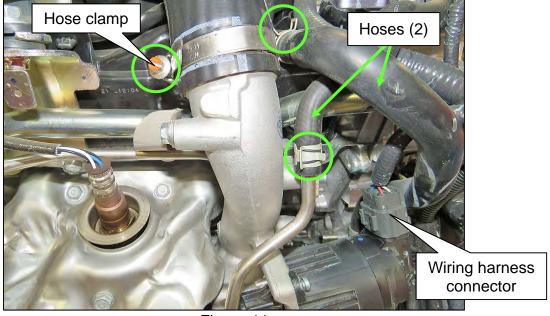
Figure 44

- 63. Loosen the Air Inlet Hose clamp shown in Figure 44. This hose will be detached in step 80 on page 24.
- 64. Release the spring clamps and disconnect the two (2) associated hoses, shown in Figure 44.

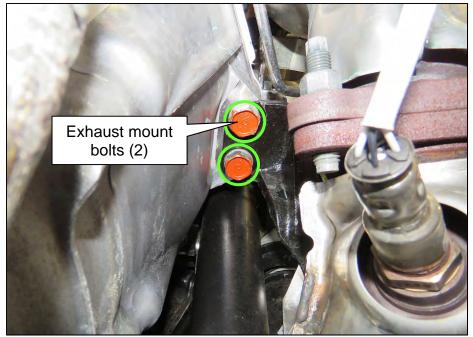
Figure 47

69. Remove the two (2) exhaust mount bolts shown in Figure 47.

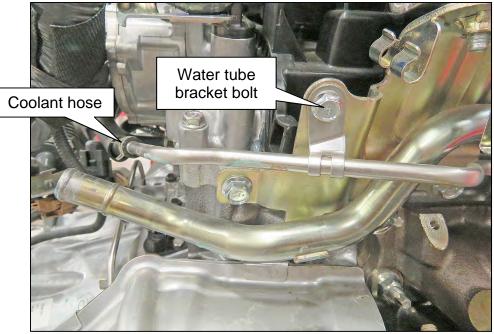
Figure 50

72. Release the spring clamp and disconnect the associated coolant hose shown in Figure 50.

73. Remove the water tube bracket bolt (Figure 50).

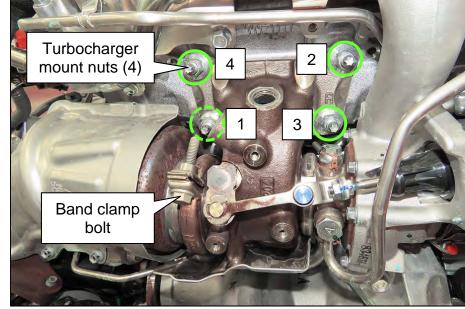
Figure 51

- 74. If present, disconnect the Turbocharger Speed Sensor (Bank 1) wiring harness connector (not shown).
- 75. Loosen the turbocharger assembly mounting nuts in order, from 1 to 4, as shown in Figure 51.

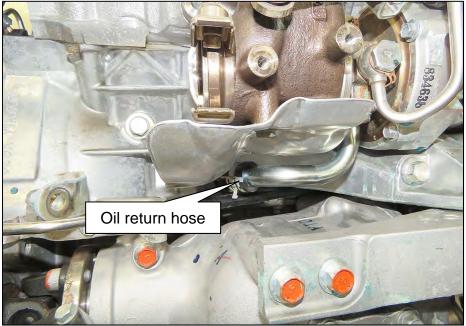
Figure 52

- 77. Detach Catalyst Converter (bank 1) from the turbocharger outlet.
- 78. Release the spring clamp and disconnect the associated oil return hose shown in Figure 52.

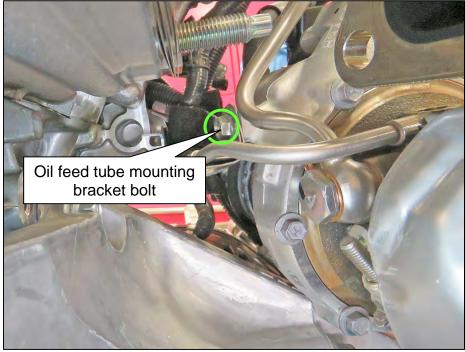
Figure 54

- 80. Detach the Air Inlet Hose from the turbocharger.
- 81. Gently remove the turbocharger from its mounting studs so that the oil line mounting bracket bolt can be reached (Figure 54).
- 82. Remove the oil feed tube mounting bracket bolt shown in Figure 54.

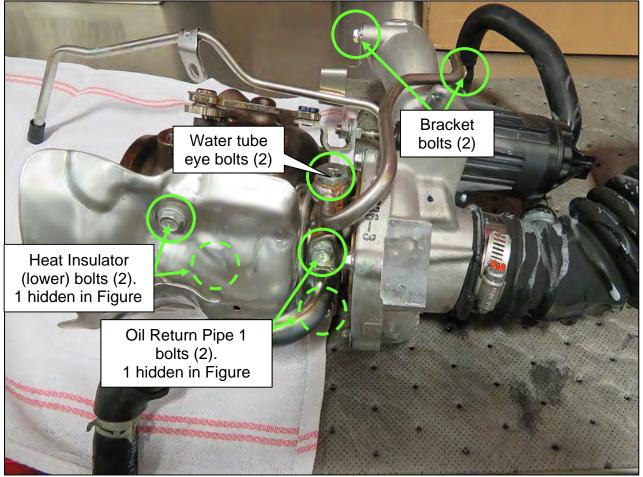
Figure 55

- Water tube eye bolt torque: 25.0 N•m (2.6 kg-m, 18 ft-lb) HINT: One (1) Water tube eye bolt is hidden in Figure 55.
- Bracket bolt torque: 9.0 N•m (0.92 kg-m, **80 in.-lb**)
- Oil Return Pipe 1 bolt torque: 9.0 N•m (0.92 kg-m, 80 in.-lb)
- Heat Insulator (lower) bolt torque: 9.0 N•m (0.92 kg-m, 80 in.-lb)
- If present, Turbocharger Speed Sensor (bank 1):
 - Wiring harness connector bracket to turbocharger torque: 7.0 N•m (0.71 kg-m, 62 in.-lb)
 - Wiring harness connector to bracket torque: 2.2 N•m (0.22 kg-m, 19 in.-lb)

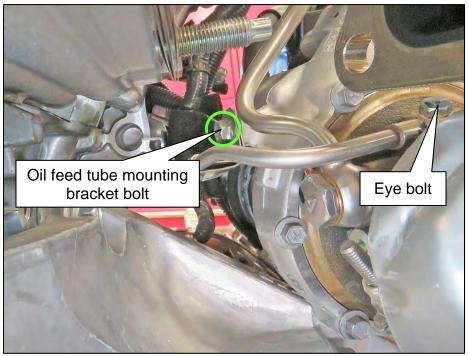
Figure 56

- 85. Install and temporarily tighten the eye bolt for the oil line, with a new gasket (Figure 56).
- 86. Reattach the oil feed tube mounting bracket with bolt (Figure 56) and torque to specification.

• Bolt torque: 9.0 N•m (0.92 kg-m, **80 in.-lb**)

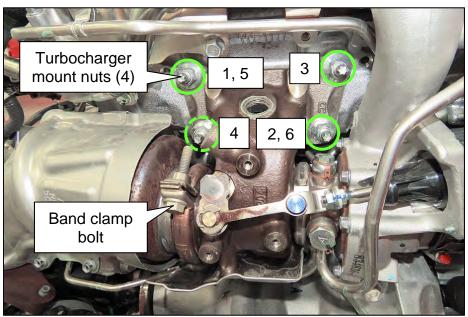
Figure 59

- 89. Install all four (4) turbocharger mount nuts, and then torque them in the order (from 1 to 6) shown in Figure 59.
 - Nut torque: 30.5 N•m (3.1 kg-m, **22 ft-lb**)
- 90. Align the Catalyst Converter (bank 1) with 2nd Catalyst Converter (bank 1) studs and install the nuts finger tight. See **PARTS INFORMATION** for new gasket.
- 91. Reattach the Catalyst Converter (bank 1) to the turbocharger outlet, and then lightly tighten the band clamp bolt enough to align catalyst, but allow it to rotate.

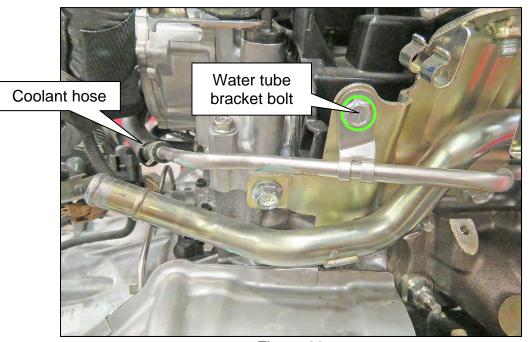
Figure 62

- 95. Reinstall the water tube bracket bolt (Figure 62) and torque to specification.
 - Bolt torque: 9.0 N•m (0.92 kg-m, **80 in.-lb**)
- 96. Reinstall the coolant hose and its spring clamp (Figure 62).

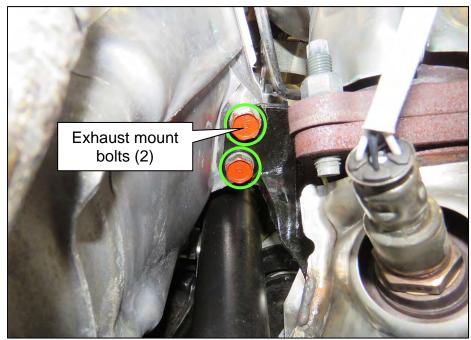
97. Reinstall the two (2) exhaust mount bolts shown in Figure 63 finger tight.

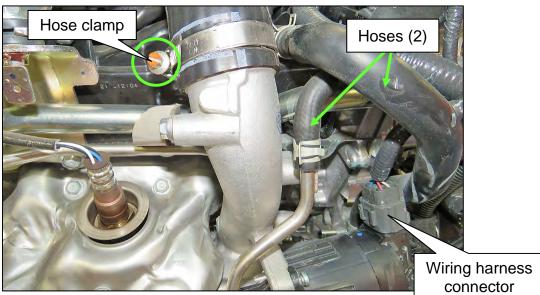
Figure 67

- 102. Tighten the hose clamp (Figure 67).
- 103. Reconnect the two (2) hoses (Figure 67).
- 104. Reconnect the wiring harness connector (Figure 67).
- 105. If the Turbocharger Exhaust Gas Temperature Sensor (bank 1) wiring harness connector was disconnected in step 74 on page 22, then reconnect it.

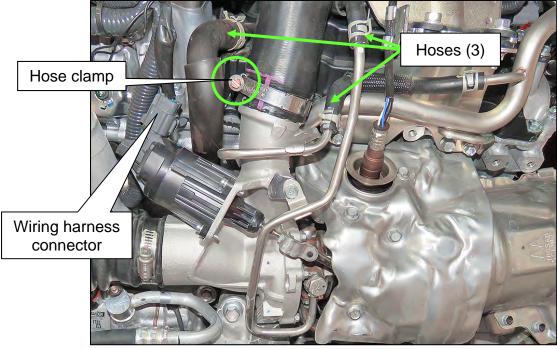
Figure 68

- 106. Loosen the hose clamp shown in Figure 68. This hose will be detached in step 124 on page 36.
- 107. Release the spring clamps and disconnect the three (3) associated hoses, shown in Figure 68.
- 108. Disconnect the wiring harness connector shown in Figure 68.

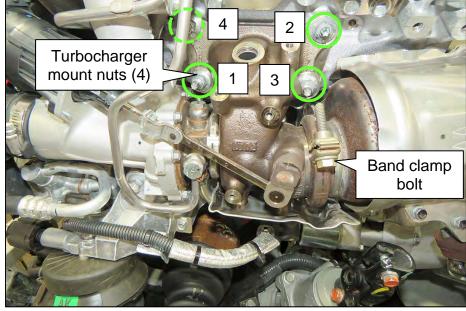
Figure 74

115. Loosen the turbocharger assembly mounting nuts in order, from 1 to 4, as shown in Figure 74.

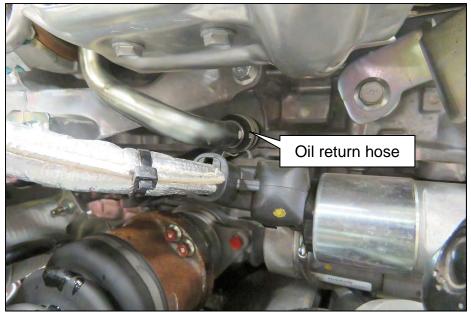
Figure 75

- 117. Detach Catalyst Converter (bank 2) from the turbocharger outlet.
- 118. Release the spring clamp and disconnect the associated oil return hose shown in Figure 75.

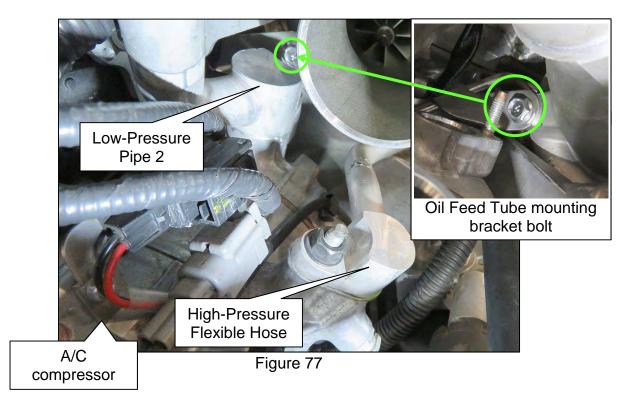
- 120. Remove both the A/C High-Pressure Flexible Hose and then the Low-Pressure Pipe 2 from the A/C compressor (Figure 77).
- 121. Remove the Oil Feed Tube mounting bracket bolt shown in Figure 77.

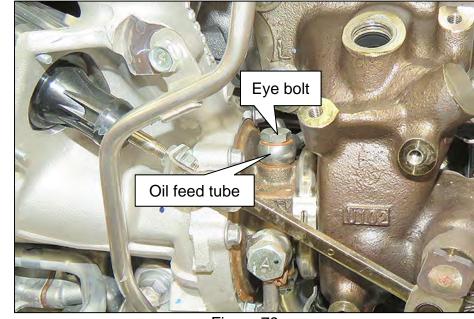
Figure 79

126. Install and temporarily tighten the eye bolt for the oil feed tube, with a new gasket (Figure 79).

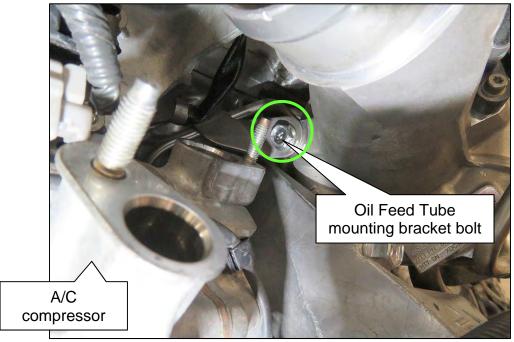
Figure 80

127. Reattach the Oil Feed Tube mounting bracket bolt (Figure 80), and then torque to specification.

• Bolt torque: 9.0 N•m (0.92 kg-m, **80 in.-lb**)

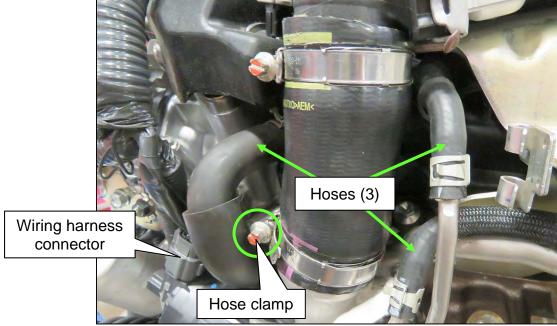
Figure 81

- 128. Align the turbocharger Air Inlet Hose 1 (bank 2) with the turbocharger output, and then slide the turbocharger onto its mounting studs.
 - Leave the turbocharger Air Inlet Hose 1 (bank 2) clamp loose at this time.
 - Replace the turbocharger to cylinder head gasket with a new one from **PARTS INFORMATION**.
- 129. Reconnect the wiring harness connector shown in Figure 81.
- 130. Reconnect the three (3) hoses shown in Figure 81.

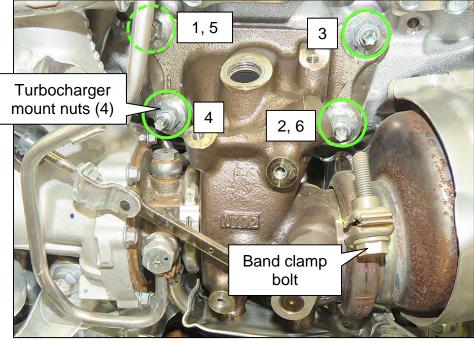
Figure 83

- 132. Install all four (4) turbocharger mount nuts, and then torque them in the order (from 1 to 6) shown in Figure 83.
 - Nut torque: 30.5 N•m (3.1 kg-m, 22 ft-lb)
- 133. Align the Catalyst Converter (bank 2) with 2nd Catalyst Converter (bank 2) studs and install the nuts finger tight.
- 134. Reattach the Catalyst Converter (bank 2) to the turbocharger outlet, and then lightly tighten the band clamp bolt just enough to align catalyst, but allow it to rotate.
 - Band clamp will be torqued in step 138 on page 42.

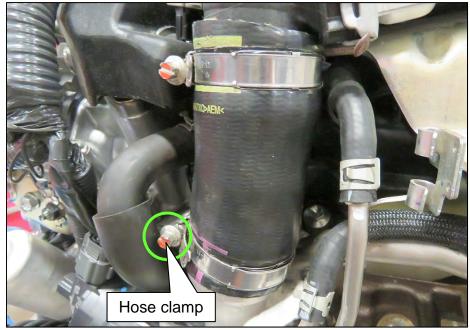
Figure 90

144. Tighten the hose clamp shown in Figure 90.

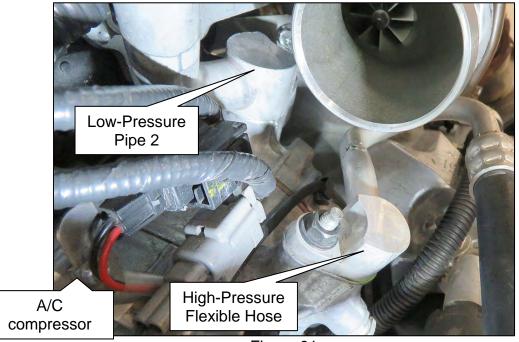
Figure 91

145. Reattach the Low-Pressure Pipe 2 and then the A/C High-Pressure Flexible Hose to the A/C compressor (Figure 91) and then torque to specification.

• Nut torque: 13.7 N•m (1.4 kg-m, 10 ft-lb)

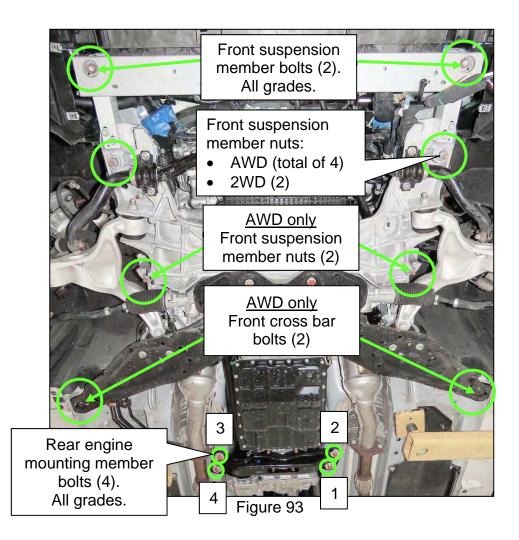
- 148. Reinstall and temporarily tighten the following nuts and bolts indicated in Figure 93.
 - AWD has a total of four (4) front suspension member nuts.
 - 2WD has two (2) front suspension member nuts.
 - Two (2) front suspension member bolts (both AWD and 2WD).
 - <u>AWD only</u>: Two (2) front cross bar bolts.
 - The rear engine mounting member bolts.

HINT: Figure 93 is of an AWD vehicle. Nut and bolt locations are similar for 2WD.

150. Torque the rear engine mounting member bolts in the pattern shown in Figure 93.

• Bolt torque: 49 N•m (5.0 kg-m, **36 ft-lb**).

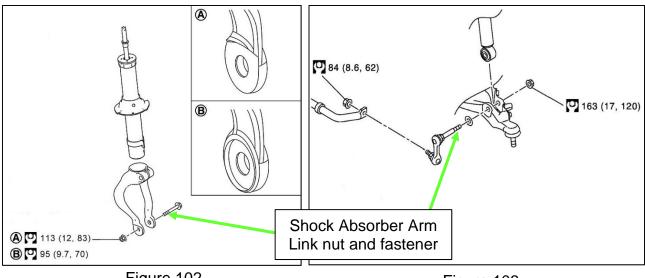
Figure 102

- 164. Reattach both Shock Absorber Arms to the Transverse Links with nuts and fasteners. and then torque to the specifications below.
 - For AWD torque, refer to Figure 102. .
 - For 2WD torque, refer to Figure 103. •

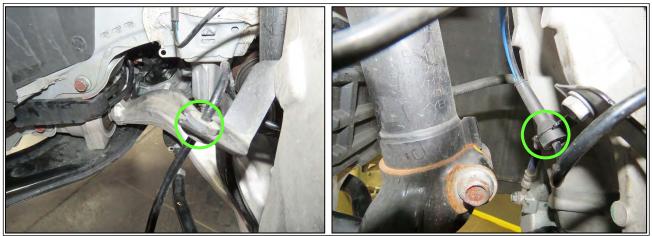
Figure 108

169. Reattach the wheel sensor harnesses to the two (2) locations, on each Steering Knuckle, shown in Figure 108.

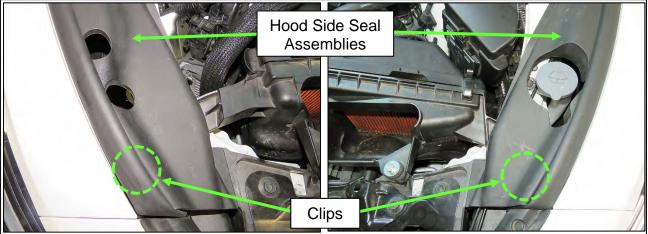
Figure 113

179. Reattach the passenger (RH) side and the driver (LH) side Hood Side Seal Assembly clips (Figure 113).

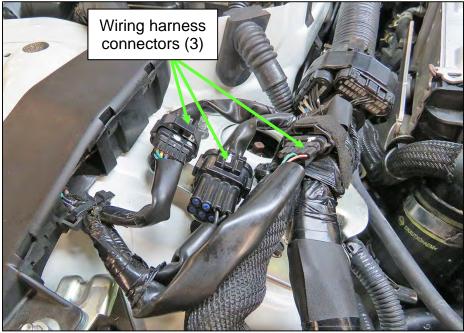
Figure 126

- 191. Reattach the positive battery cable to the battery terminal with fusible link.
 - Nut torque: 13.5 N•m (1.4 kg-m, 10 ft-lb)
- 192. Reconnect the three (3) wiring harness connectors shown in Figure 126.
