WML0 – Retrofitting Loudspeaker Booster (Delivery Stop)

Model Line: **Cayenne (9YA/9YB)**

Concerns: **Loudspeaker booster**

Action required: Retrofit loudspeaker booster.

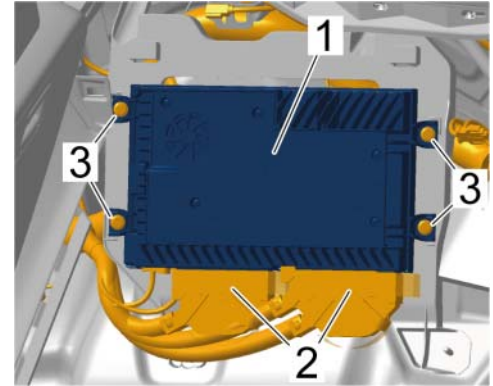
Loudspeaker booster

The number of connecting lines for the loudspeaker booster will vary depending on equipment and the connecting lines are located close to the installation position. These may be fastened in place and may have to be exposed beforehand.

- 2 Position loudspeaker booster ⇒ *Loudspeaker booster -1-*, screw in fastening screws ⇒ *Loudspeaker booster -3-* and tighten to **Tightening torque 6 Nm (4.5 ftlb.)** .

- 3 Plug in and lock electric plug connections ⇒ *Loudspeaker booster -2-*.
- 4 Install side trim panel for rear luggage compartment at the right. ⇒ *Workshop Manual '700319 Removing and installing side trim panel for rear luggage compartment'*
- 5 After installing the loudspeaker booster, continue as follows:
Continue with ⇒ *Technical Information '700319 Warranty processing'*
