**NUMBER:** 23-005-21 REV. A

Front Seat Side Shield Updated Service Procedure

2014 - 2019 (KL) Jeep Cherokee

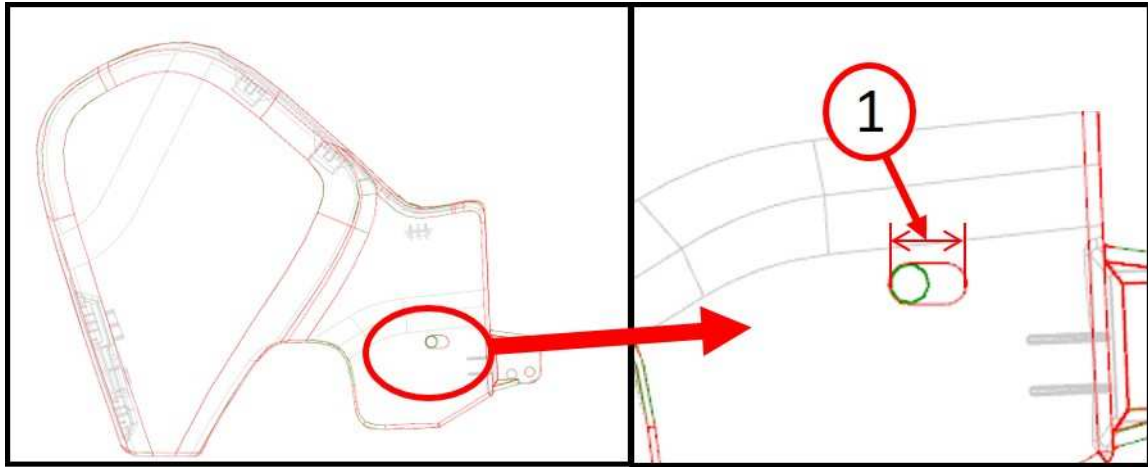
**Fig. 2**  
**Back Side Shield Modification Area**

1 - 12.5 mm (.5 in.) Hole

2. Remove inboard side shield. Refer to the detailed service procedures available in DealerCONNECT/Service Library under: Service Info 23 - Body / Seats, Front / Side Shields, Seat, Manual (or Power) / Removal.
3. Use a hand held rotary multi use tool or a file (Fig. 1) to elongate the hole to 12.5 mm (.5 in.) slot (Fig. 2) .
