TO: Mercedes-Benz Principals, General Managers, Sales Managers, Service Managers, Parts Managers	FROM: Anthony Washington, Department Manager, Regulations and Certifications
<b>Re: Recall Campaign Launch Notification Models 907 (Sprinter) Model Years 2019-2020 Remove Power Sliding Door Function</b>	DATE: December, 2022

<b>Campaign No. :</b>	<b>Campaign Desc. :</b>	<b>Remove Power Sliding Door Function</b>
<b>2022120001</b>	<b>VS3SCHIEBT</b>	
<p>This is to notify you of a <b>Recall Campaign Launch</b> to remove power sliding door function on approximately <b>56</b> MY19-20 Mercedes-Benz Sprinter vans. The recall campaign will be visible on the <a href="http://www.safercar.gov">www.safercar.gov</a> website and may generate questions from customers. All affected VINs will be flagged "<b>OPEN</b>" in VMI and <b>cannot be sold</b> until remedied.</p>		
<b>Background</b>		
<b>Issue</b>	<p>Mercedes-Benz AG ("MBAG"), the manufacturer of Mercedes-Benz vans, has determined that certain Sprinter vehicles from platform 907 (VS30) that are equipped with an optional electric sliding door may have been manufactured with an auxiliary lock on the sliding door that was not specified for use in conn

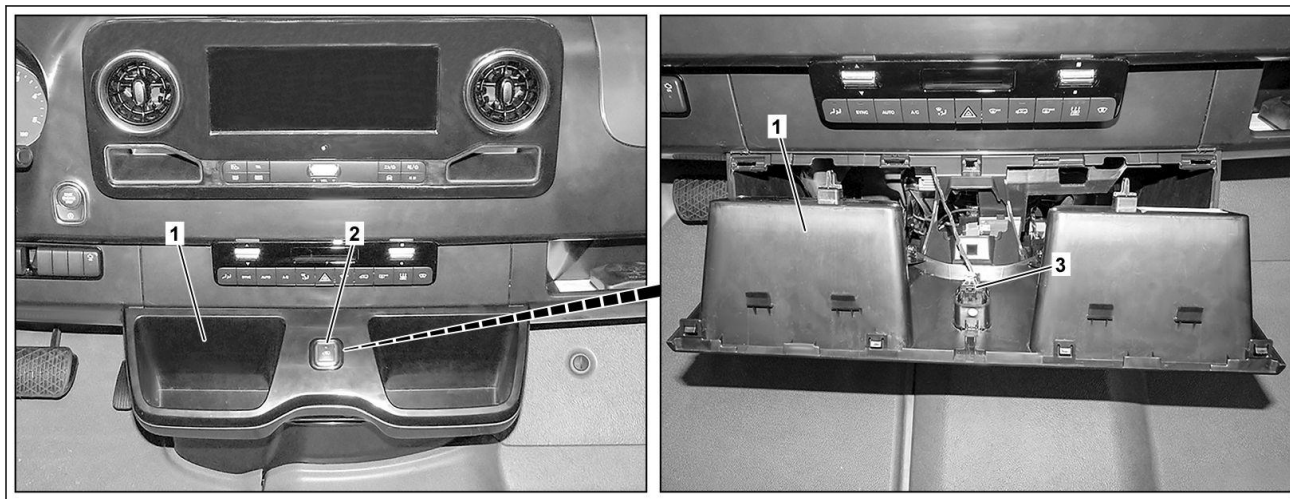
D72.16-A045-08

**Shown on vehicle with automatic transmission**

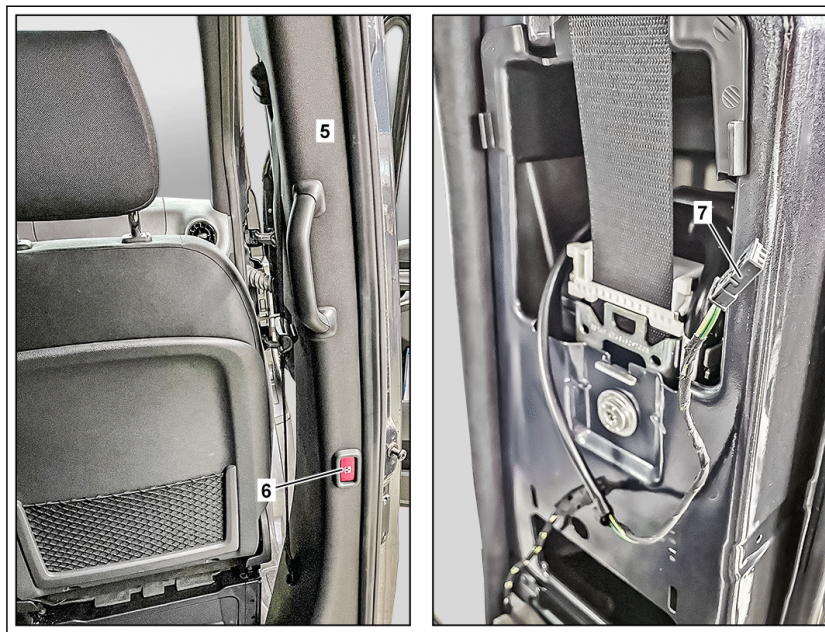
D72.16-A043-76

**Shown on vehicle with code T74  
(Grab handle for entrance)**

- 5 B-pillar paneling
- 6 Switches
- 7 Connector

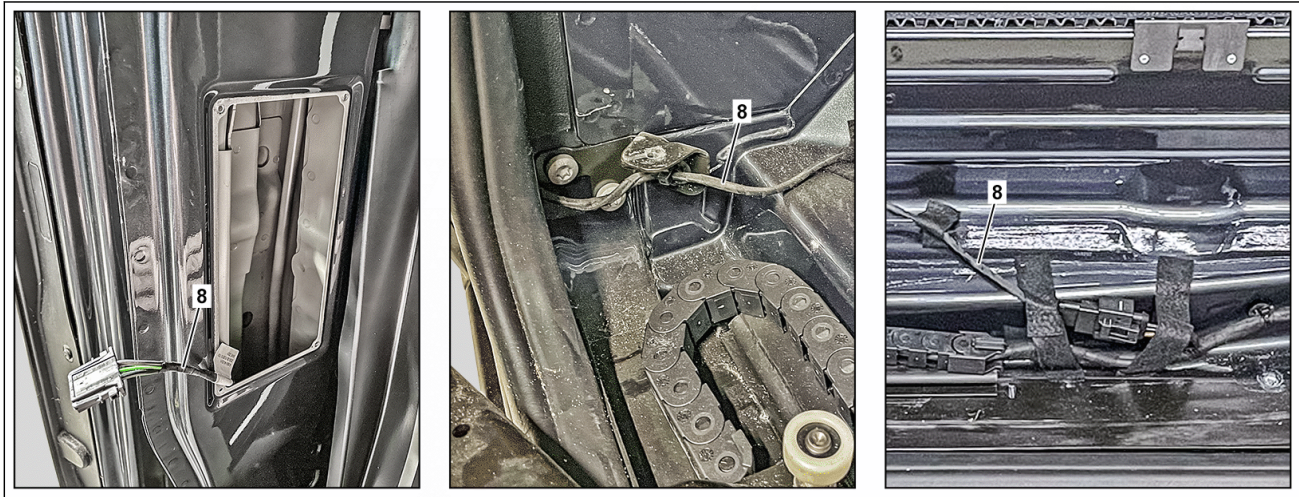
D72.16-A051-78

8 Closing assist motor electrical wiring harness

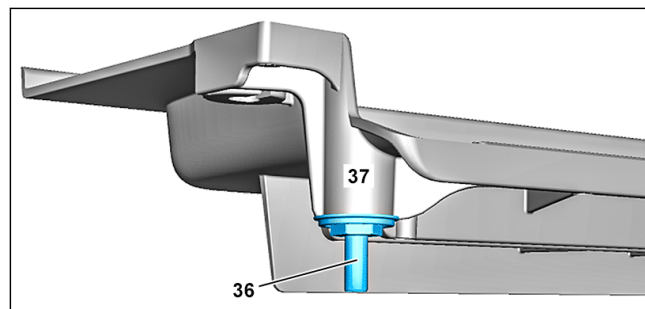
D72.16-A058-80

36 Retaining bolt

37 Guide rail

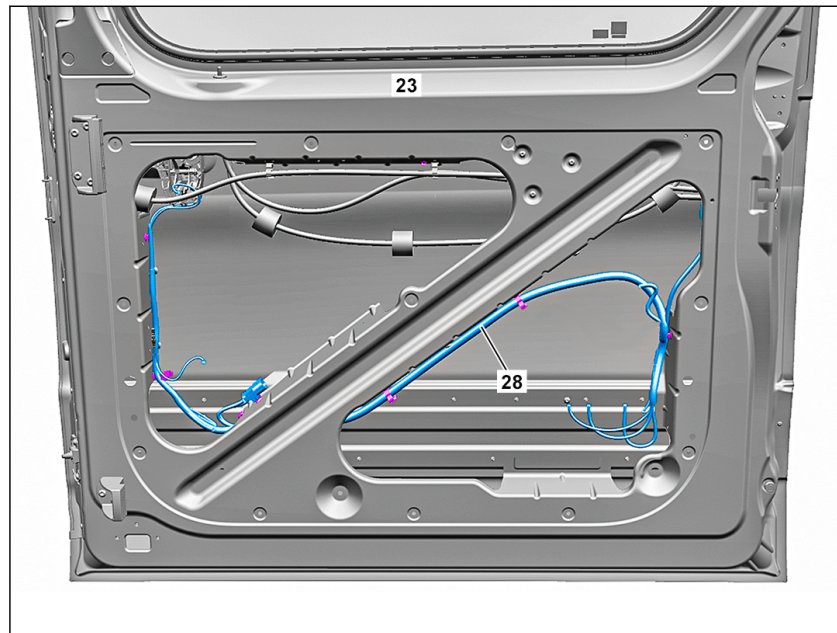
D72.16-A049-76

- 1 Remove electrical wiring harness (28).

The electrical wiring harness (28) is no longer required.

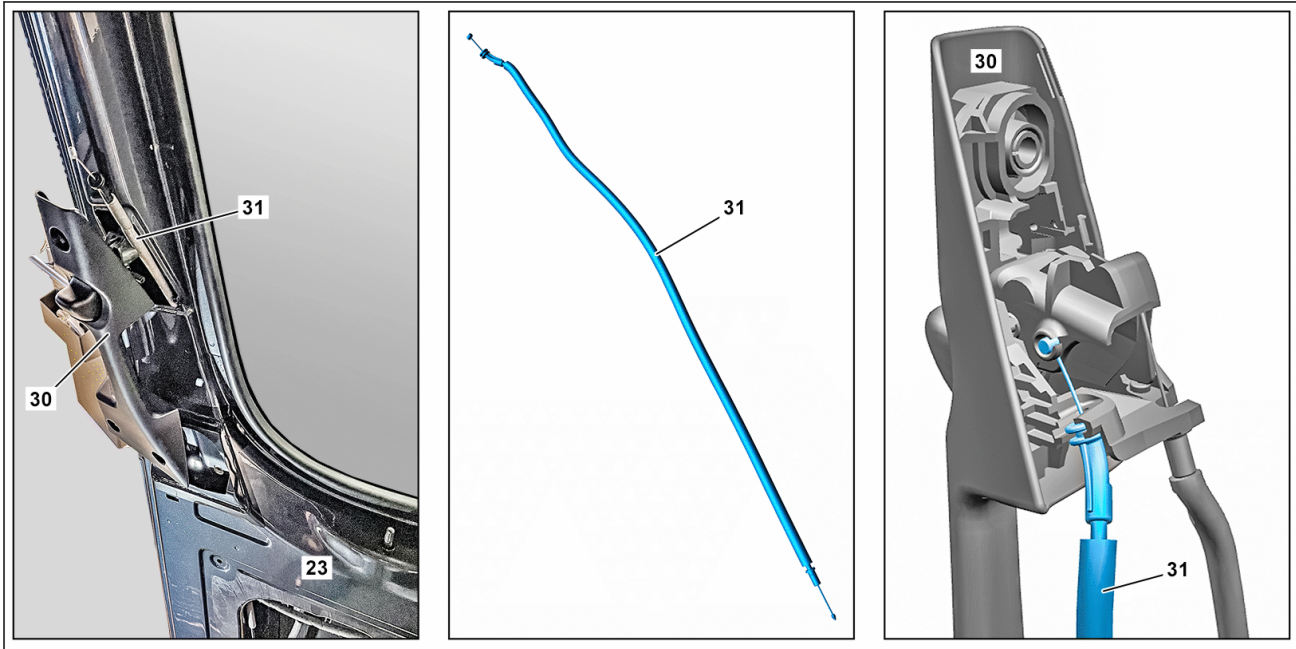
D72.16-A054-79

- 3 Route cable (31) through sliding door (23) to door handle (30).  
 ⚠ Handle cables carefully and do not kink them.  
 Damage may occur otherwise.

- 4 Install cable (31) in door handle (30).

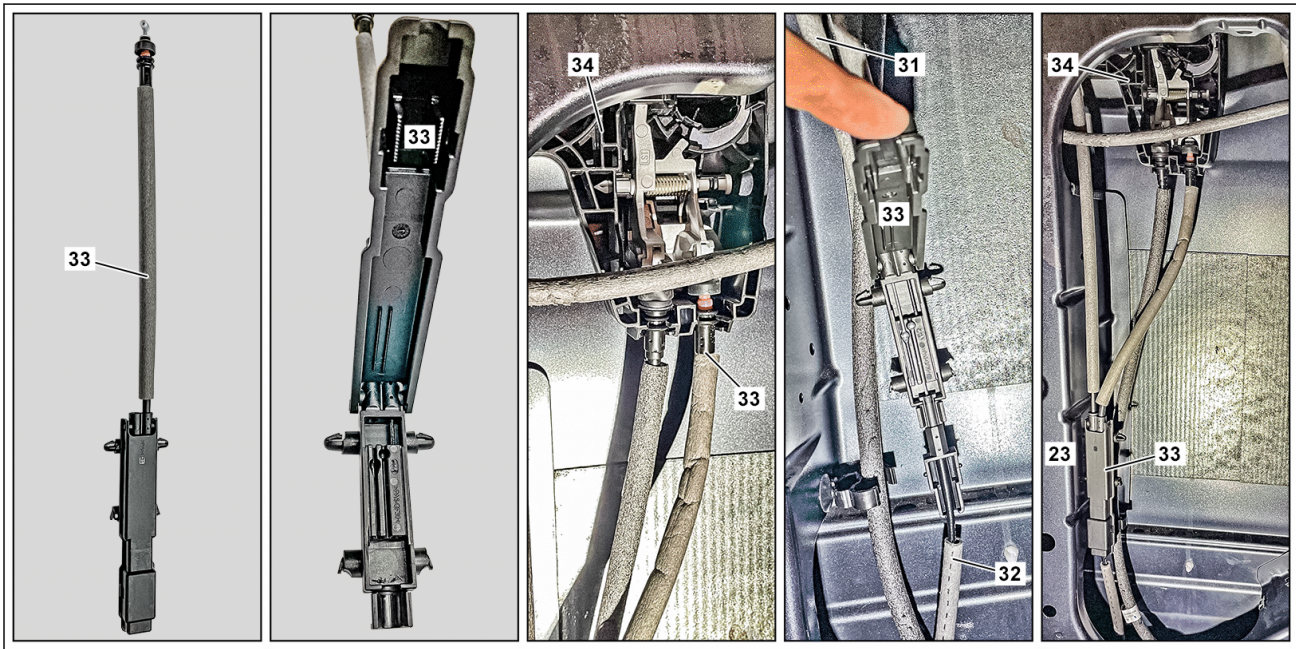
D72.16-A056-79

- 5 Open cable (33).

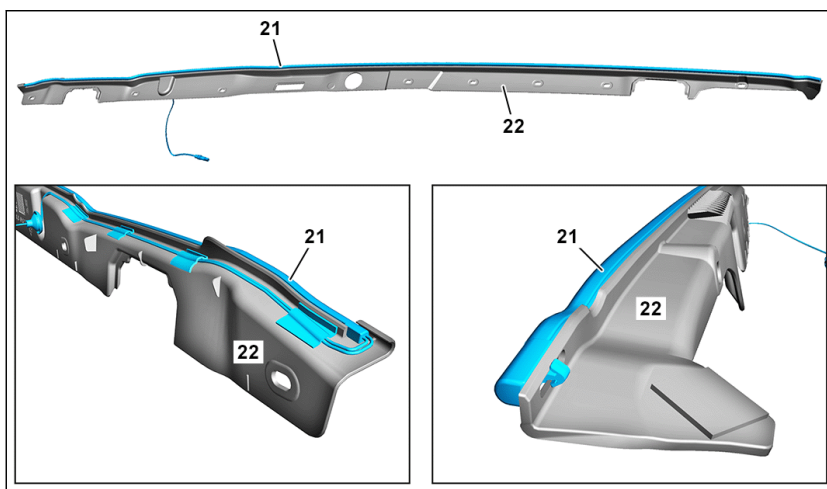
D72.16-A052-75

The anti-entrapment strip (21) is no longer required.

- 10 Install trim (22) on sliding door (23).

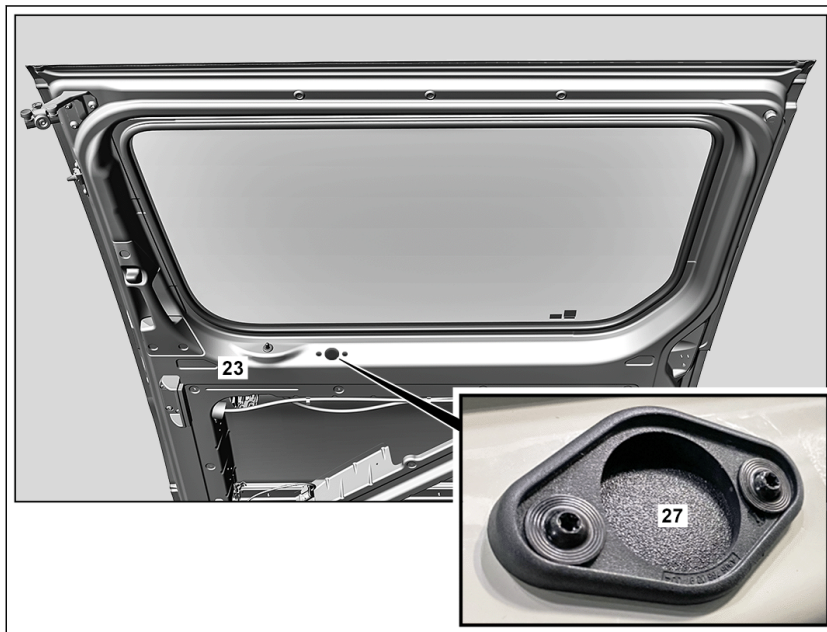
D72.16-A048-76

- 15 Remove information label (35) from sliding door.

**i**  
The information label is no longer required.

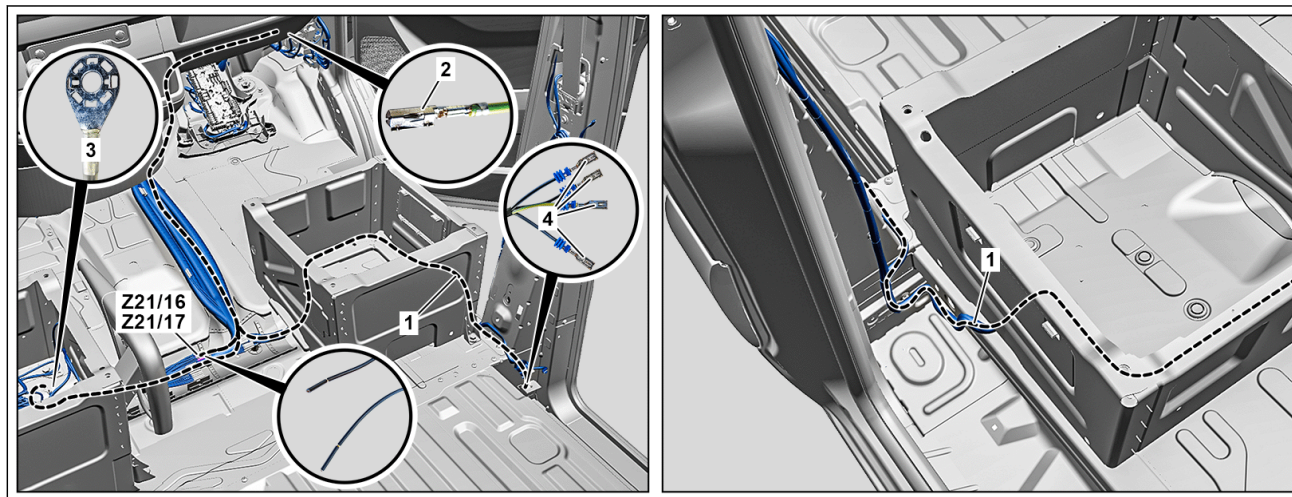
D72.16-A060-78

### Route electrical wiring harness (1)

- 3 Loosely fasten electrical wiring harness (1) in sections at factory-installed electrical wiring harness or at a suitable position using cable ties.

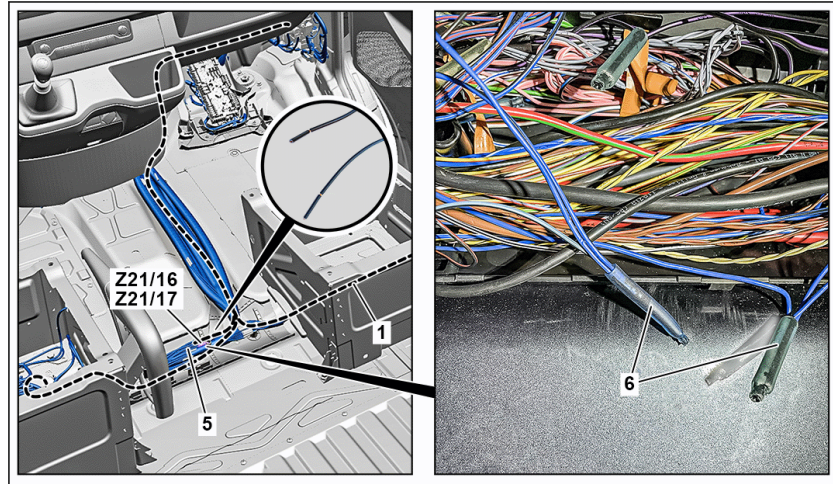
D72.16-A038-75

| 5 | <p>Connect electric line "BU/BK" of electrical wiring harness (5) and electric line "BU/BK" of electrical wiring harness (1) to new end sleeve (6).</p> <p><b>i</b><br/>To do so, use heat gun with reflector or adapter.<br/> Use basic wiring harness repair kit.</p> | 7 | <p>Connect electric line "BU/BN" of electrical wiring harness (5) and electric line "BU/BN" of electrical wiring harness (1) to new end sleeve (6).</p> <p><b>i</b><br/>To do so, use heat gun with reflector or adapter.<br/> Use basic wiring harness repair kit.</p> |

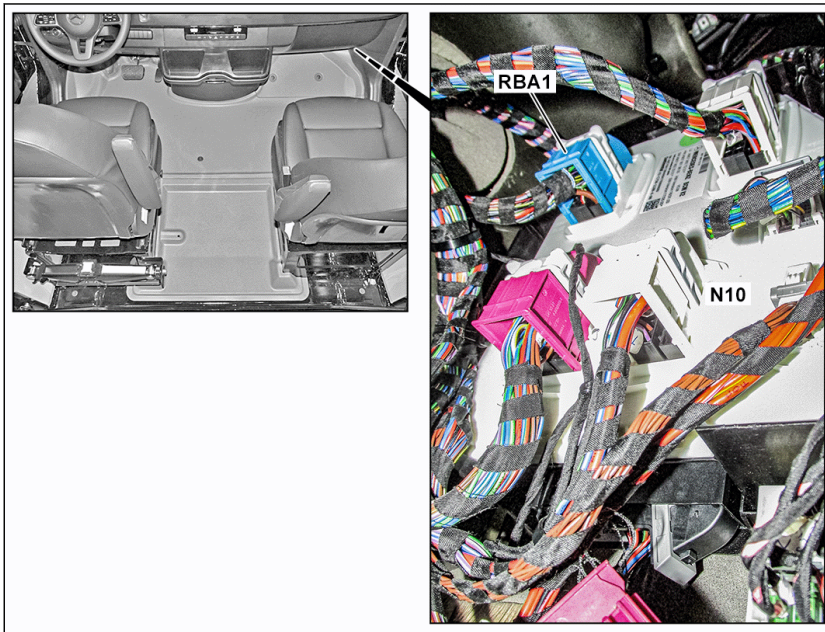
D72.16-A039-76

**Electrical wiring harness (1) to signal acquisition and actuation module (SAM) control unit**

- 8 Release and disconnect electrical connector (RBA1) from SAM (N10).

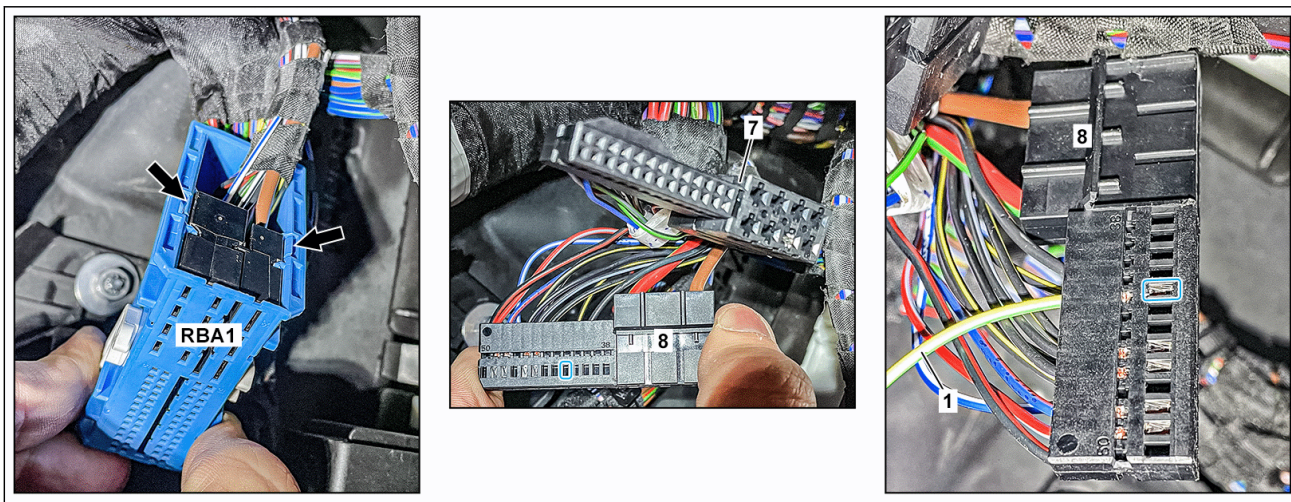
D72.16-A040-78

- 9 Disassemble electrical connector (RBA1).  
 ⓘ  
 To do so, release plug housing (arrows A), guide out plugs (7, 8) and disconnect from each other.
- 10 Install electric line "YE/GN" of electrical wiring harness (1) into contact cavity 42 of plug (8).
- 11 Assemble electrical connector (RBA1).  
 ⓘ  
 To do so, connect plugs (7, 8) and guide into plug housing, then lock.
- 12 Use cable ties to fasten electric line "YE/GN" directly behind plug housing of electrical connector (RBA1) to factory-installed electrical wiring harness.

14 Connect electrical connector (RBA1) to SAM control unit (N10).

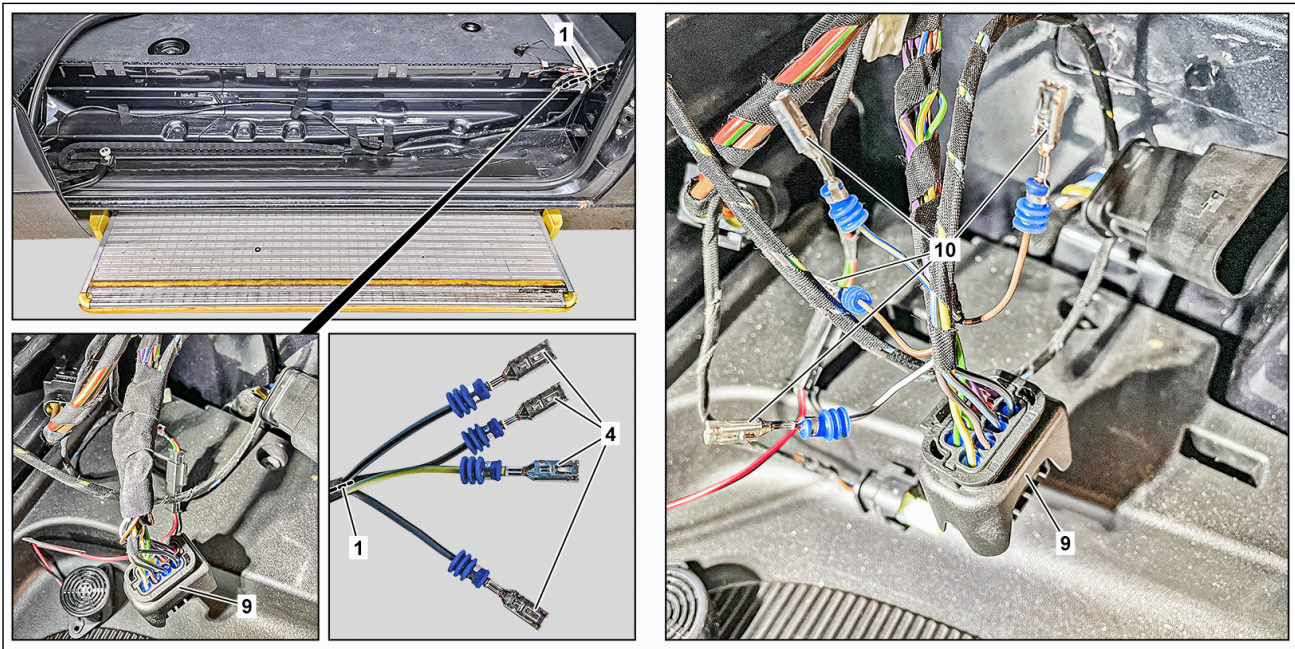
D72.16-A061-79

**Electrical wiring harness (1) to "Right sliding door electrical connector 1 (B-pillar) (X100/11x1)" or "Right**

use basic wiring harness repair kit.
- 16 Use fabric tape to individually insulate removed contact sockets (10).
- 17 Strap down removed contact sockets (10) at suitable point using cable tie.
- 19 Connect plug (9) to plug (11).

- 18 Install contact sockets (4) in plug (9).  
*i*  
 Contact cavity 1: Electric line **"YE/GN"**  
 Contact cavity 2: Electric line **"BN"**  
 Contact cavity 3: Electric line **BU/BN**  
 Contact cavity 4: Electric line **"BU/BK"**  
 Contact cavity 5: Electric line **"VT/YE"**  
 Contact cavity 6: Electric line **"VT/BK"**

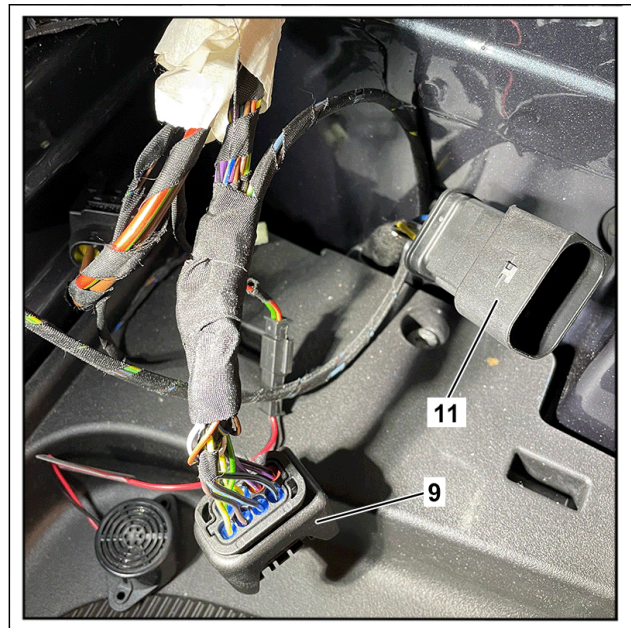
D72.16-A062-82

- 20 Remove plug connector (51) from closing assist motor electrical wiring harness (8).
- i**  
For this purpose, **S** use basic wiring harness repair kit.
- 21 Install blind plugs (9) into plug connector (51).
- 22 Reinstall plug connector (51) on factory-installed electrical wiring harness.

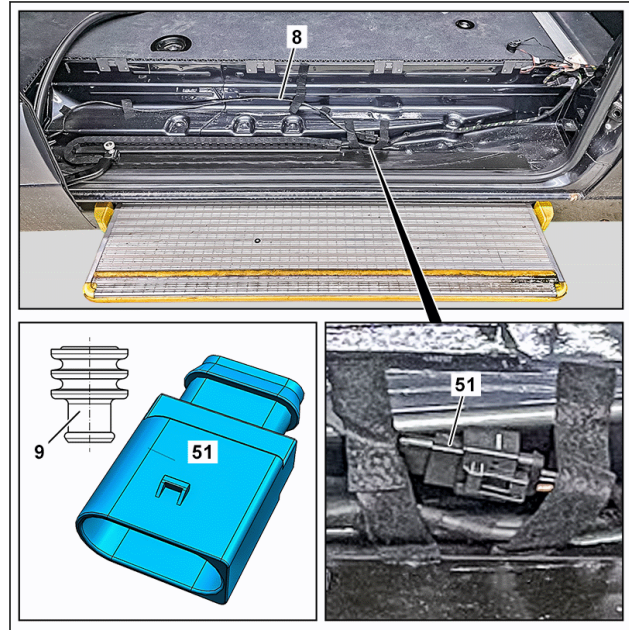
D72.16-A082-82

#### Electrical wiring harness (1) to ground connection

- 23 Remove nut of driver seat base ground point 1 (W105/1).
- 24 Connect cable lug (3) of electrical wiring harness (1) to driver seat base ground point 1 (W105/1).
- 25 Attach nut of driver seat base ground point 1 (W105/1) **Nm**.

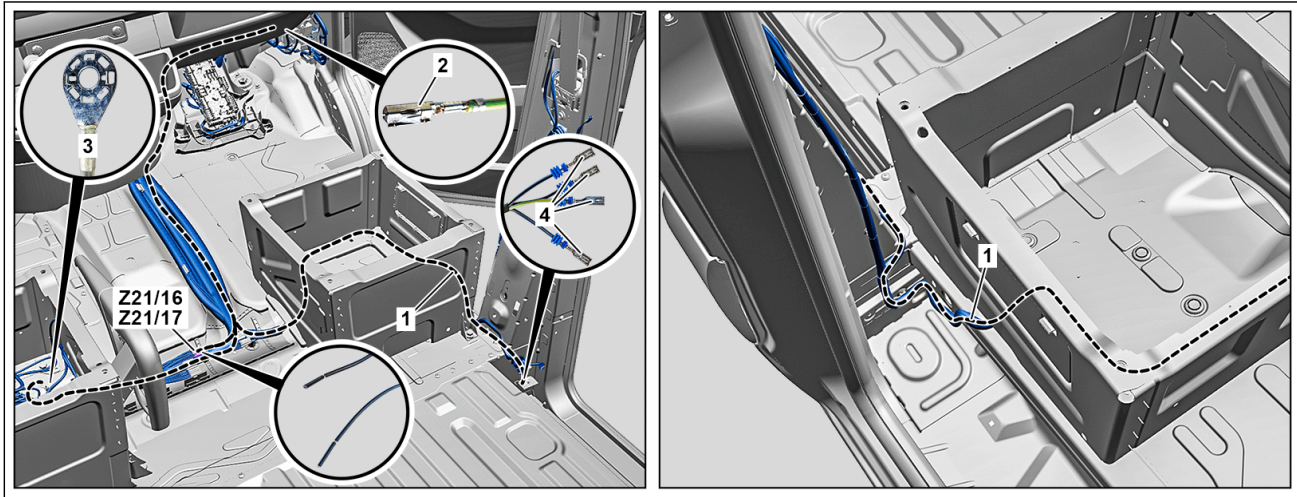
D72.16-A060-78

### Tighten electrical wiring harness (1)

- 26 Tighten loosely attached cable ties on complete electrical wiring harness (1).  
If necessary,

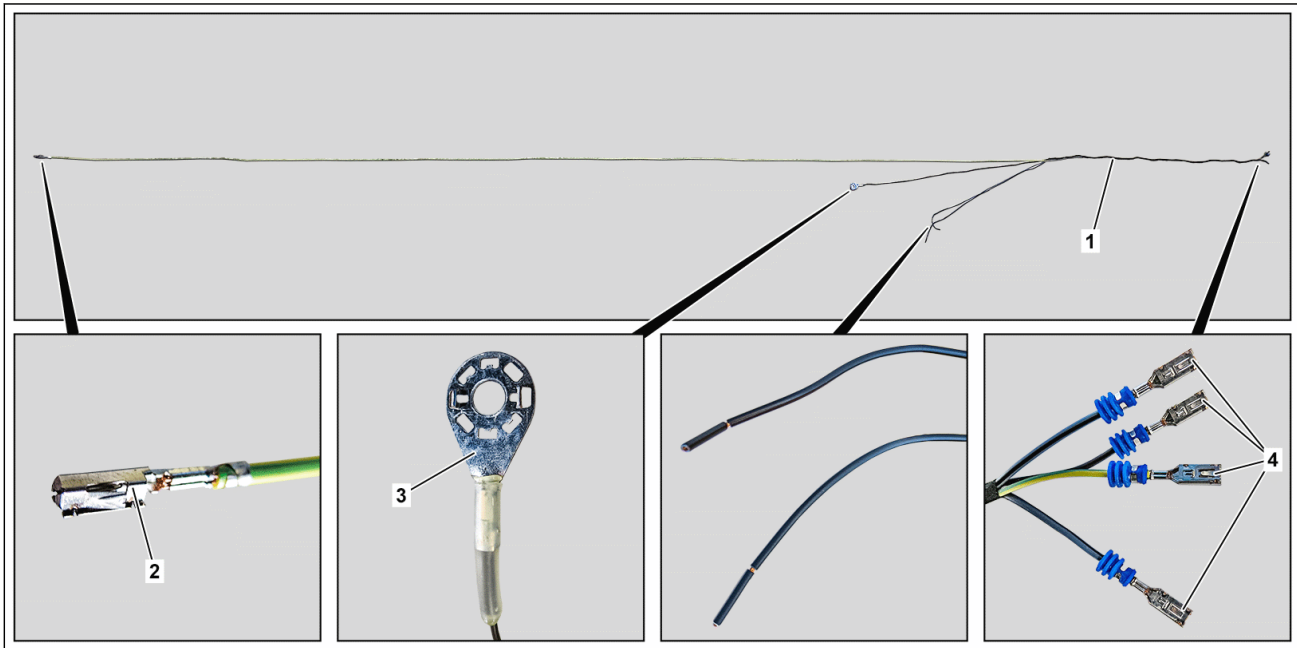
D72.16-A036-79

| <p>2 Prepare electric line "BN".</p> <p><b>i</b></p> <p>X100/1 to W105/1<br/>Line color "BN"<br/>Length approx. 255 cm<br/>Cross section 0.5 mm<sup>2</sup></p> | <p>5 Crimp contact socket (2) onto electric line "YE/GN".</p> <p><b>i</b></p> <p> Use basic wiring harness repair kit.</p> <p><b>i</b></p> <p>A 013 545 76 26 Contact socket</p> |
| <p>3 Prepare electric line "BU/BK".</p> <p><b>i</b></p> <p>X100/1 to Z21/16<br/>Line color "BU/BK"<br/>Length approx. 232 cm<br/>Cross section 0.75 mm<sup>2</sup></p> | <p>6 Crimp cable lug (3) onto electric line "BN".</p> <p><b>i</b></p> <p> Use basic wiring harness repair kit.</p> <p><b>i</b></p> <p>A 001 982 57 02 Cable lug</p> |
| <p>4 Prepare electric line "BU/BN".</p> | <p>7 Crimp contact sockets (4) on one side onto electric lines "YE/GN", "BN", "BU/BK", "BN/BN".</p> <p><b>i</b></p> <p> Use basic wiring harness repair kit.</p> |

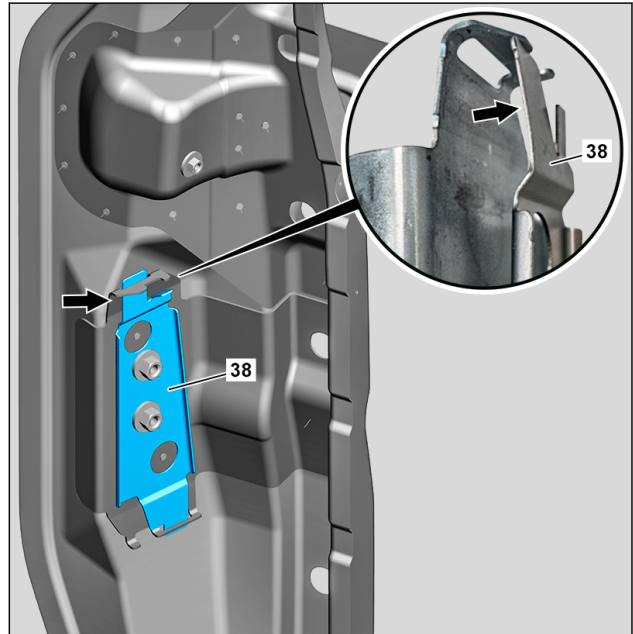
D72.16-A078-82

- 2 Install reinforcement (38) on C-pillar (40).

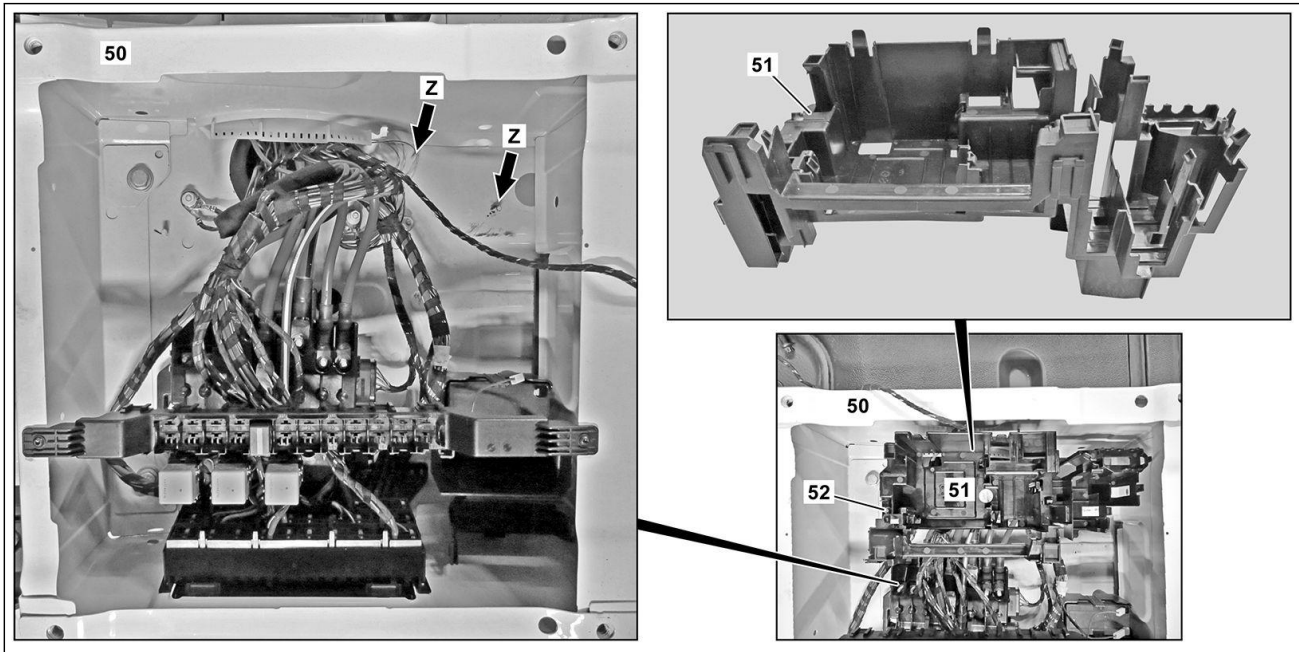
51 Control unit bracket

52 Nut

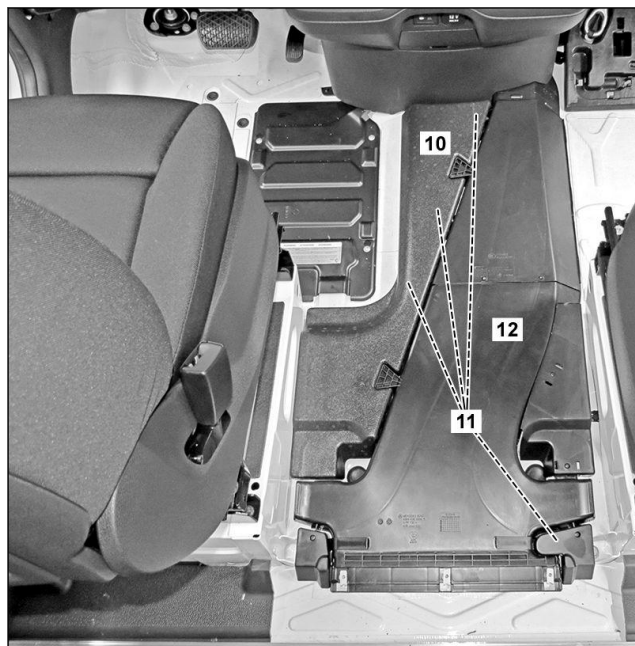
D31.19-1216-12

**Shown on model 907.7 without S23 (Front passenger bench seat)**

- 10 Cover
- 11 Nuts
- 12 Air duct

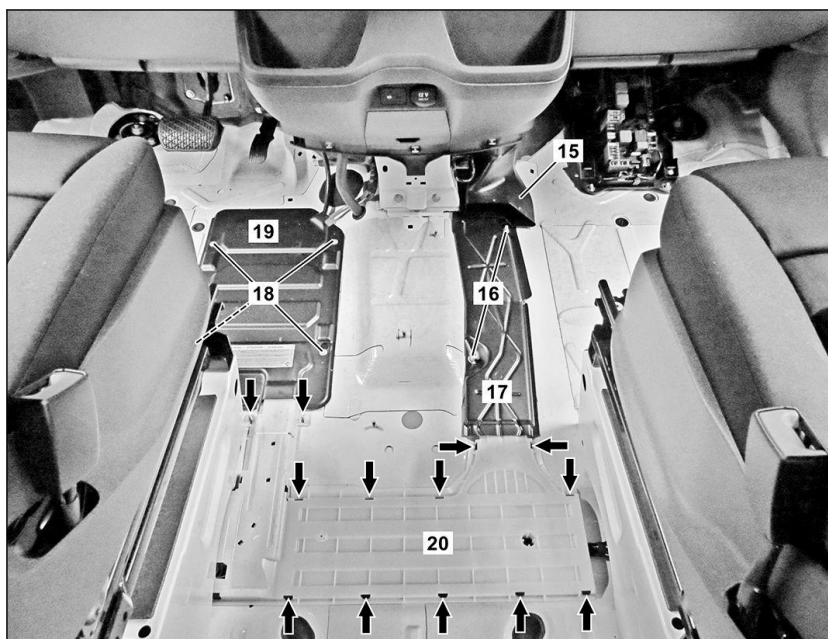
D31.19-1217-06

**Shown on model 907.7 without S23 (Front passenger bench seat)**

- 15 Air duct
- 16 Nuts
- 17 Cable duct
- 18 Bolts
- 19 Battery cover
- 20 Cover

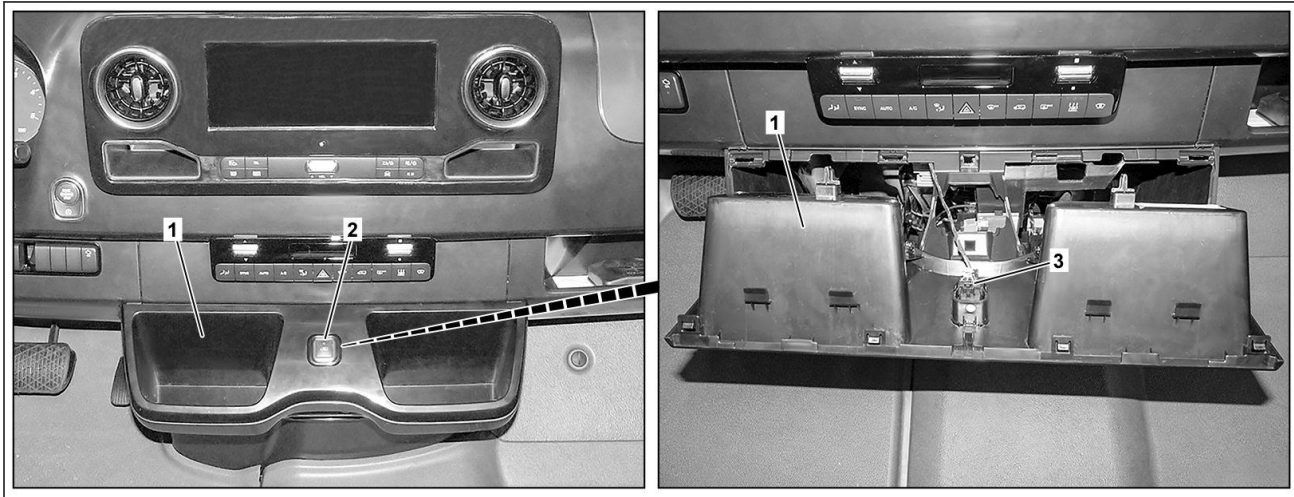
D72.16-A045-08

**Shown on vehicle with automatic transmission**

- 1 Stowage compartment
- 2 Switches
- 3 Connector
- 4 Cover

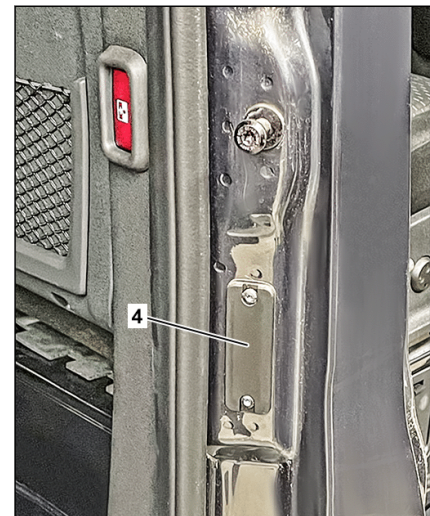
D72.16-A044-72

**Shown on vehicle with code T74  
(Grab handle for entrance)**

- 5 B-pillar paneling
- 6 Switches
- 7 Connector

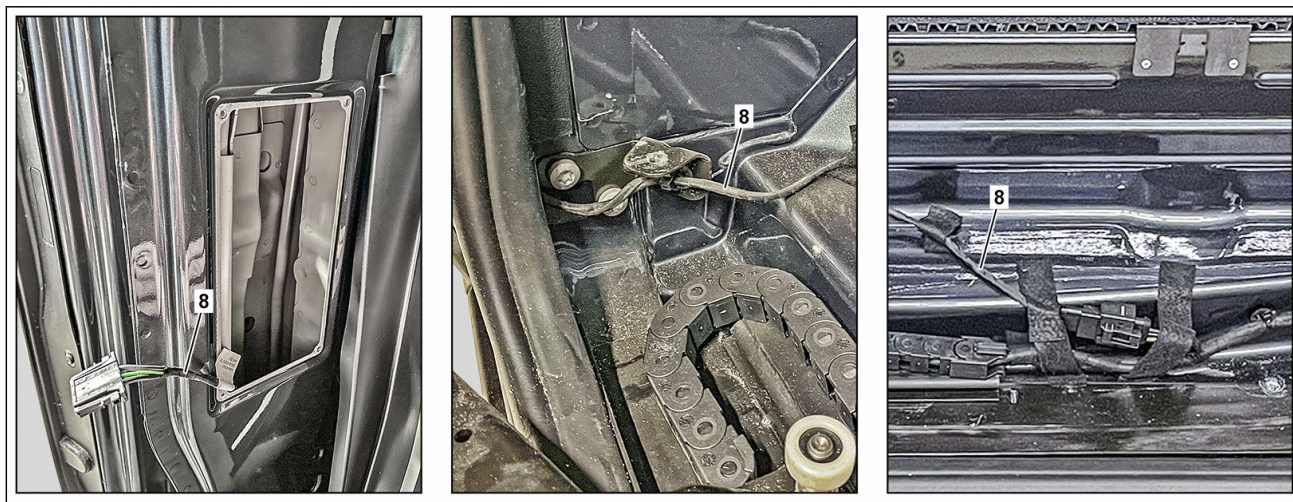
D72.16-A051-78

- 8 Closing assist motor electrical wiring harness

- 9 Blind plug
- 13 Connector
- 14 Connector

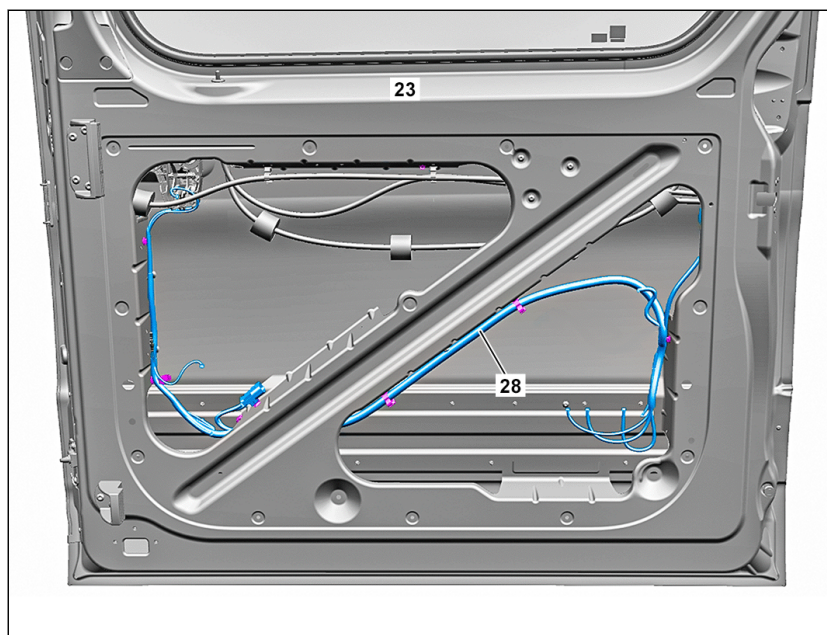
D72.16-A049-76

- 1 Remove electrical wiring harness (28).

The electrical wiring harness (28) is no longer required.

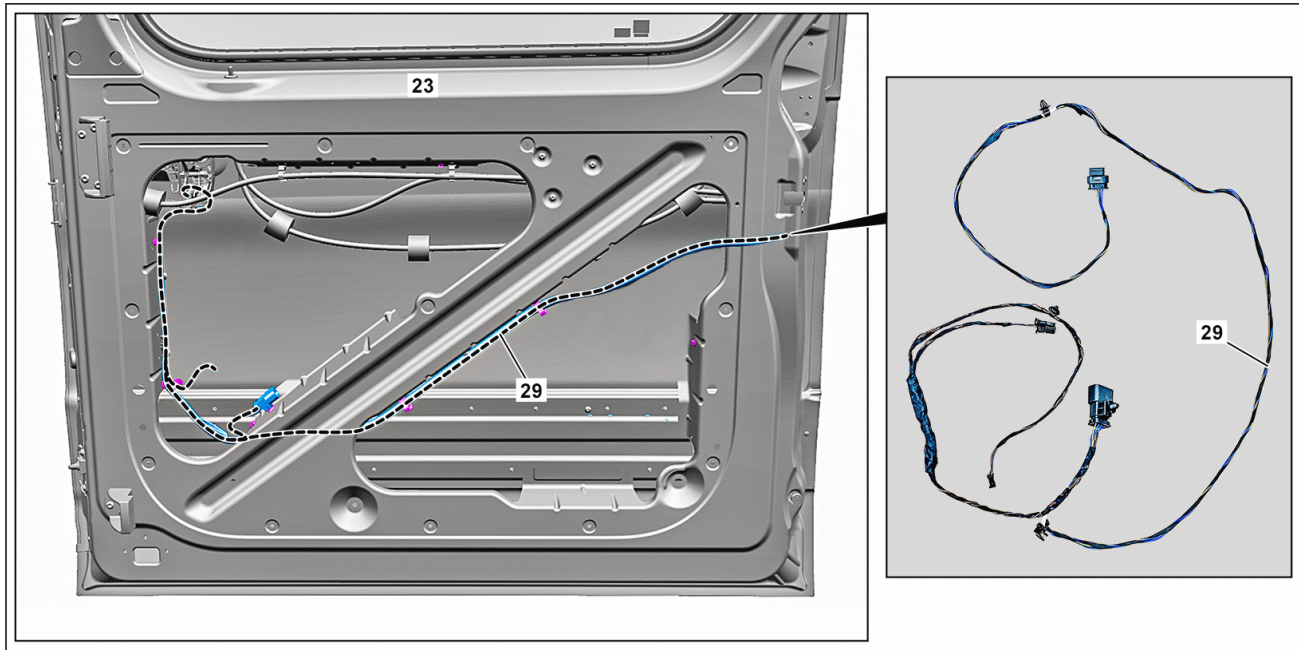
D72.16-A050-79

**Shown on model 907.7 with code EL9 (2-way speaker system, front and rear)**

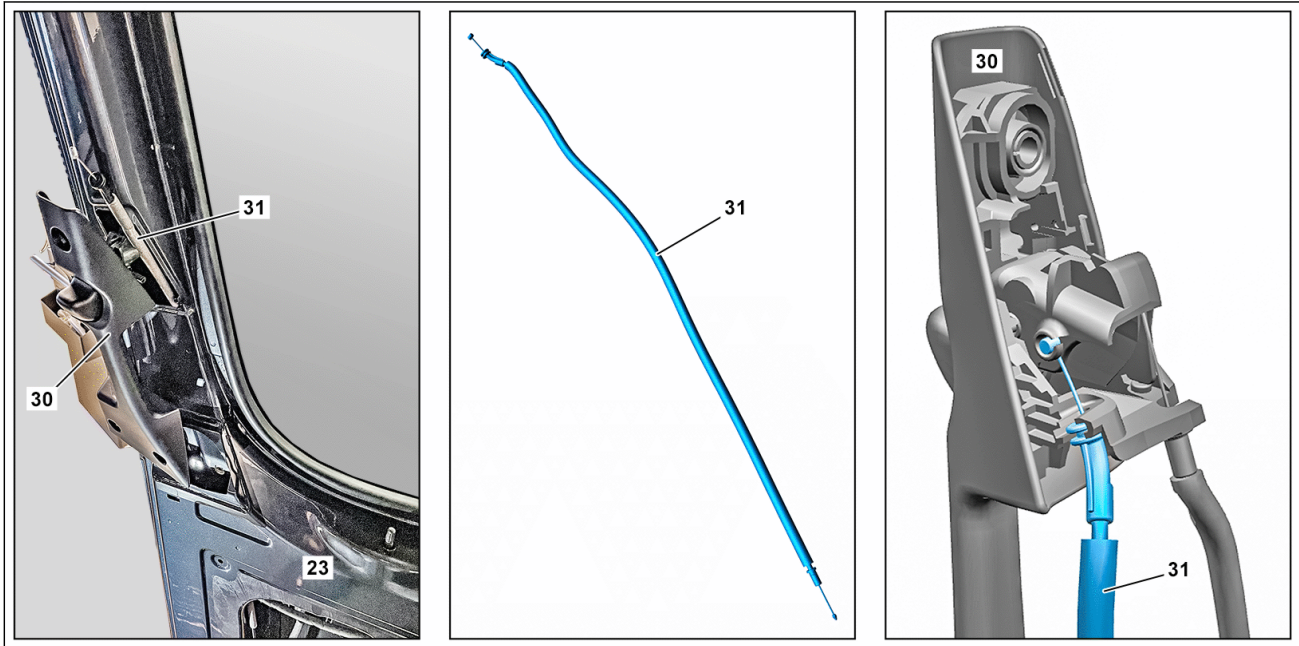
D72.16-A054-79

- 3 Route cable (31) through sliding door (23) to door handle (30).  
 ⓘ  
 Handle cables carefully and do not kink them.  
 Damage may occur otherwise.

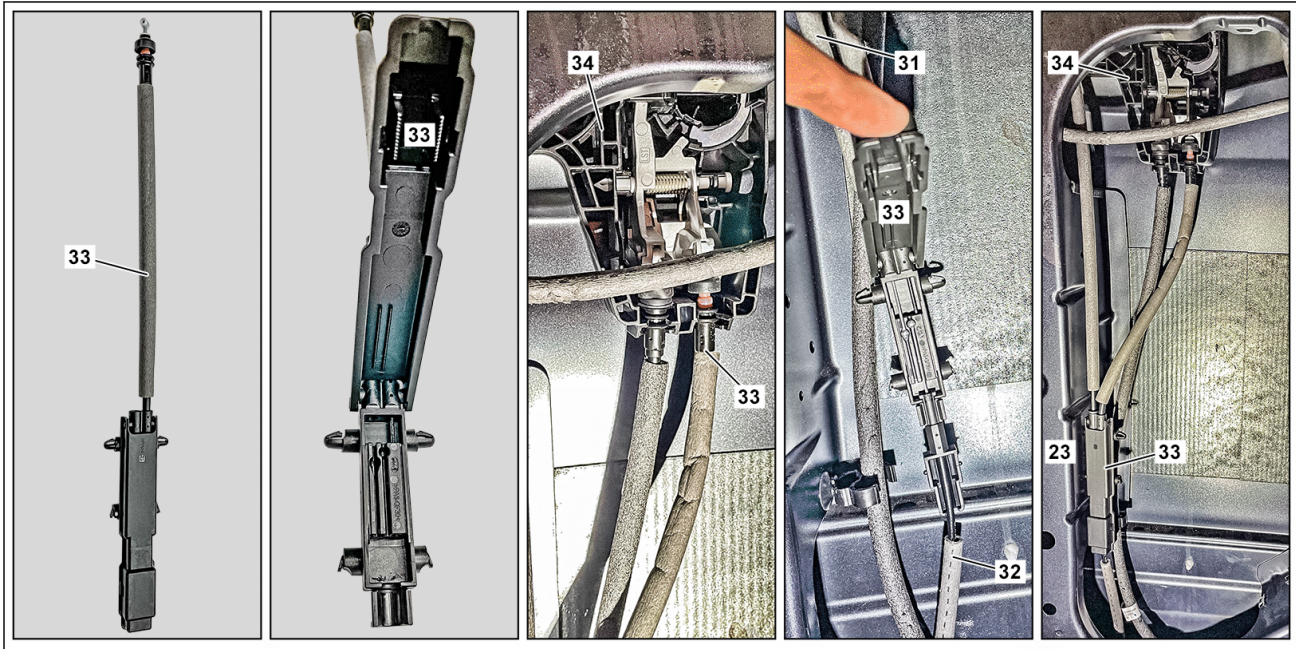
D72.16-A056-79

- 6 Open cable (33).  
i  
 A 910 760 15 00
- 7 Install cable (33) in bearing bracket (34).
- 8 Install cable (31) and cable (32) in cable (33).
- 9 Close cable (33) and clip into sliding door (23).  
i  
 Continue in the higher-level service document.

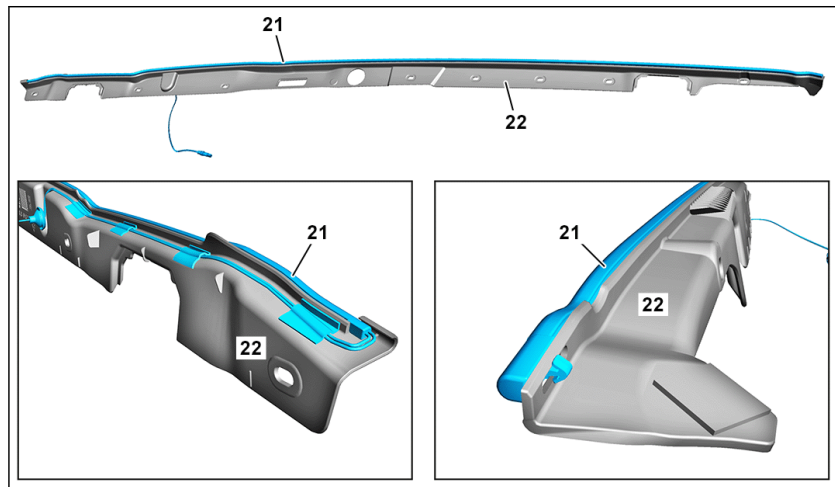
D72.16-A052-75

- 10 Remove anti-entrapment strip (21) from trim (22).  
i  
 To do so, remove anti-entrapment strip (21) using clip remover then remove adhesive tape.  
i  
 The anti-entrapment strip (21) is no longer required.

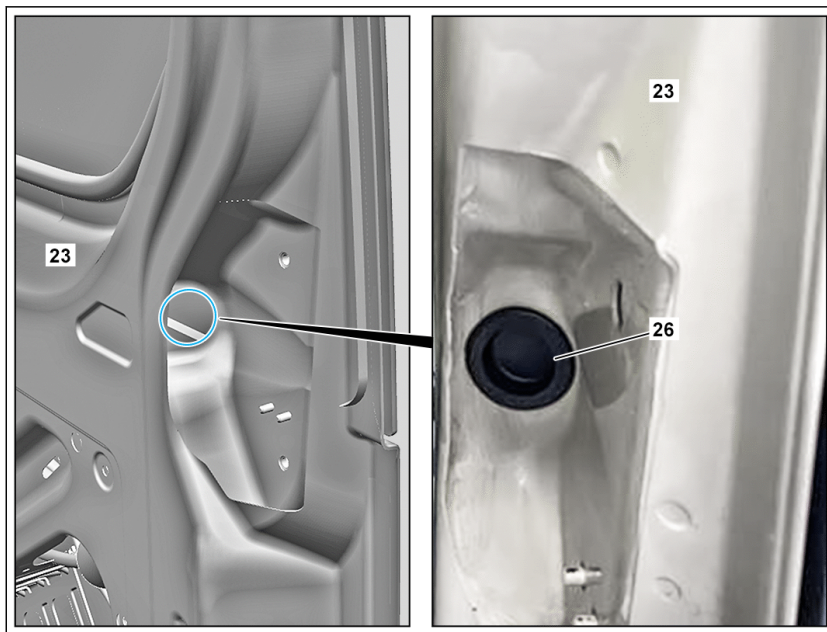
D72.16-A047-76

13 Install cover (27) at old position of switch for deactivation of electric sliding door (23).

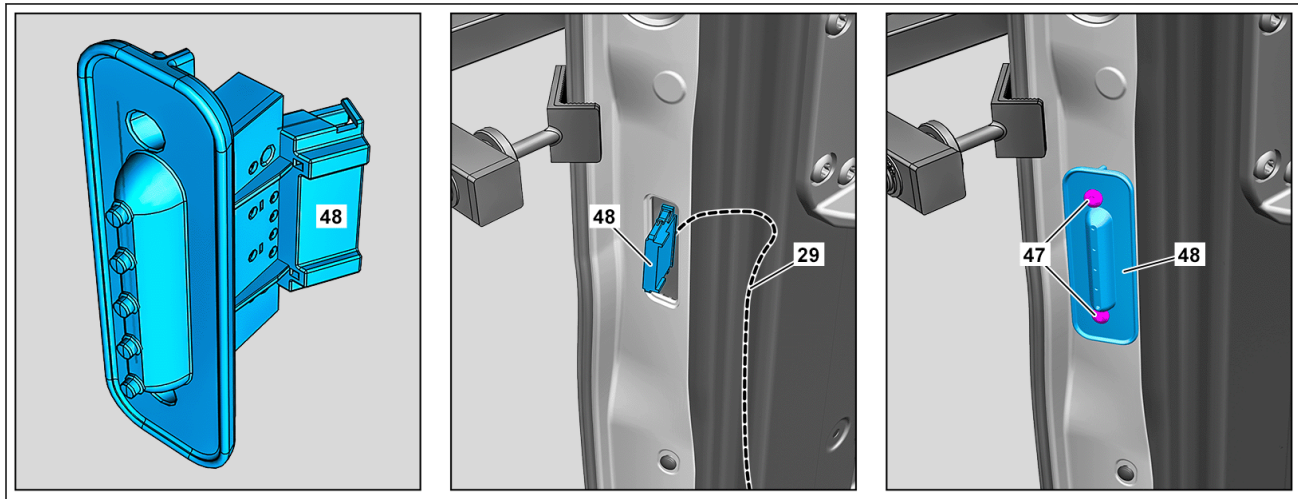
D72.16-A077-78

- 22 Connect contact switch (48) to plug connector (49) of new electrical wiring harness (29).

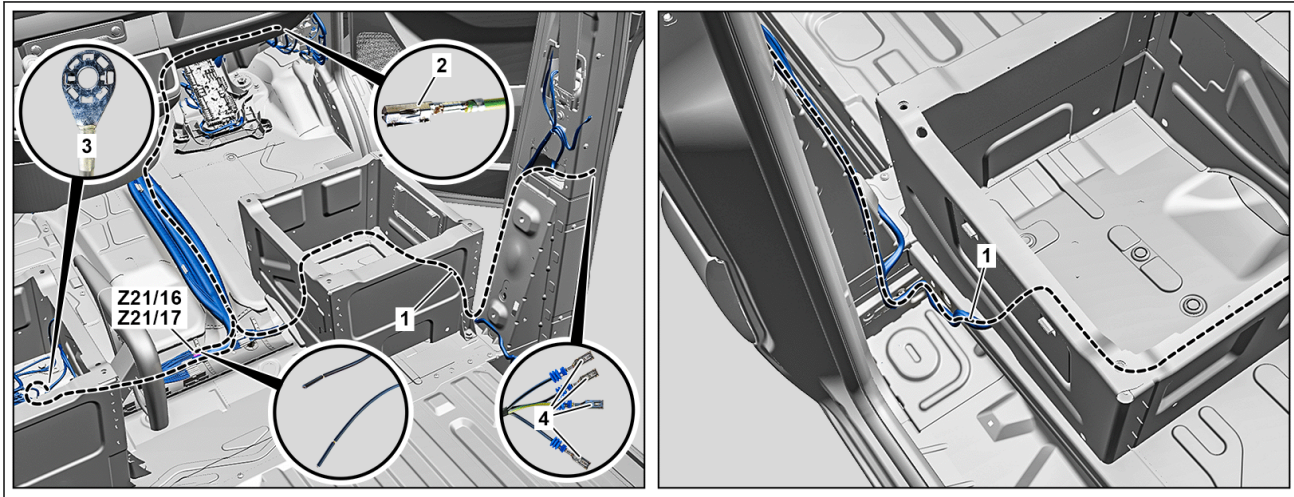
D72.16-A037-78

### Route electrical wiring harness (1)

- 3 Loosely fasten electrical wiring harness (1) in sections at factory-installed electrical wiring harness or at a suitable position using cable ties.

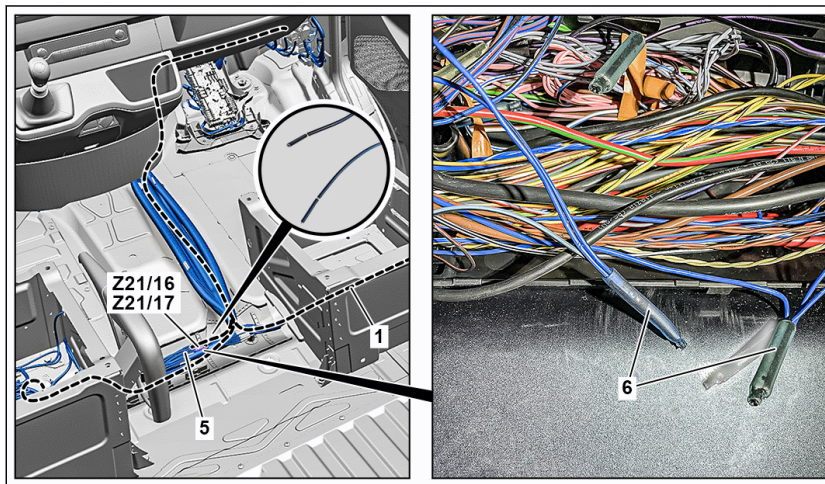
D72.16-A038-75

| 5 | <p>Connect electric line "BU/BK" of electrical wiring harness (5) and electric line "BU/BK" of electrical wiring harness (1) to new end sleeve (6).</p> <p><b>i</b><br/>To do so, use heat gun with reflector or adapter.<br/> Use basic wiring harness repair kit.</p> | 7 | <p>Connect electric line "BU/BN" of electrical wiring harness (5) and electric line "BU/BN" of electrical wiring harness (1) to new end sleeve (6).</p> <p><b>i</b><br/>To do so, use heat gun with reflector or adapter.<br/> Use basic wiring harness repair kit.</p> |

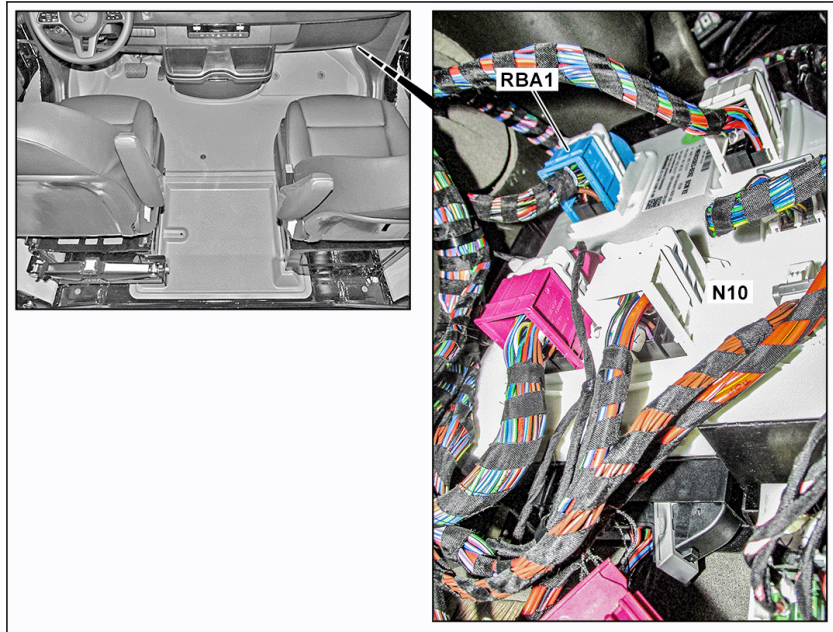
D72.16-A039-76

**Electrical wiring harness (1) to signal acquisition and actuation module (SAM) control unit**

- 8 Release and disconnect electrical connector (RBA1) from SAM (N10).
