TO: Mercedes-Benz Principals, General Managers, Sales Managers, Service Managers, Parts Managers	FROM: Anthony Washington, Department Manager, Regulations and Certifications
<b>Re: Recall Campaign Launch Notification Models 907 (Sprinter) Model Years 2019-2020 Remove Power Sliding Door Function</b>	DATE: December, 2022

<b>Campaign No. :</b>	<b>Campaign Desc. :</b>	<b>Remove Power Sliding Door Function</b>
<b>2022120001</b>	<b>VS3SCHIEBT</b>	
<p>This is to notify you of a <b>Recall Campaign Launch</b> to remove power sliding door function on approximately <b>56</b> MY19-20 Mercedes-Benz Sprinter vans. The recall campaign will be visible on the <a href="http://www.safercar.gov">www.safercar.gov</a> website and may generate questions from customers. All affected VINs will be flagged "<b>OPEN</b>" in VMI and <b>cannot be sold</b> until remedied.</p>		
<b>Background</b>		
<b>Issue</b>	<p>Mercedes-Benz AG ("MBAG"), the manufacturer of Mercedes-Benz vans, has determined that certain Sprinter vehicles from platform 907 (VS30) that are equipped with an optional electric sliding door may have been manufactured with an auxiliary lock on the sliding door that was not specified for use in conn

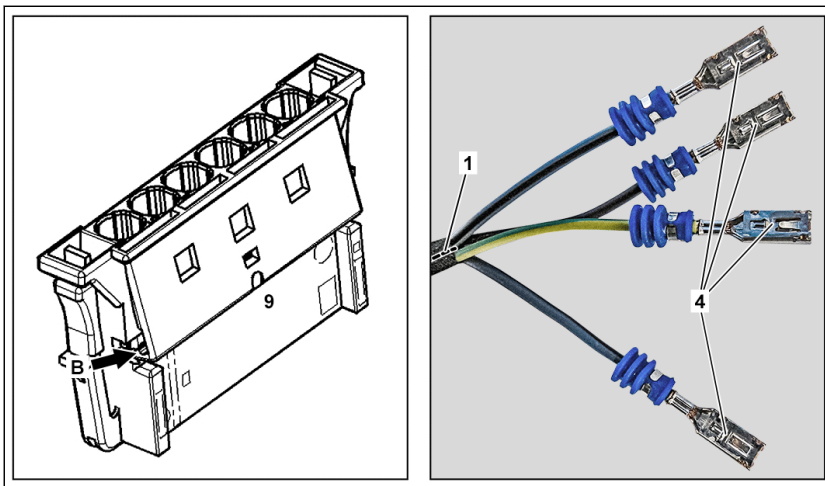
D72.16-A041-75

Electrical wiring harness (1) to "Right sliding door contact plate 1 electrical connector (X100/1)" (plug (9))

15 Release plug (9) (arrow B).

Electrical wiring harness (1) to "Right sliding door contact plate 1 electrical connector (X100/1)" (plug (9))

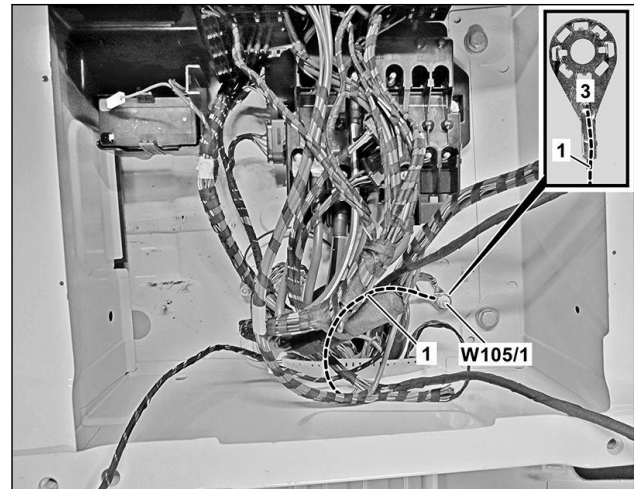
D72.16-A042-11

### Electrical wiring harness (1) to ground connection

- 18 Remove nut of driver seat base ground point 1 (W105/1).
- 19 Connect cable lug (3) of electrical wiring harness (1) to driver seat base ground point 1 (W105/1).
- 20 Attach nut of driver seat base ground point 1 (W105/1) [Nm](#).

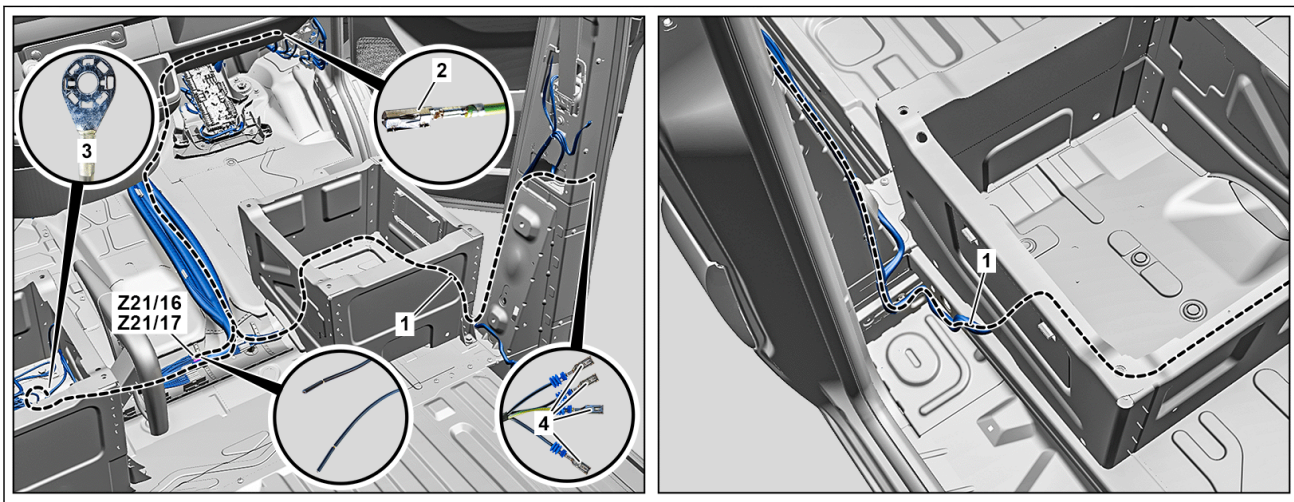
D72.16-A037-78

### Tighten electrical wiring harness (1)

- 21 Tighten loosely attached cable ties on complete electrical wiring harness (1).  
If necessary,
- ↓
- Strap down extended length of electrical wiring harness (1) at a suitable point.

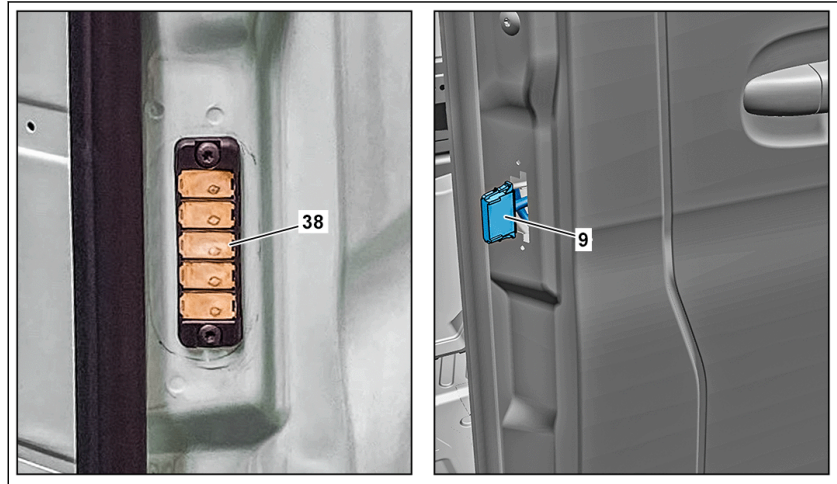
D72.16-A059-75

- 22 Install contact plate (38).  
**i**  
To do so, connect plug (9) and screw in screws.

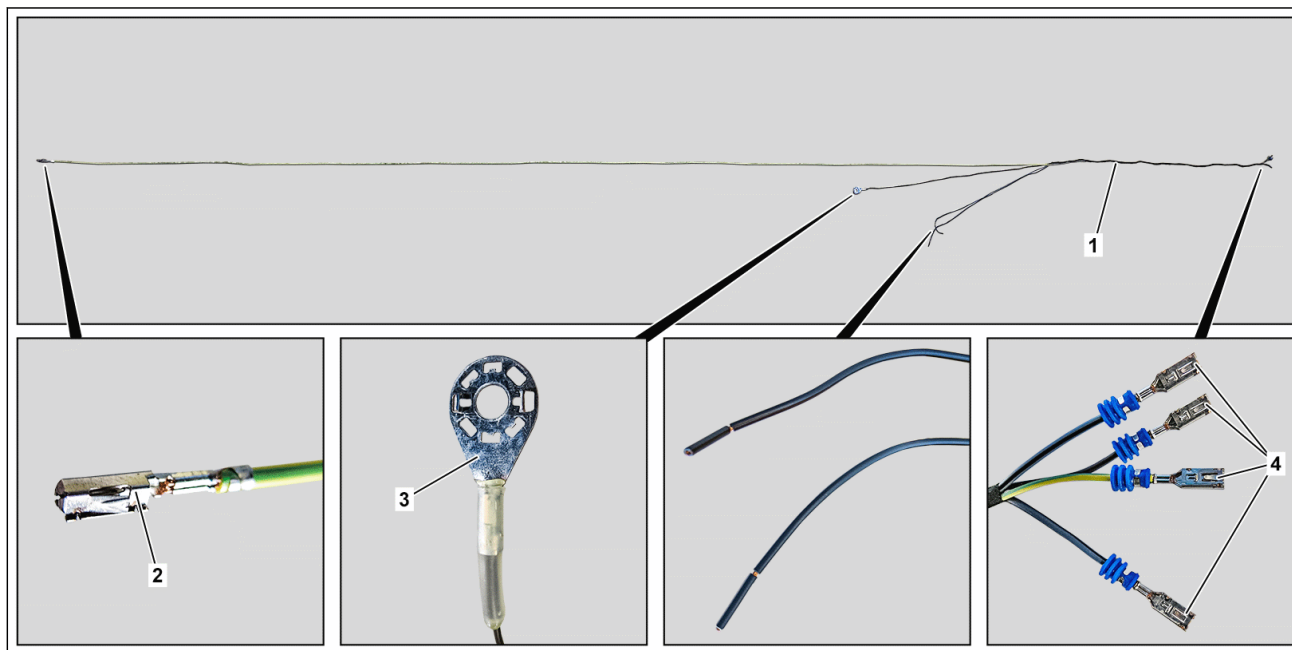
D72.16-A036-79

| 3 | <p>Prepare electric line "BU/BK".</p> <p><b>i</b></p> <p>X100/1 to Z21/16<br/>Line color "BU/BK"<br/>Length approx. 232 cm<br/>Cross section 0.75 mm<sup>2</sup></p> | <p>Crimp contact socket (2) onto electric line "YE/GN".</p> <p><b>i</b></p> <p> Use basic wiring harness repair kit.</p> <p><b>i</b></p> <p>A 013 545 76 26 Contact socket</p> |
| 7 | <p>Crimp contact sockets (4) on one side onto electric lines "YE/GN", "BN", "BU/BK", "BN/BN".</p> <p><b>i</b></p> <p> Use basic wiring harness repair kit.</p> | <p>Crimp cable lug (3) onto electric line "BN".</p> <p><b>i</b></p> <p> Use basic wiring harness repair kit.</p> <p><b>i</b></p> <p>A 001 982 57 02 Cable lug</p> |

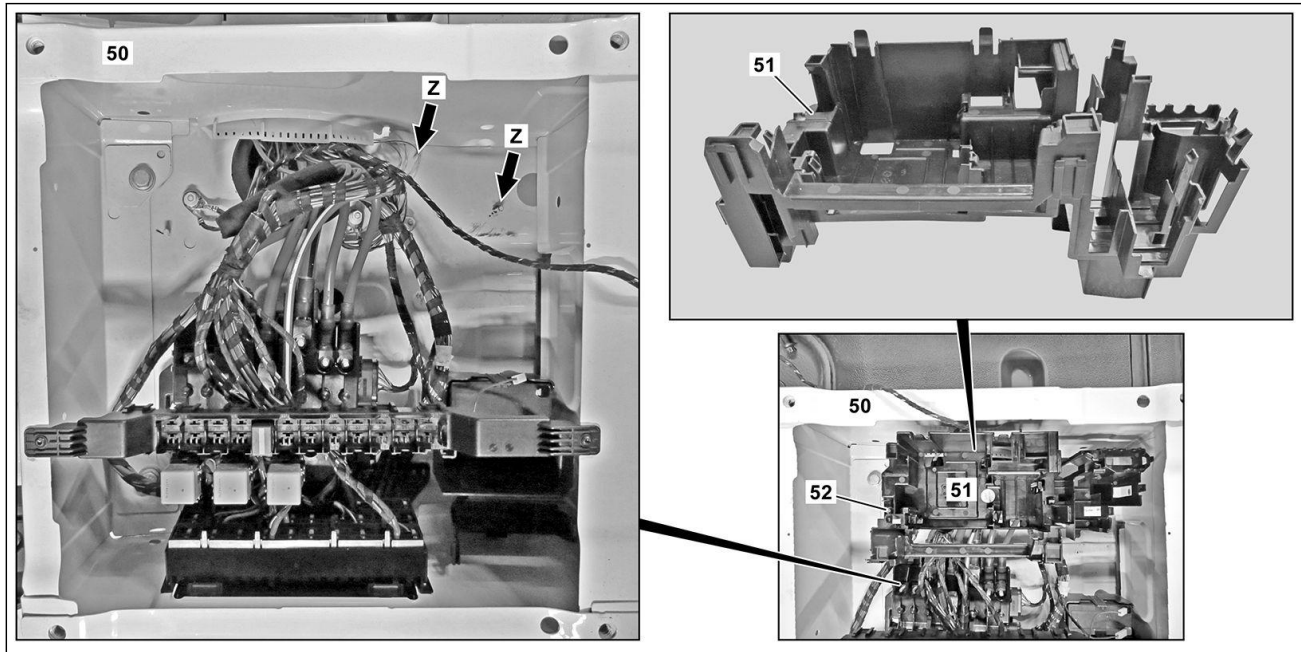
51 Control unit bracket

52 Nut

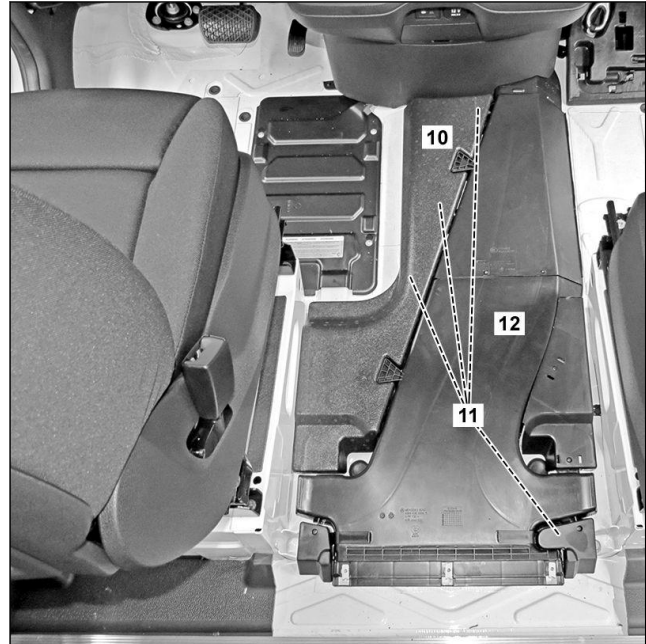
D31.19-1216-12

**Shown on model 907.7 without S23 (Front passenger bench seat)**

- 10 Cover
- 11 Nuts
- 12 Air duct

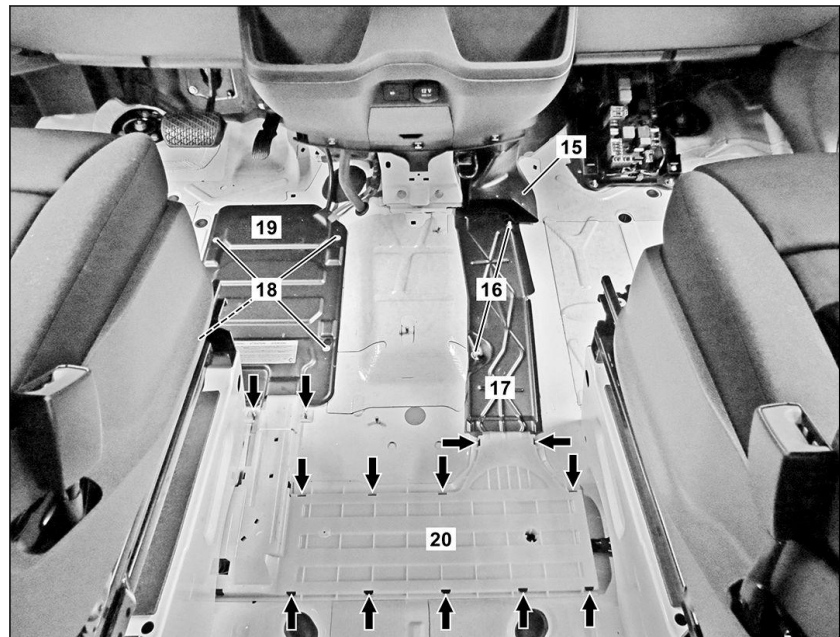
D31.19-1217-06

**Shown on model 907.7 without S23 (Front passenger bench seat)**

- 15 Air duct
- 16 Nuts
- 17 Cable duct
- 18 Bolts
- 19 Battery cover
- 20 Cover

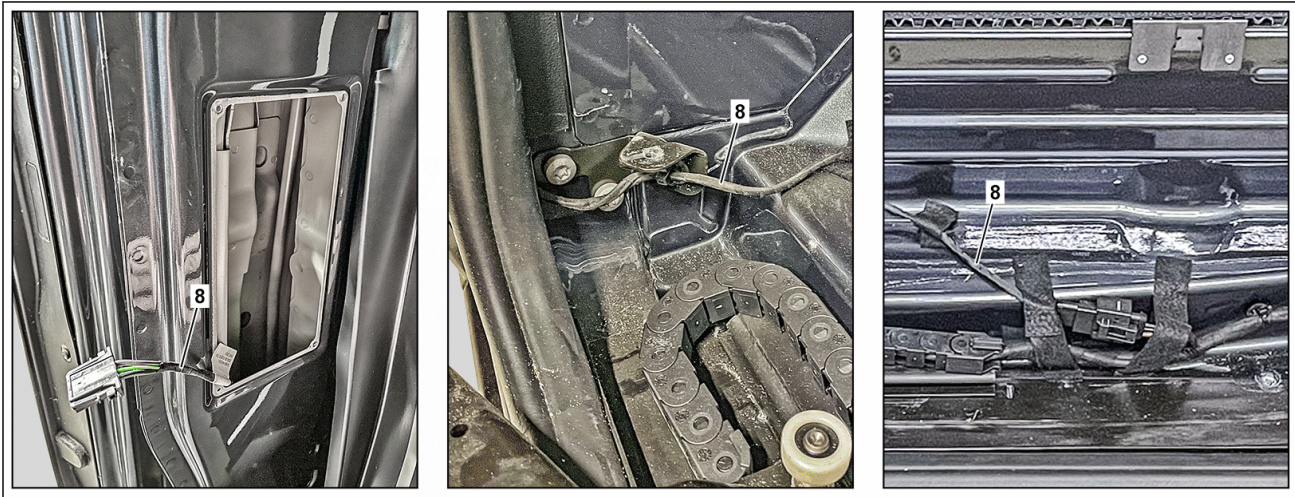
D72.16-A051-78

8 Closing assist motor electrical wiring harness

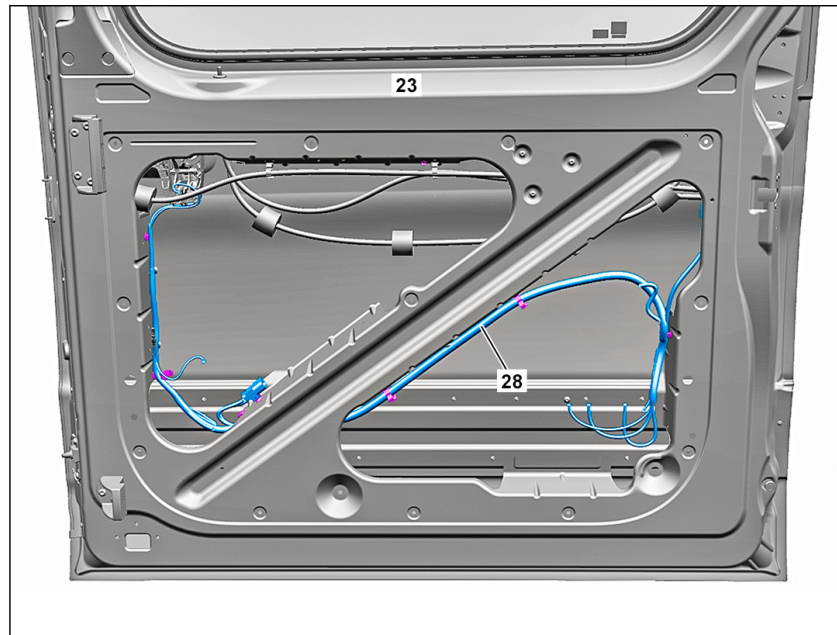
D72.16-A049-76

- 1 Remove electrical wiring harness (28).

The electrical wiring harness (28) is no longer required.

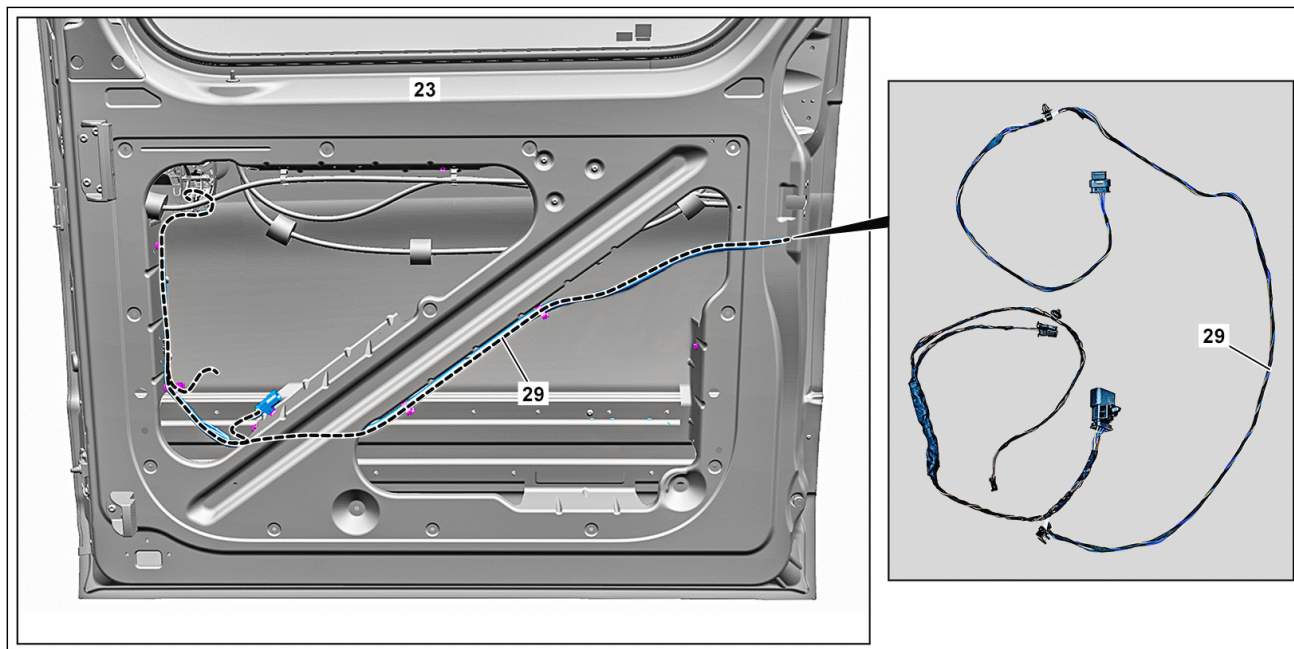
D72.16-A050-79

**Shown on model 907.7 with code EL9 (2-way speaker system, front and rear)**

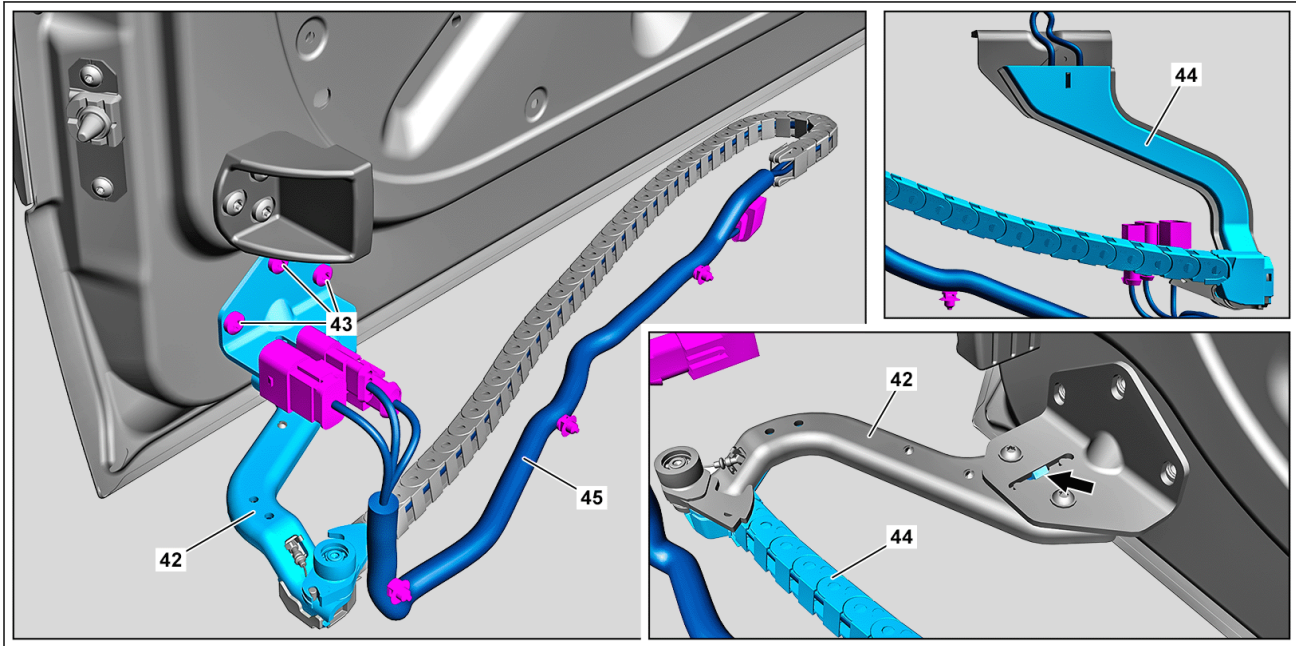
D72.16-A079-79

- 3 Remove lower carriage (42) from sliding door.

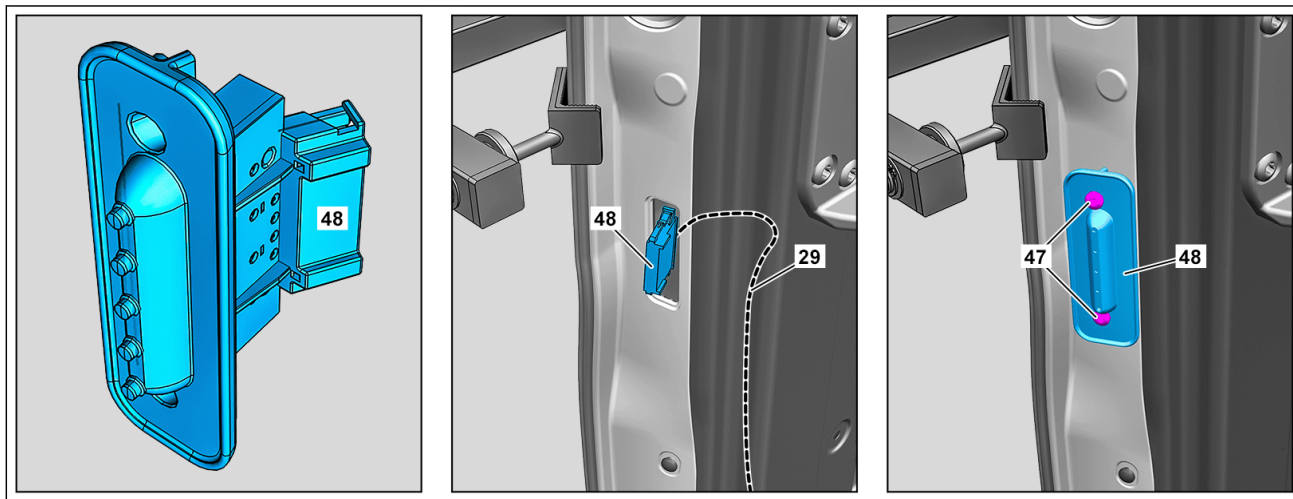
D72.16-A077-78

- 7 Connect contact switch (48) to plug connector (49) of new electrical wiring harness (29).
- 8 Install contact switch (48).

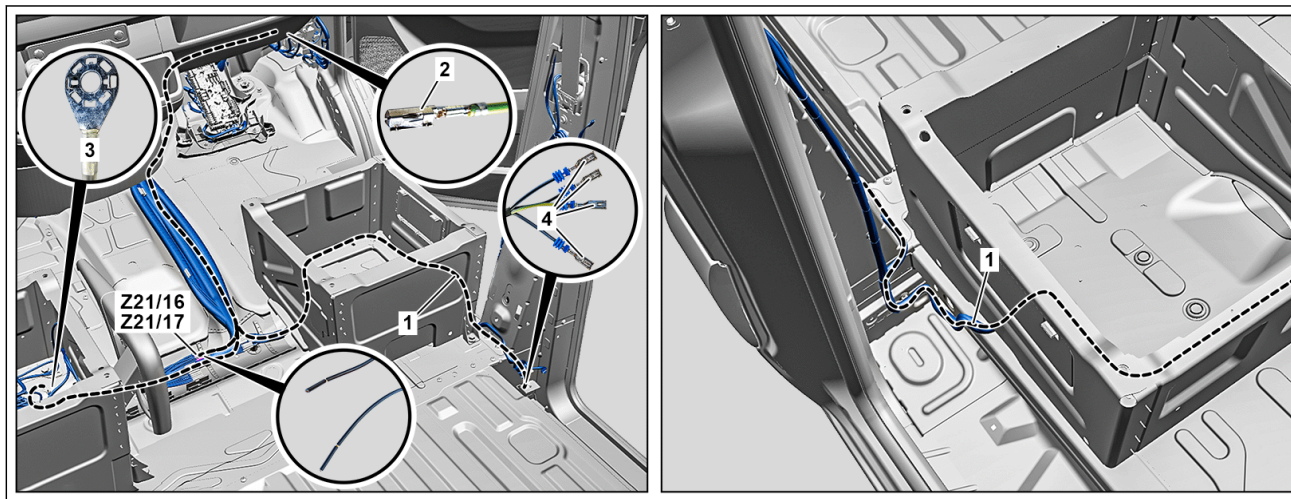
D72.16-A060-78

### Route electrical wiring harness (1)

- 3 Loosely fasten electrical wiring harness (1) in sections at factory-installed electrical wiring harness or at a suitable position using cable ties.

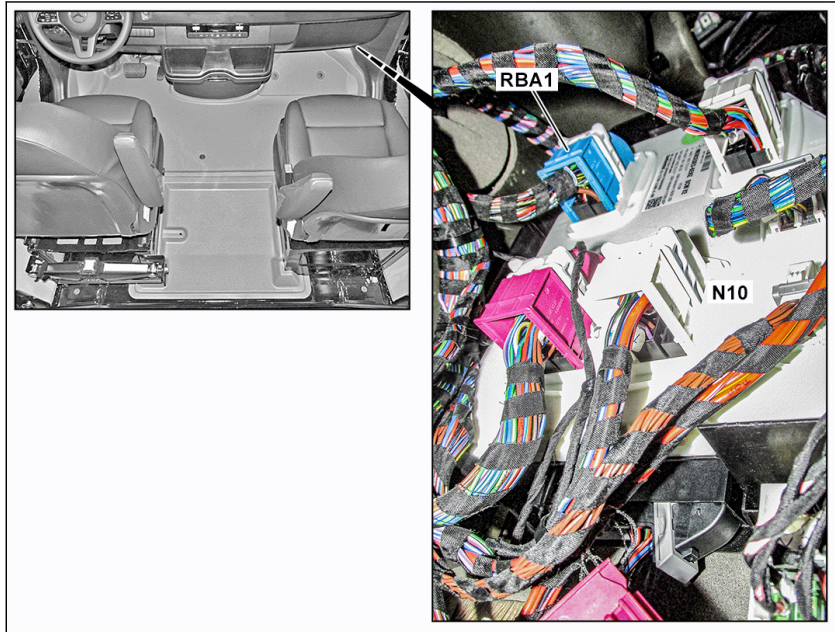
D72.16-A039-76

**Electrical wiring harness (1) to signal acquisition and actuation module (SAM) control unit**

- 8 Release and disconnect electrical connector (RBA1) from SAM (N10).

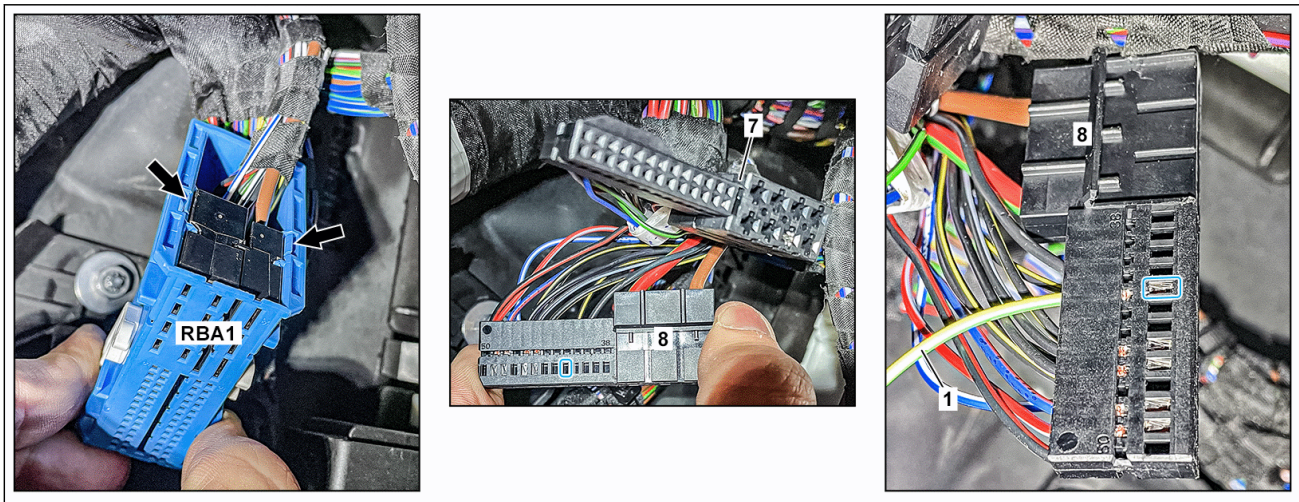
D72.16-A040-78

- 9 Disassemble electrical connector (RBA1).  
**i**  
 To do so, release plug housing (arrows A), guide out plugs (7, 8) and disconnect from each other.
- 10 Install electric line "YE/GN" of electrical wiring harness (1) into contact cavity 42 of plug (8).

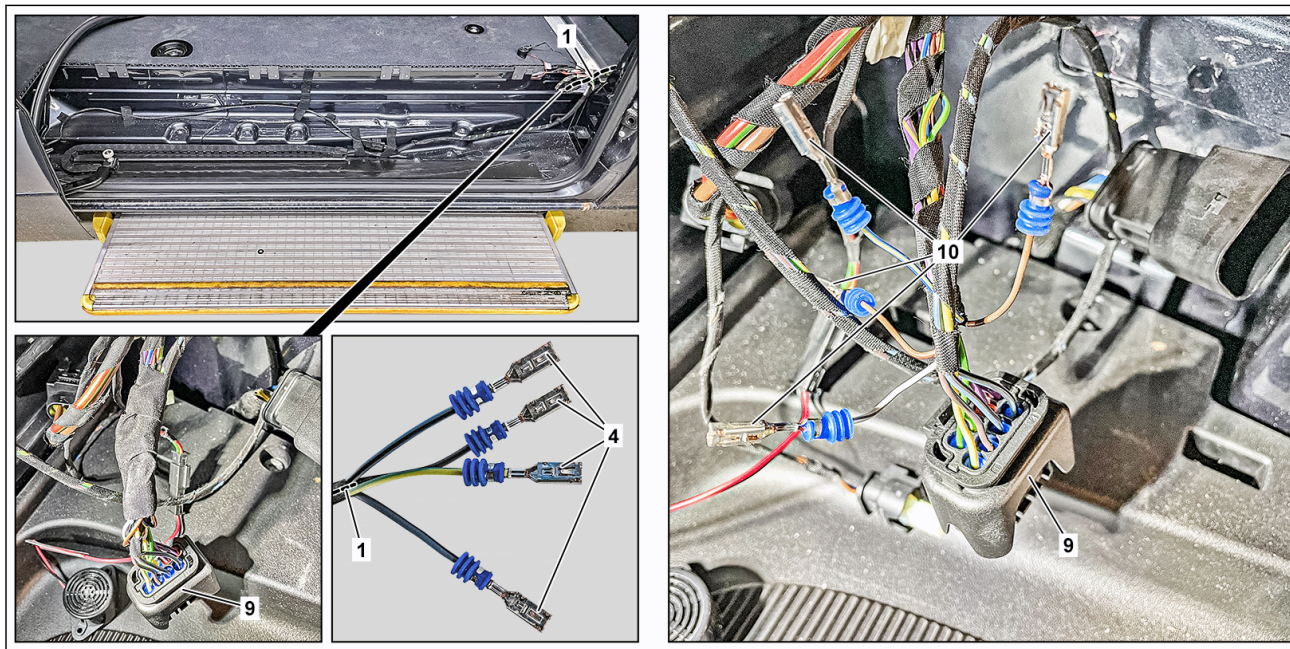
D72.16-A061-79

**Electrical wiring harness (1) to "Right sliding door electrical connector 1 (B-pillar) (X100/11x1)" or "Right**

- 18 Install contact sockets (4) in plug (9).  
**i**  
Contact cavity 1: Electric line **"YE/GN"**  
Contact cavity 2: Electric line **"BN"**  
Contact cavity 3: Electric line **BU/BN**  
Contact cavity 4: Electric line **"BU/BK"**  
Contact cavity 5: Electric line **"VT/YE"**  
Contact cavity 6: Electric line **"VT/BK"**

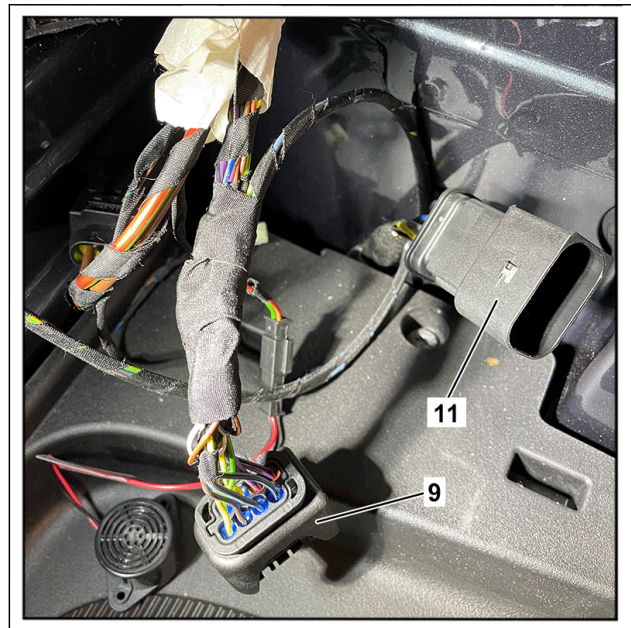
D72.16-A062-82

- 20 Remove plug connector (51) from closing assist motor electrical wiring harness (8).
- i**  
For this purpose, **S** use basic wiring harness repair kit.
- 21 Install blind plugs (9) into plug connector (51).
- 22 Reinstall plug connector (51) on factory-installed electrical wiring harness.

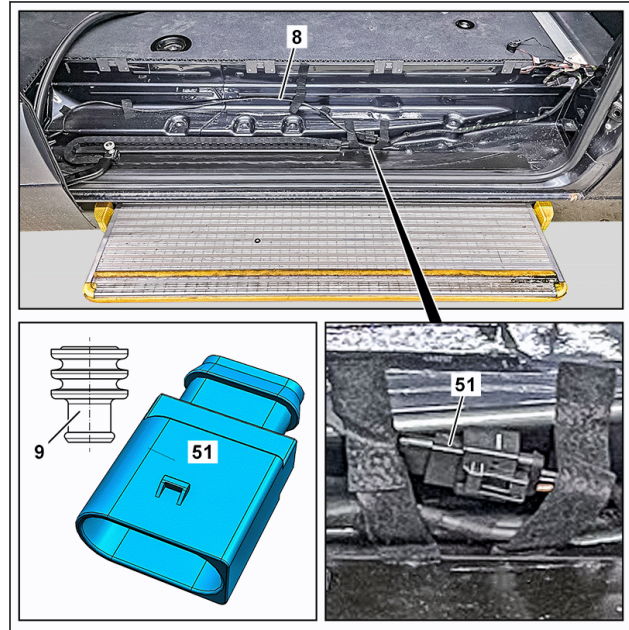
D72.16-A082-82

### Electrical wiring harness (1) to ground connection

- 23 Remove nut of driver seat base ground point 1 (W105/1).
- 24 Connect cable lug (3) of electrical wiring harness (1) to driver seat base ground point 1 (W105/1).
- 25 Attach nut of driver seat base ground point 1 (W105/1) **Nm**.

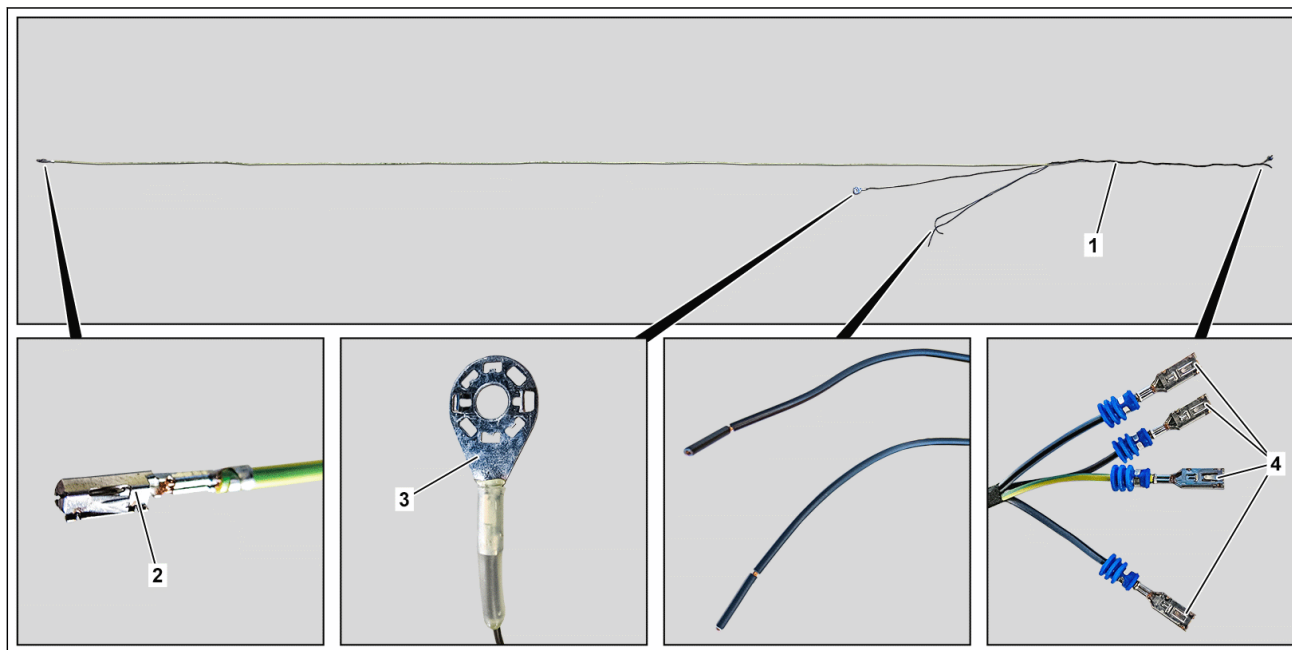
D72.16-A036-79

- 1 Prepare electric line "YE/GN".  
*i*  
 X100/1 to RBA1  
 Line color "YE/GN"  
 Length approx. 410 cm  
 Cross section 0.5 mm<sup>2</sup>
- 2 Prepare electric line "BN".  
*i*  
 X100/1 to W105/1  
 Line color "BN"  
 Length approx. 255 cm  
 Cross section 0.5 mm<sup>2</sup>

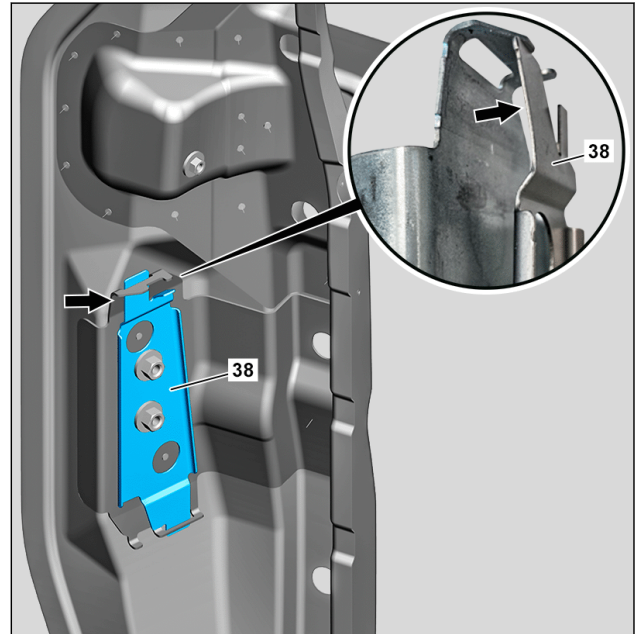
D72.16-A078-82

The new C-pillar part is not required and should be disposed of properly.

- 2 Install reinforcement (38) on C-pillar (40).

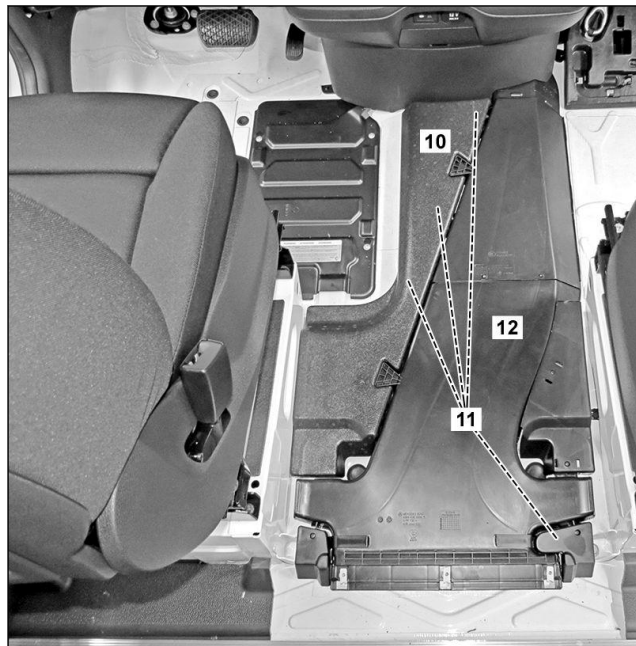
D31.19-1216-12

**Shown on model 907.7 without S23 (Front passenger bench seat)**

- 10 Cover
- 11 Nuts
- 12 Air duct

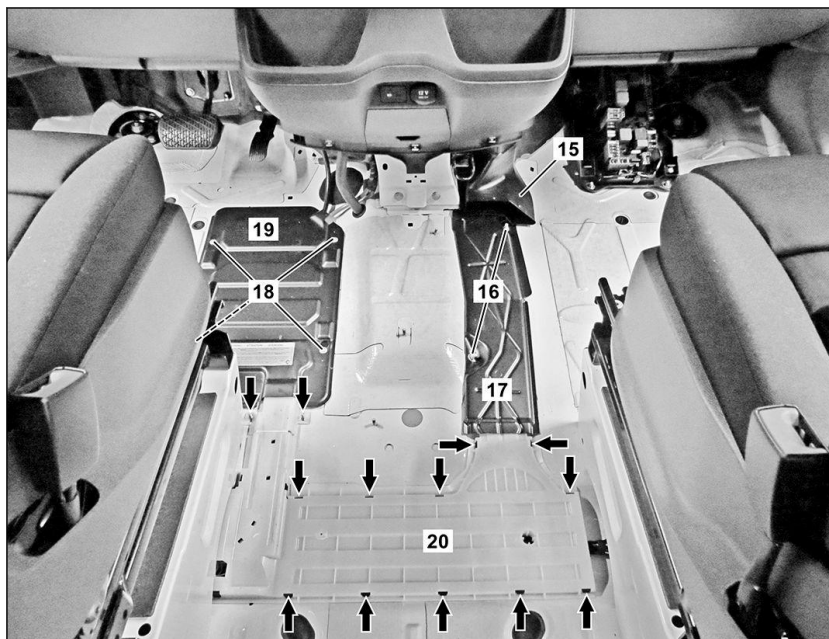
D31.19-1217-06

**Shown on model 907.7 without S23 (Front passenger bench seat)**

- 15 Air duct
- 16 Nuts
- 17 Cable duct
- 18 Bolts
- 19 Battery cover
- 20 Cover

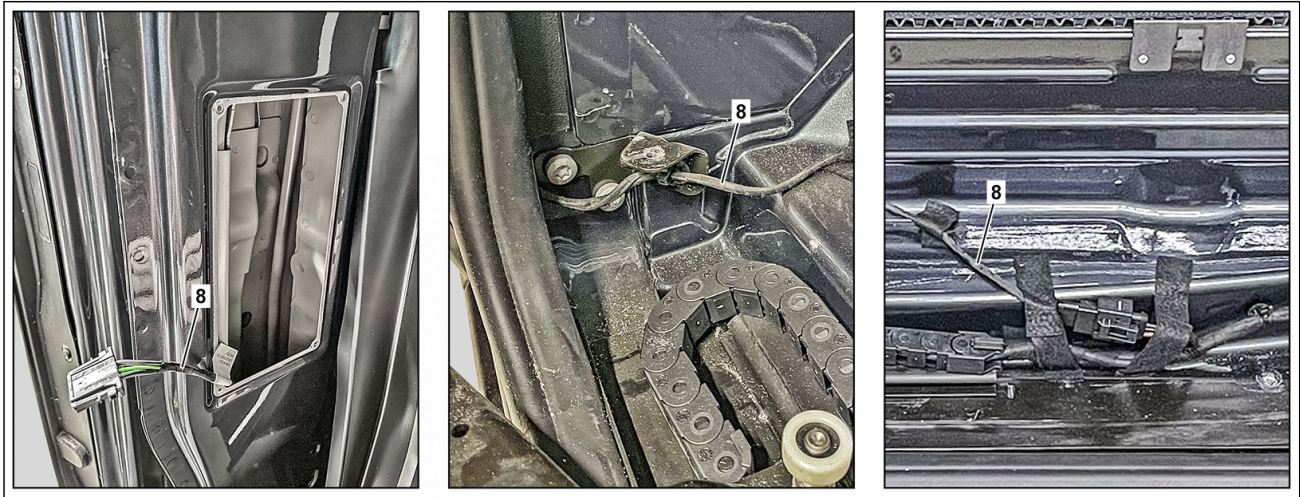
D72.16-A051-78

8 Closing assist motor electrical wiring harness

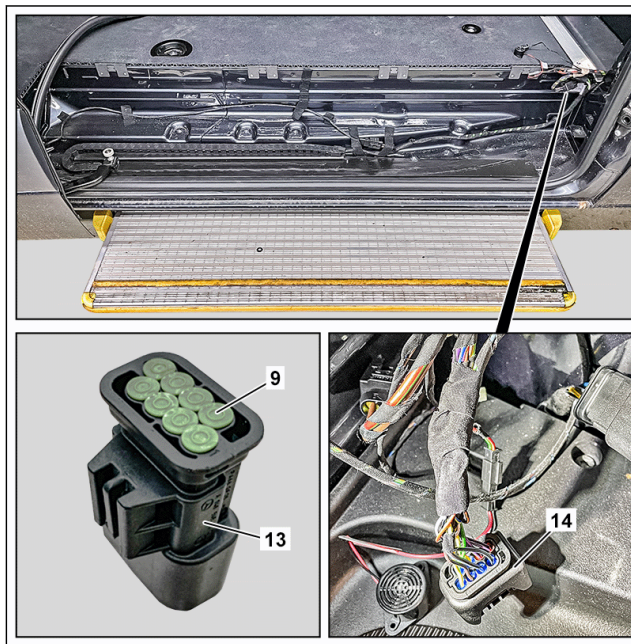
D72.16-A046-82

- 9 Blind plug
- 13 Connector
- 14 Connector

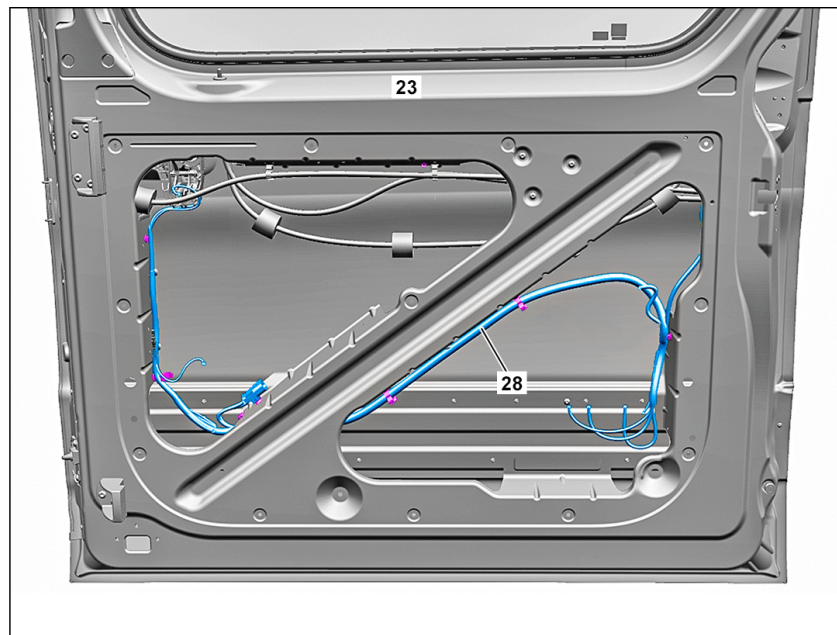
D72.16-A049-76

- 1 Remove electrical wiring harness (28).

The electrical wiring harness (28) is no longer required.

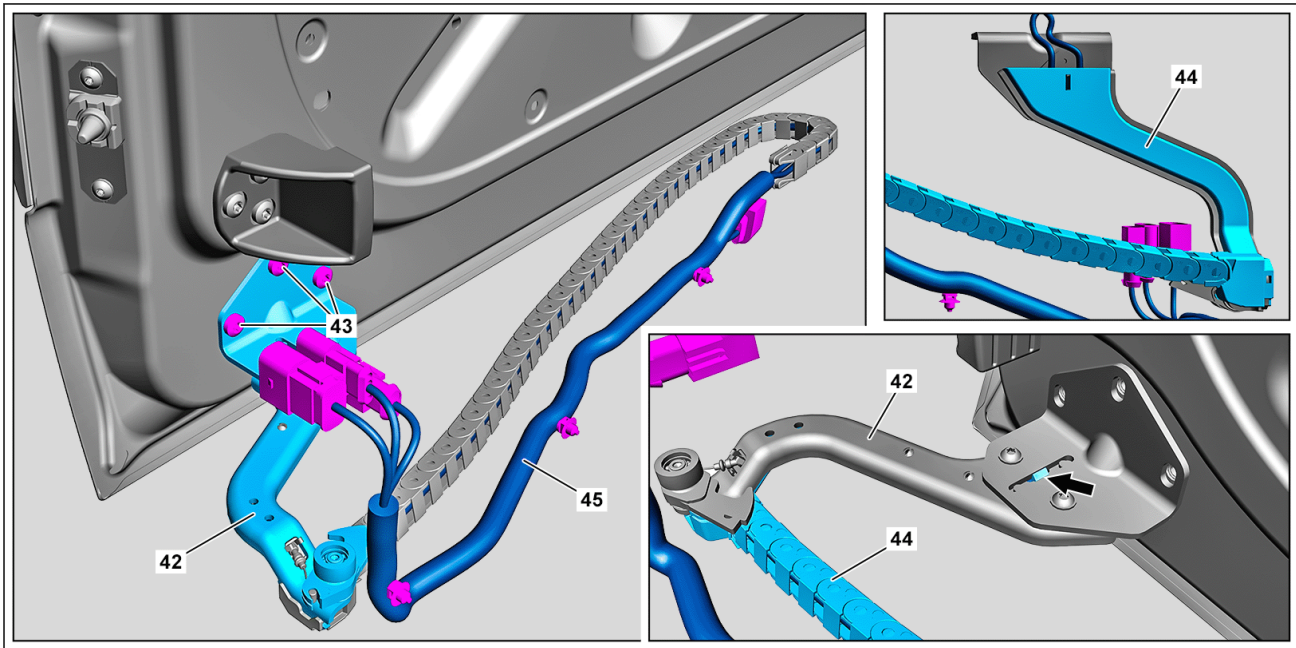
D72.16-A079-79

-----  
**Modify sliding door detachable parts**

- 3 Remove lower carriage (42) from sliding door.

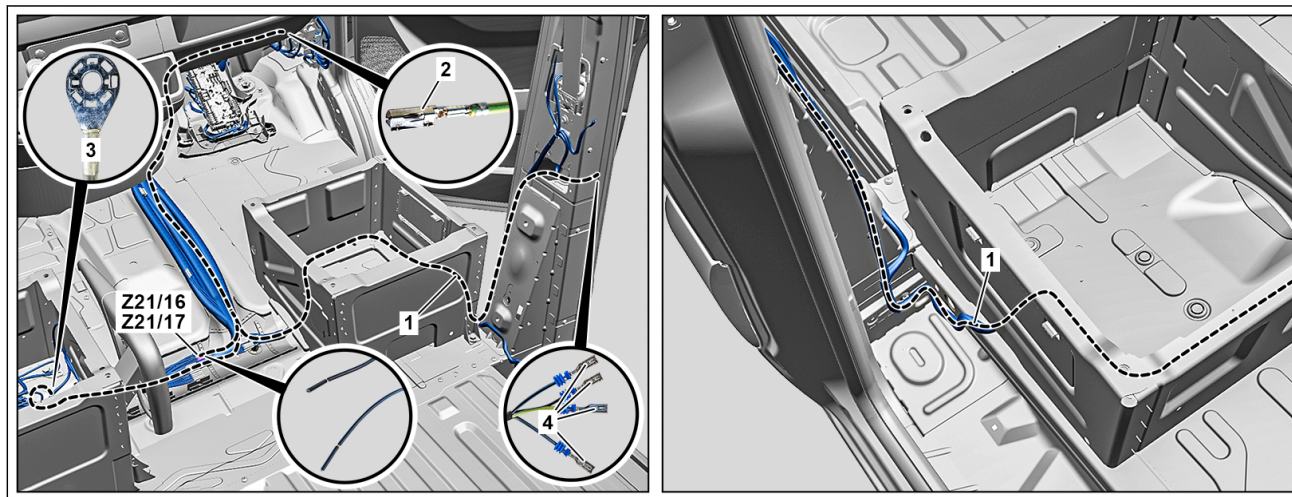
D72.16-A037-78

### Route electrical wiring harness (1)

- 3 Loosely fasten electrical wiring harness (1) in sections at factory-installed electrical wiring harness or at a suitable position using cable ties.

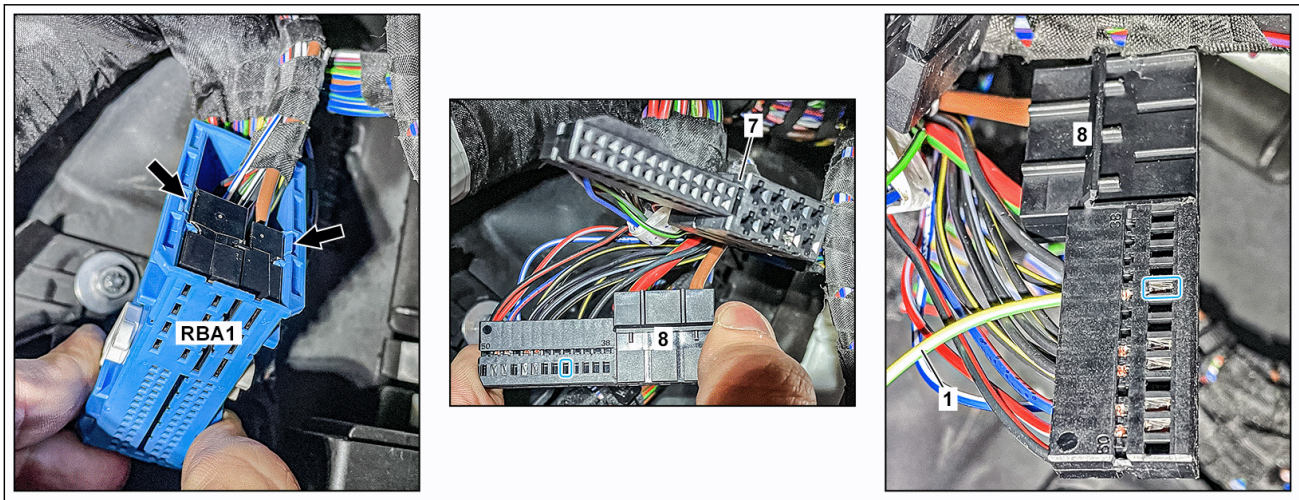
D72.16-A040-78

- 9 Disassemble electrical connector (RBA1).  
**i**  
 To do so, release plug housing (arrows A), guide out plugs (7, 8) and disconnect from each other.
- 10 Install electric line "YE/GN" of electrical wiring harness (1) into contact cavity 42 of plug (8).

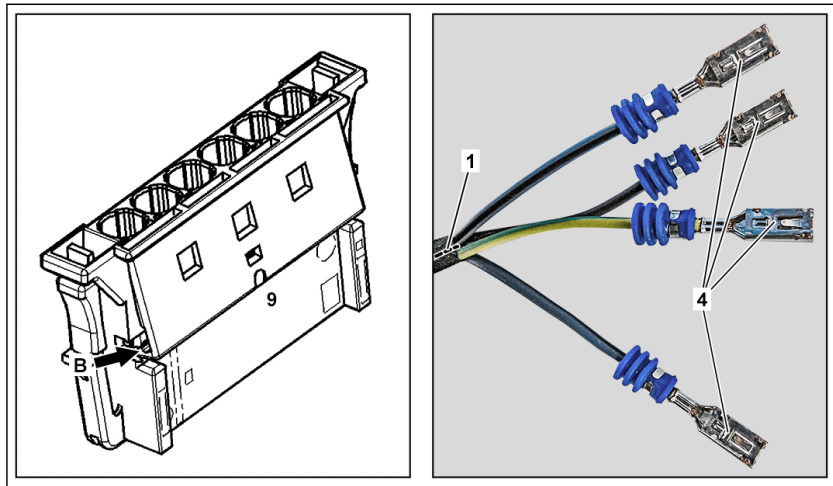
D72.16-A041-75

- 15 Release plug (9) (arrow B).

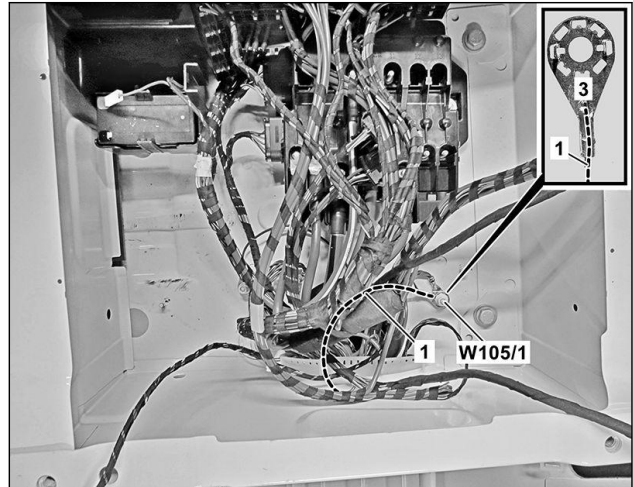
D72.16-A042-11

**Electrical wiring harness (1) to ground connection**

18 Remove nut of driver seat base ground point 1 (W105/1).

20 Attach nut of driver seat base ground point 1 (W105/1) [Nm](#).

19 Connect cable lug (3) of electrical wiring harness (1) to driver seat base ground point 1 (W105/1).

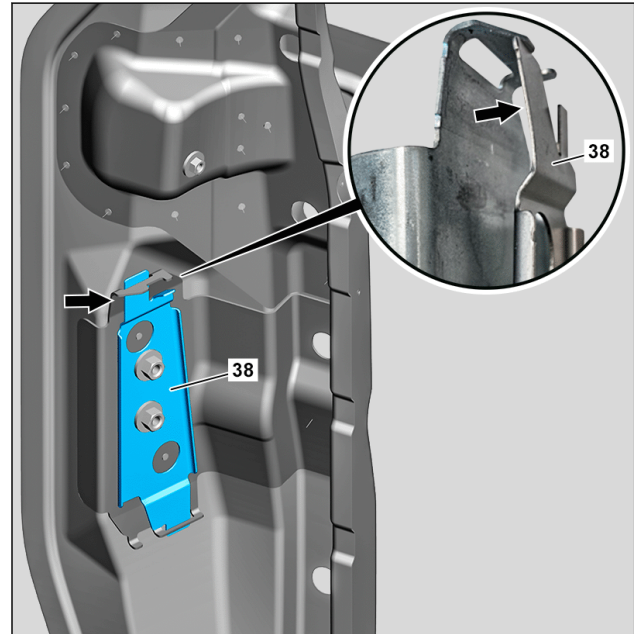
D72.16-A078-82

The new C-pillar part is not required and should be disposed of properly.

- 2 Install reinforcement (38) on C-pillar (40).

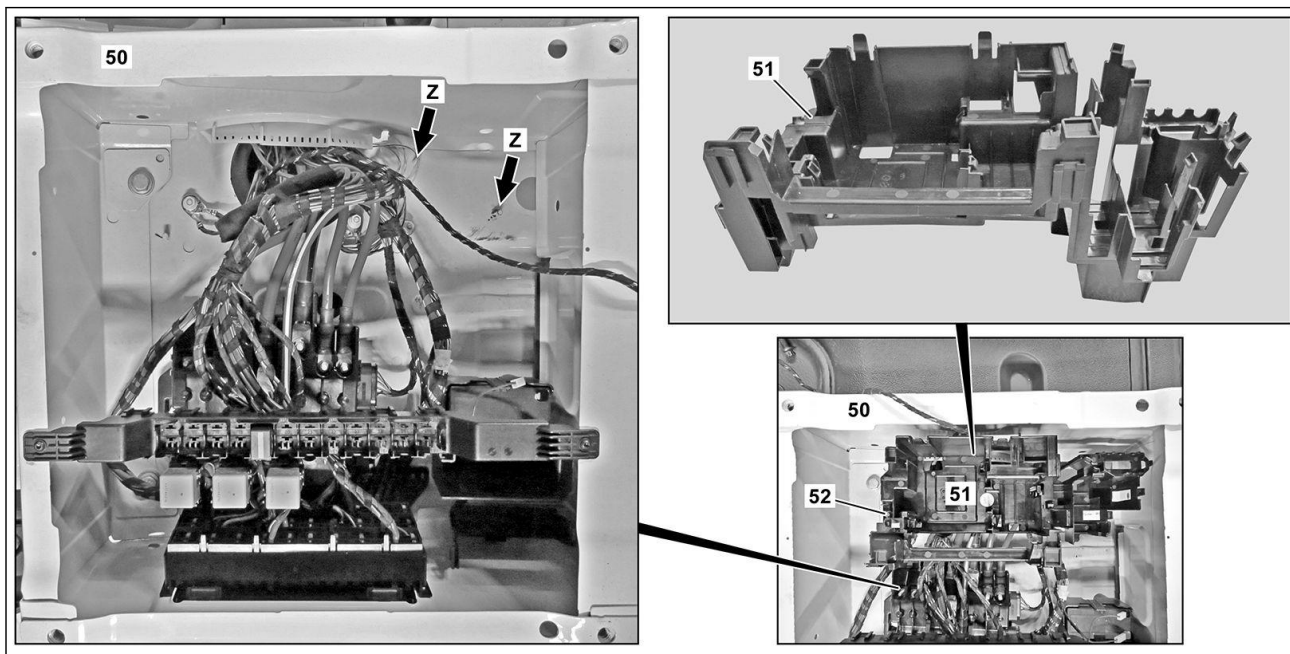
51 Control unit bracket

52 Nut

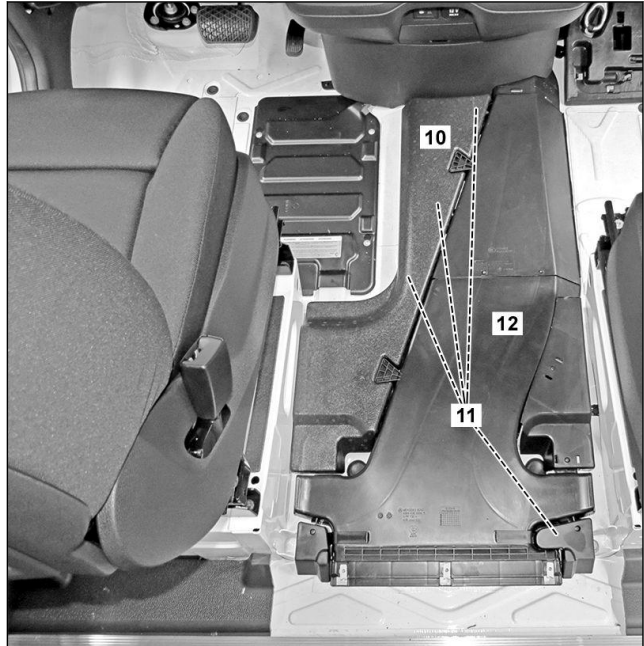
D31.19-1216-12

**Shown on model 907.7 without S23 (Front passenger bench seat)**

- 10 Cover
- 11 Nuts
- 12 Air duct

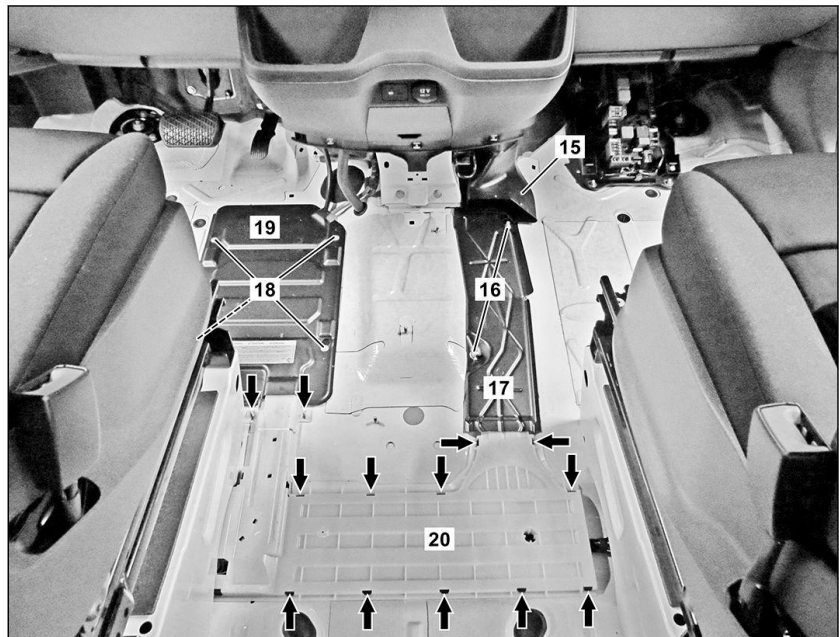
D31.19-1217-06

**Shown on model 907.7 without S23 (Front passenger bench seat)**

- 15 Air duct
- 16 Nuts
- 17 Cable duct
- 18 Bolts
- 19 Battery cover
- 20 Cover
