WML0 – Retrofitting Loudspeaker Booster (Stop Delivery)

Revision: This bulletin replaces bulletin Group 9 155/21 WML0 (982), dated November 29, 2022.

Model Line: **718 (982)**

Concerns: **Loudspeaker booster**

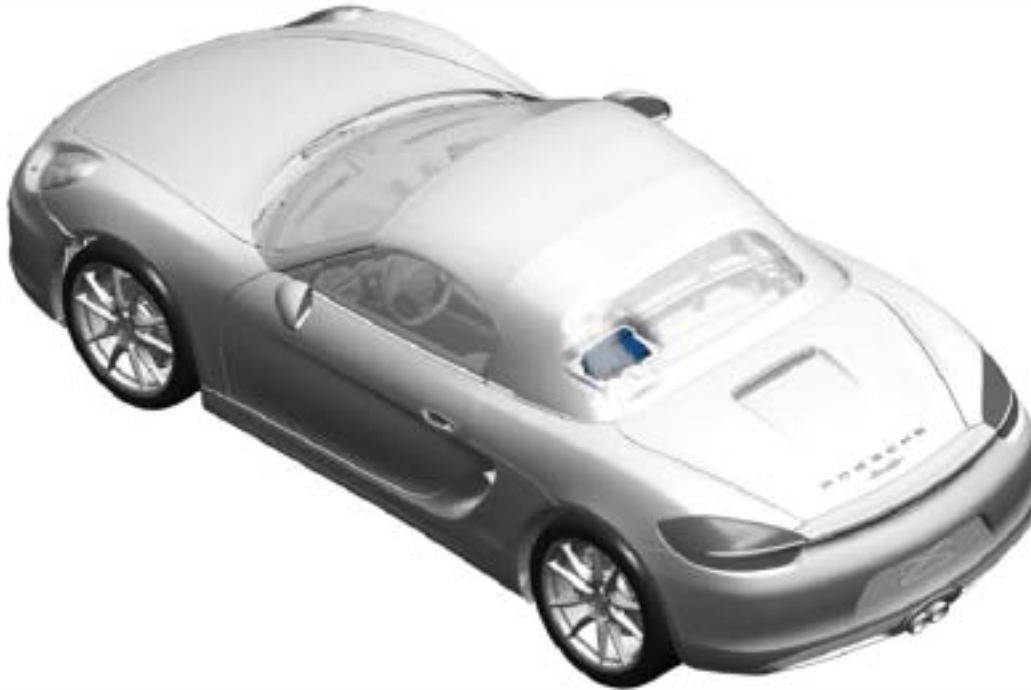
Installation position

Installation
Position:

– (Retrofitting) loudspeaker booster

- 2 Install loudspeaker booster. ⇒ *Workshop Manual '914419 Removing and installing loudspeaker booster'*
- 3 Fold the right front seat forward and screw it on completely. For instructions, see ⇒ *Workshop Manual '720119 Removing and installing front seat'*
- 4 **Only relevant for vehicles with Scope 6:** Teaching loudspeaker booster. ⇒ *Workshop Manual '914455 Replacing loudspeaker booster'*
- 5 Enter the campaign in the Warranty and Maintenance booklet.
