Service Bulletin

22-011

Product Update: 2022 CR-V EPS Gearbox Replacement

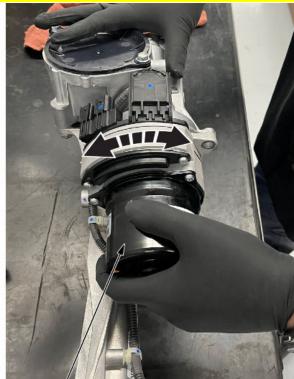
23.4. Turn the EPS motor/control unit two or three times to the right and left about 45 degrees.

EPS MOTOR CONTROL UNIT
Turn unit two or three times to the right and left (about 45 degrees).

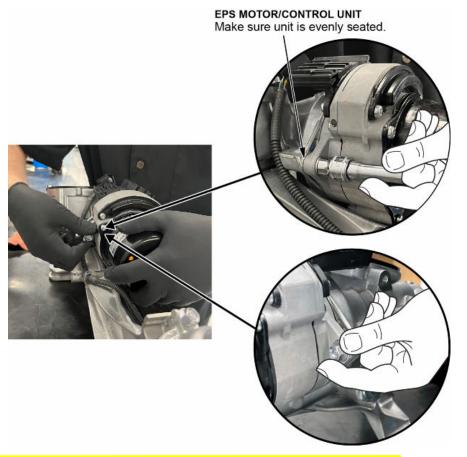
23.5. Loosely install the EPS motor/control unit mounting bolts by hand but do not tighten.

- To prevent damaging the motor and/or gearbox, DO NOT use power tools to install or tighten the bolts.
- Make sure the EPS motor/control unit is evenly seated on the P/S Gearbox.

- 23.6. Tighten the EPS motor/control unit mounting bolts to 20 N.m (15 lb-ft).
- 24. Install the new P/S gearbox kit (with EPS motor), and reassemble in the reverse order of removal.
