TECHNICAL SERVICE BULLETIN

Crew Cab - Folding Rear Seat Backrest Assembly Excessive Latching Effort When Returning To The Upright Position

23-2062

Ford 2019-2023 Ranger

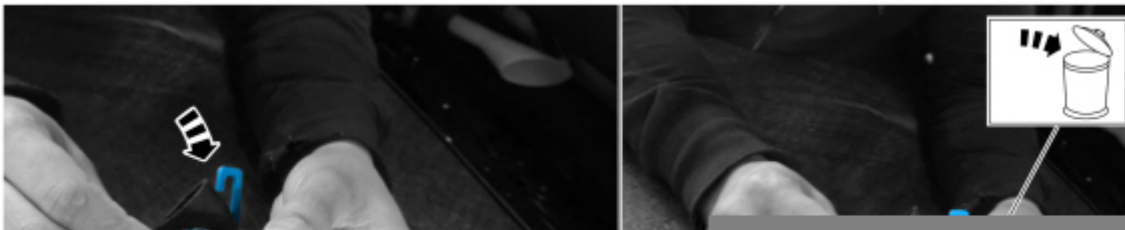
Figure 6

7. Remove and discard the rear seat backrest latch from the rear seat backrest release strap. (Figure 6)
