TECHNICAL SERVICE BULLETIN

BT21-001A

REAR PERSONAL LAMP NOT WORKING OR SWITCH COMING APART

APPLIED VEHICLES: 2020 - 2023 Titan/Titan XD (A61)
Built on or after: December 13, 2019

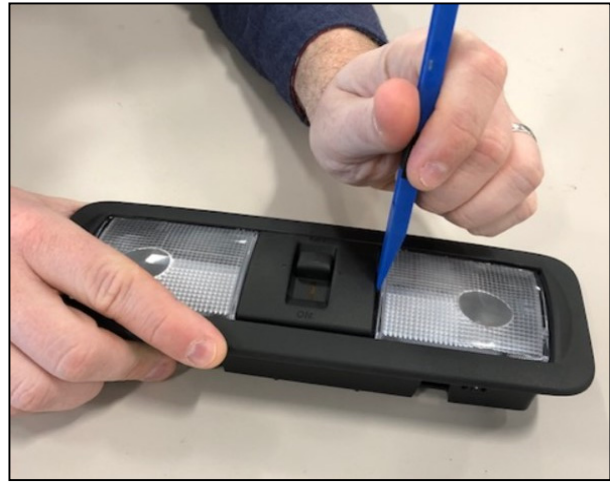
Figure 1

1. Insert a trim/finesse stick between the lamp lens and the knob switch trim bezel, in the middle of the trim bezel.

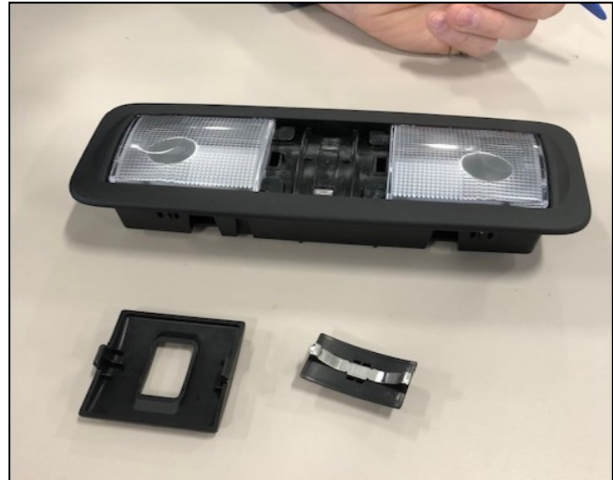
Figure 3

3. Remove the old trim bezel and knob switch and discard both (they will not be reused).

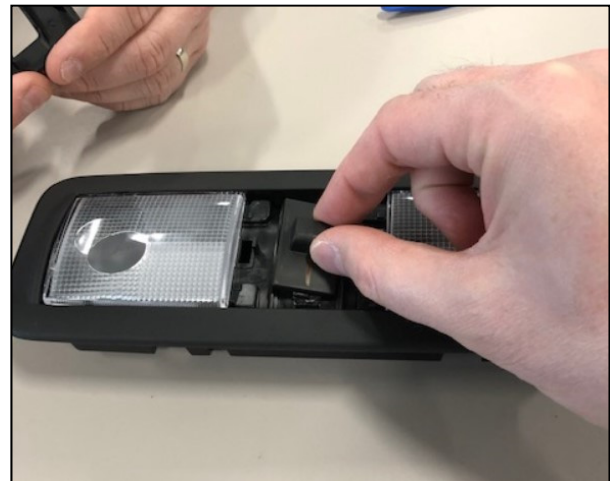
Figure 4

4. Install the new knob switch assembly into the lamp unit.

HINT: Be sure to place the knob switch assembly between the two guide ribs in the lamp housing assembly.

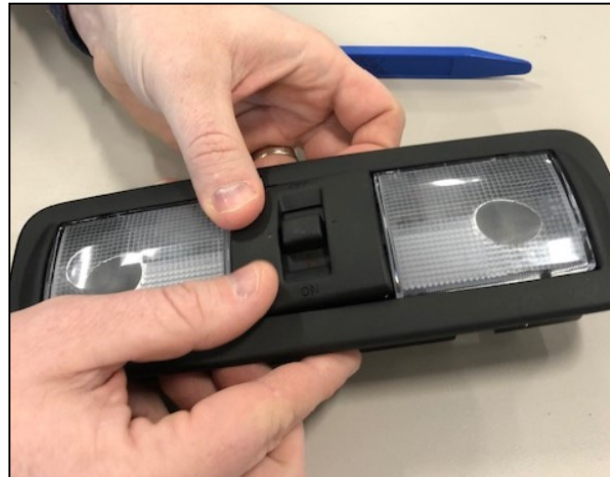
Figure 7

6. Carefully press down on one side of the trim bezel to engage the snap lock.

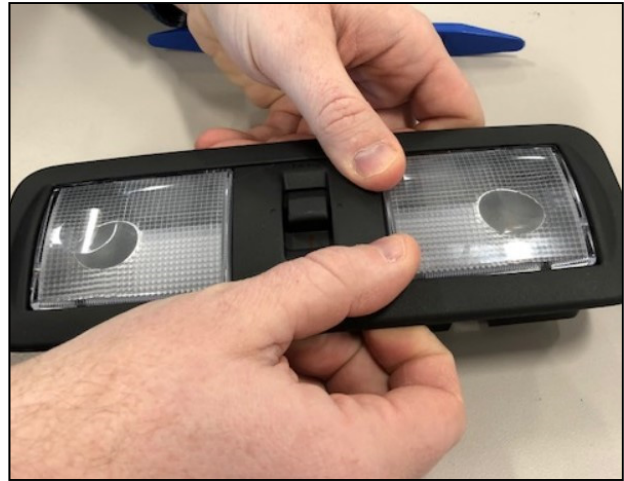
Figure 8

- Carefully press down on the opposite side of the trim bezel to engage the final snap lock.
