Preliminary Information

PIT5993 No Crank Due To Dead Battery / Battery Draw / Unwanted Alarm

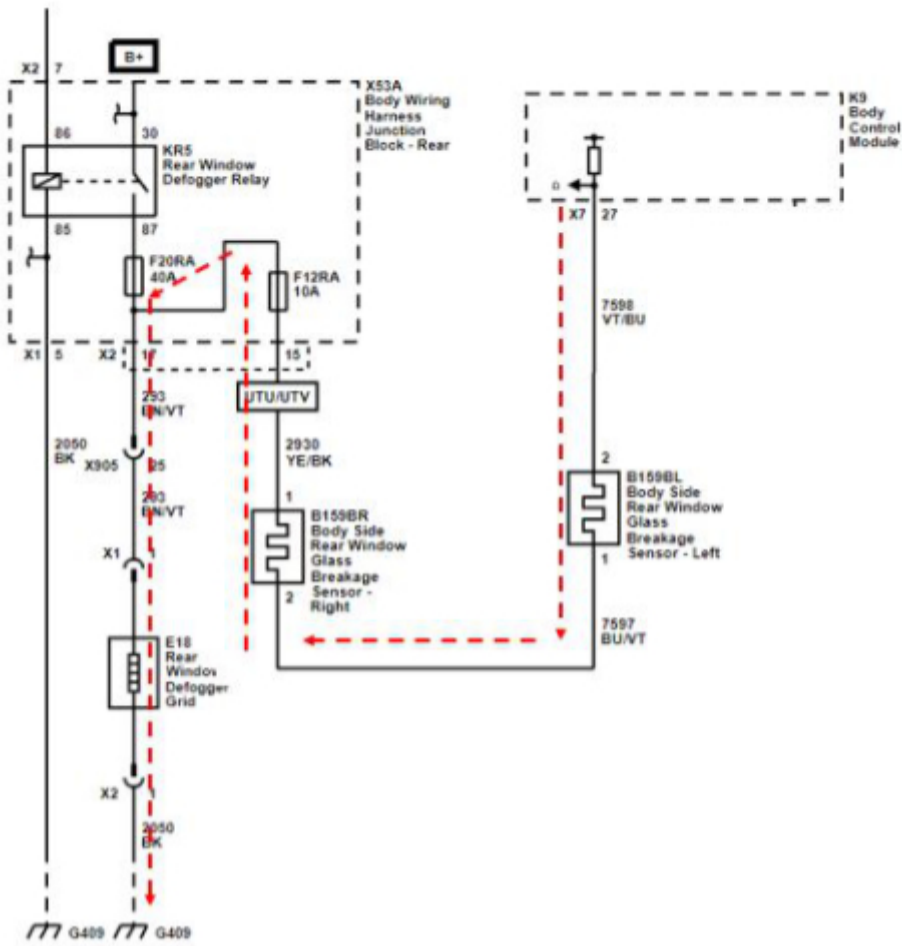
| Cause | <p>These concerns could be caused by high resistance in the glass breakage loop, which is shown below with a dotted red line. The glass breakage loop consists of the rear window defogger grid and each rear quarter glass, which are all connected in series. Normally, the complete glass breakage loop should have less than 20 ohms of resistance to ground. If there is high resistance or a break at any place in this series circuit, it could cause the condition.</p> <p>Note: In some cases, the battery draw may only be duplicated if the vehicle is completely closed up (all door and hood latches tripped) and the vehicle is locked.</p> |

To test the glass breakage loop, disconnect the battery and the BCM X4 and X7 connectors. Using the correct test probe (EL-38125-58) check for proper terminal tension at the BCM X7 terminal 27. If terminal tension is good then use an ohmmeter to check the resistance of the glass breakage loop to the BCM ground. Do this by connecting one lead of the ohmmeter to the BCM ground at connector X4 terminal 24 or 25 and the other ohmmeter lead to terminal 27 of the BCM X7 connector. Measure the resistance.

If the resistance to ground is greater than 20 ohms, then inspect the glass breakage loop for poor connections, which could occur at any point in the series circuit, shown above. The most common areas seen are the connections at either of the rear quarter glass assemblies.

If the resistance to ground is less than 20 ohms, then the loop resistance is within spec, but if you are dealing with an intermittent issue then inspect and manipulate the glass breakage loop connections/wiring to see if the resistance increases. Repair any points of high resistance.
