Technical Service Bulletin

GROUP BODY	NUMBER 23-BD-003H-1
DATE APRIL, 2023	MODEL(S) PALISADE (LX2)

SUBJECT: SUNROOF WIND DEFLECTOR AND MECHANISM REPLACEMENT

Description: On certain Palisade (LX2) vehicles, the sunroof wind deflector may malfunction and cause damage to the sunroof mechanism. The sunroof may be inoperable and become stuck in the open, partially open, or closed position. This bulletin describes the procedure to replace the sunroof wind deflector and sunroof mechanisms with revised parts.

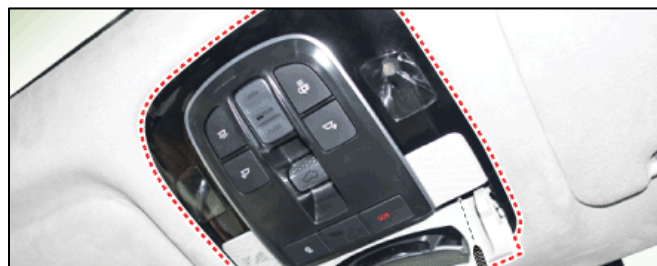
1. Open the sunroof glass by pressing the sunroof switch.

If the sunroof cannot be opened with the sunroof switch, refer to the shop manual for the emergency operating procedure.

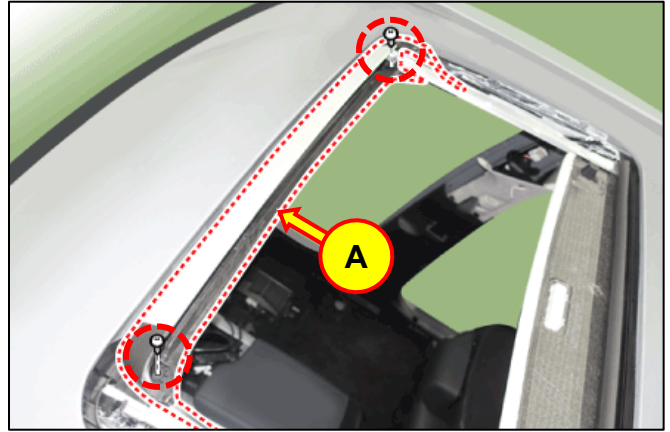
2. Remove the wind deflector screws and remove the wind deflector (A).

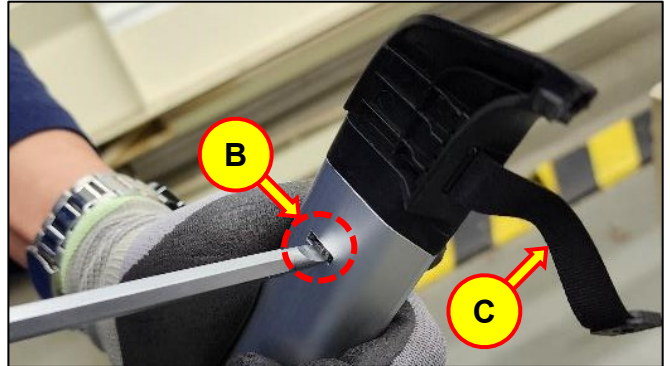
3. Press the locking tabs by inserting a flat-head screwdriver in the indicated holes (B) and remove the wind deflector arms (C) on both sides.

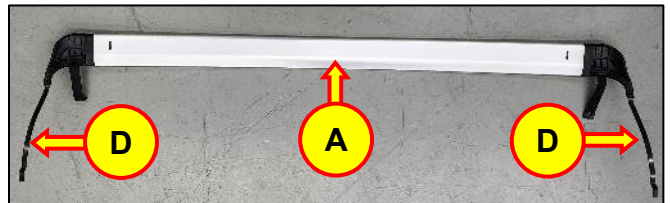
4. Install the new wind deflector arms (D) onto the wind deflector (A).

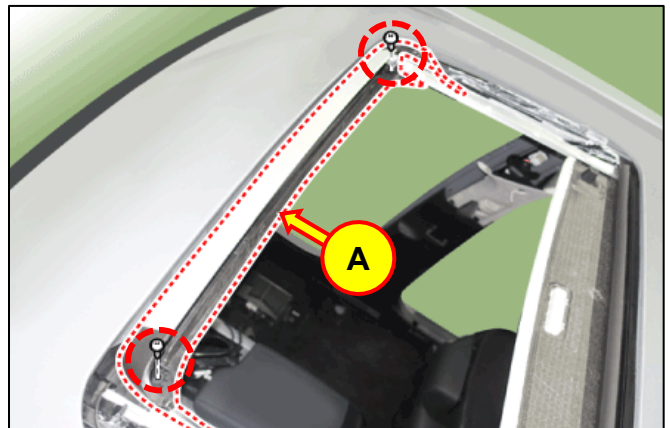
5. Reinstall the wind deflector (A).

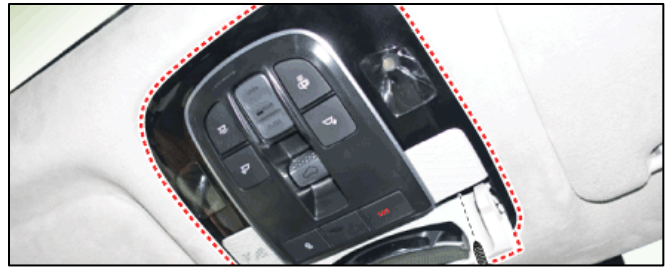
1. Move the sunroof glass into the tilt position by pressing the sunroof switch.

If the sunroof cannot be moved with the sunroof switch, refer to the shop manual for the emergency operating procedure.

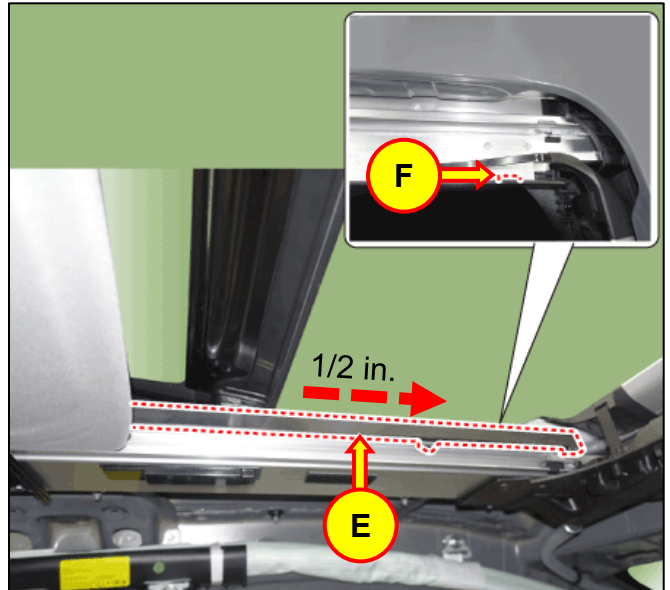
2. Remove the sunroof mechanism covers (E) on both sides.

- Push the cover forward approximately 1/2 in. until it aligns with the groove (F), then pull it towards the center of the vehicle.

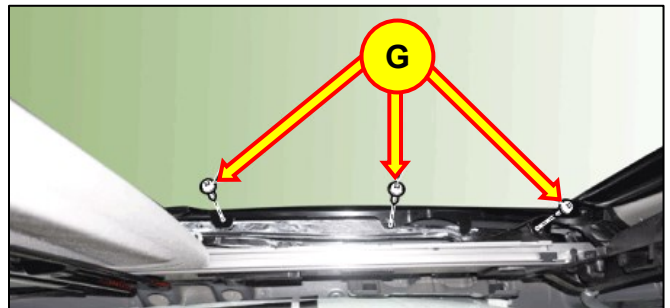
3. Remove the interior sunroof glass bolts (G) on both sides (6 total).

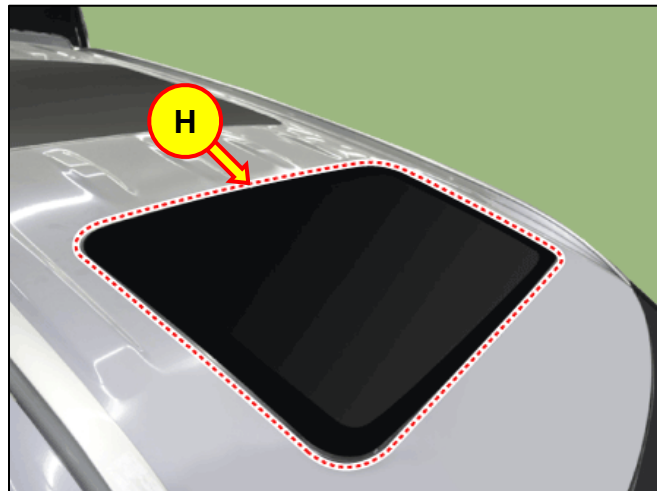
4. Carefully lift and remove the sunroof front glass (H).

- Assistance may be required to safely lift and remove the glass.
- Place the glass on a workbench with a soft surface to prevent damage.

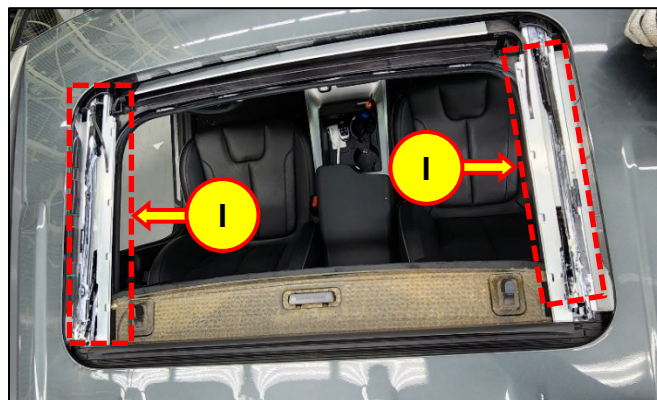
5. Inspect both sides of the sunroof mechanism (I) for any damage or debris.
- Only replace the side(s) that is damaged or broken.

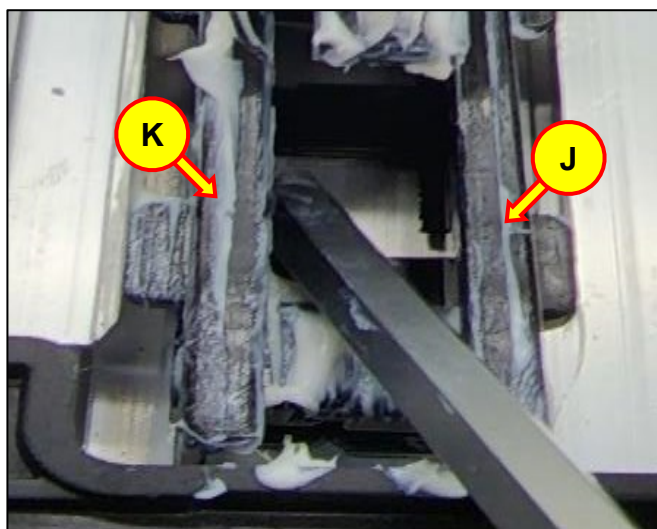
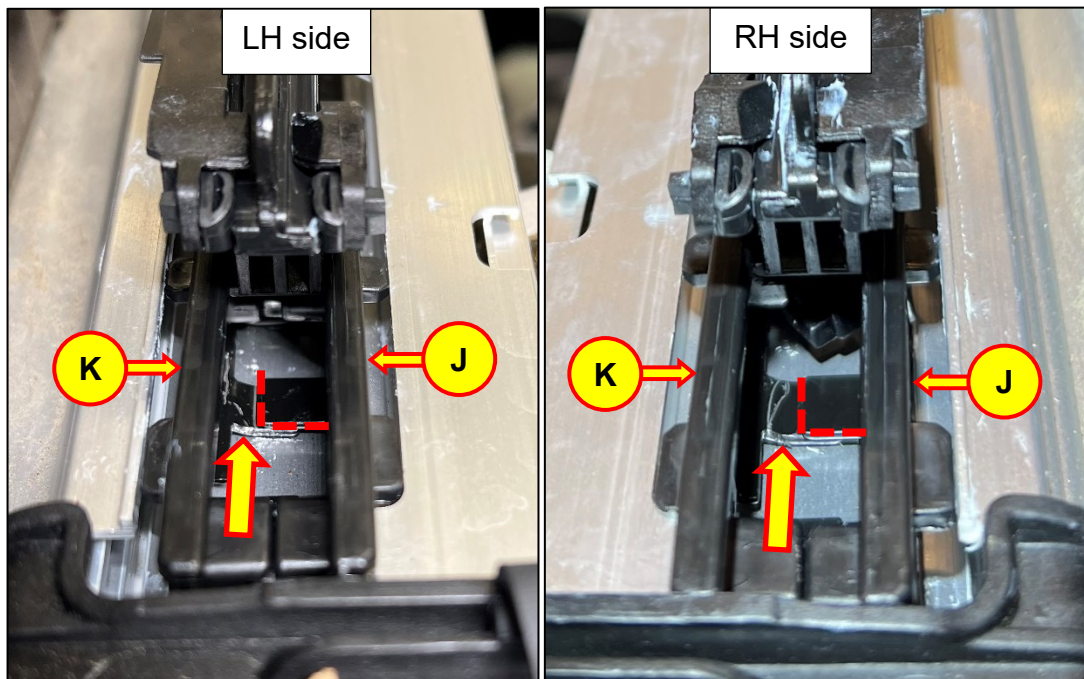
6. Disconnect curve guide B (K) from curve guide A (J).

Use a flat-head screwdriver to lightly tap (towards the front of the vehicle) on the indicated metal tab on curve guide B (K).

Refer to the photos on the following page for the exact location of the metal tab on curve guide B (K) and the direction to apply force.

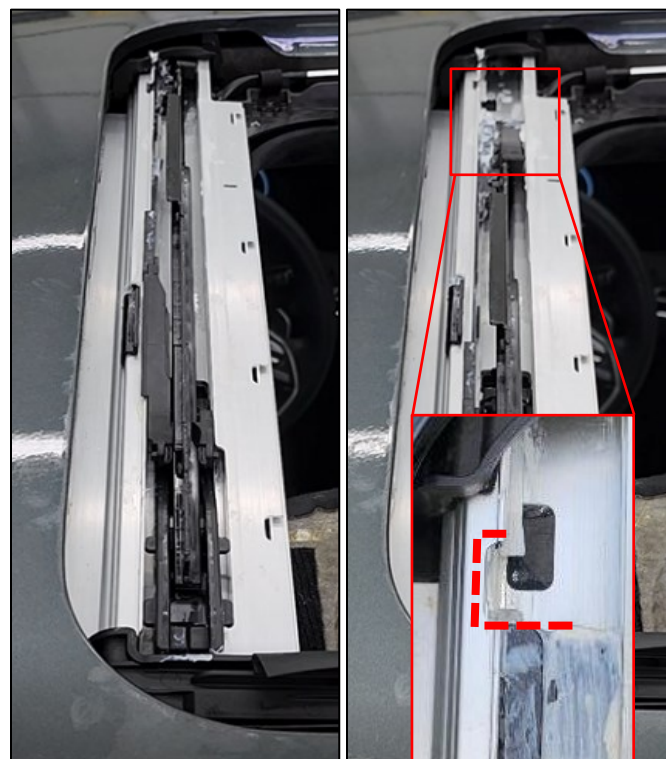
7. Use the sunroof switch to move the sunroof mechanism rearwards (approx. 2 in) past the cutout in the sunroof rail.

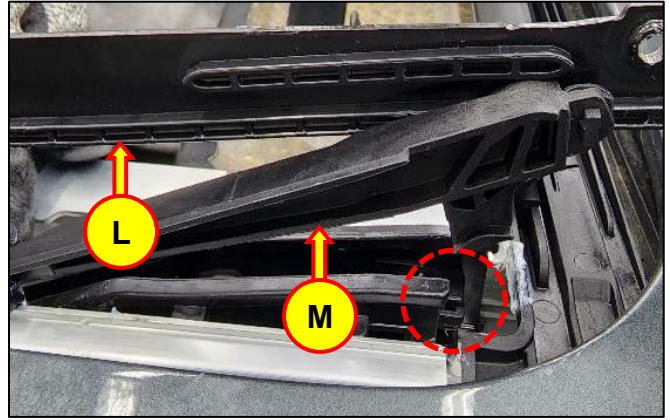
8. While lifting the rear of the carriage bar (L), separate the driving wedge (M) from the curve guides.

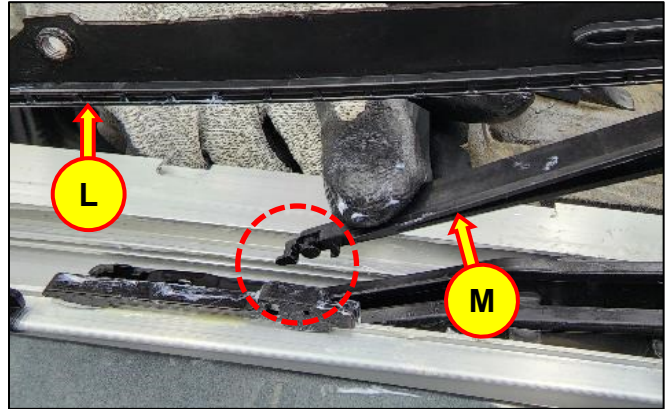
9. While lifting the rear of the carriage bar (L), disconnect the locking tab of the driving wedge (M).

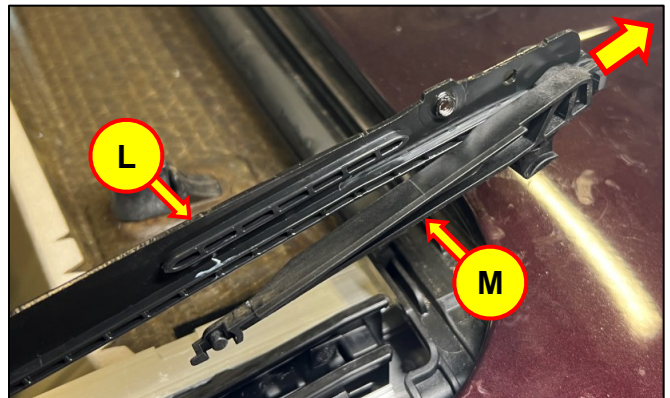
10. Slide the driving wedge (M) off the carriage bar (L).

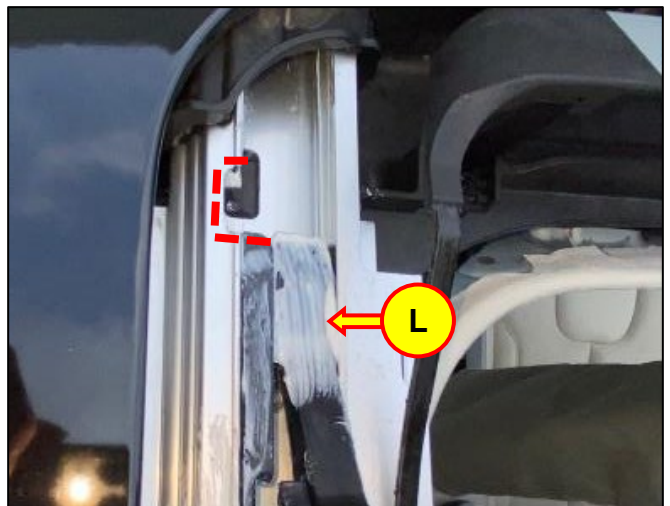
11. Push the carriage bar (L) forward past the cutout in the rail, then remove it.

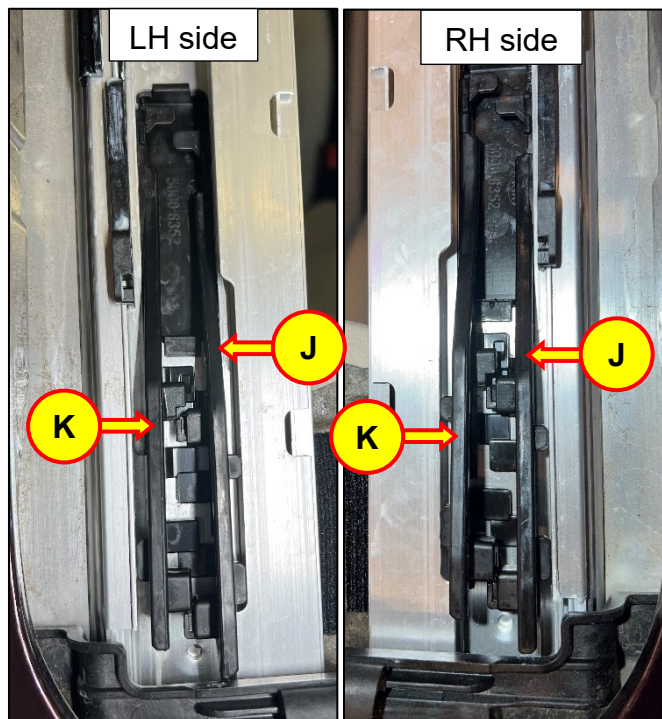
12. Remove the curve guide B (K) first, then remove the curve guide A (J).

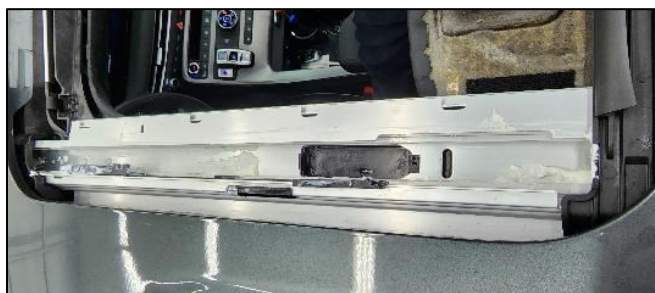
13. Inspect the sunroof mechanism rail(s) for any debris and remove any contaminants.

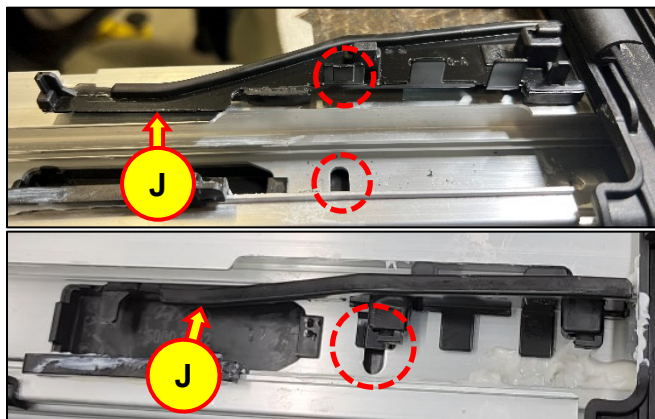
14. Install the new curve guide A (J) into the sunroof mechanism rail.

- Align the groove on the bottom of new curve guide A (J) with the slot in the rail.

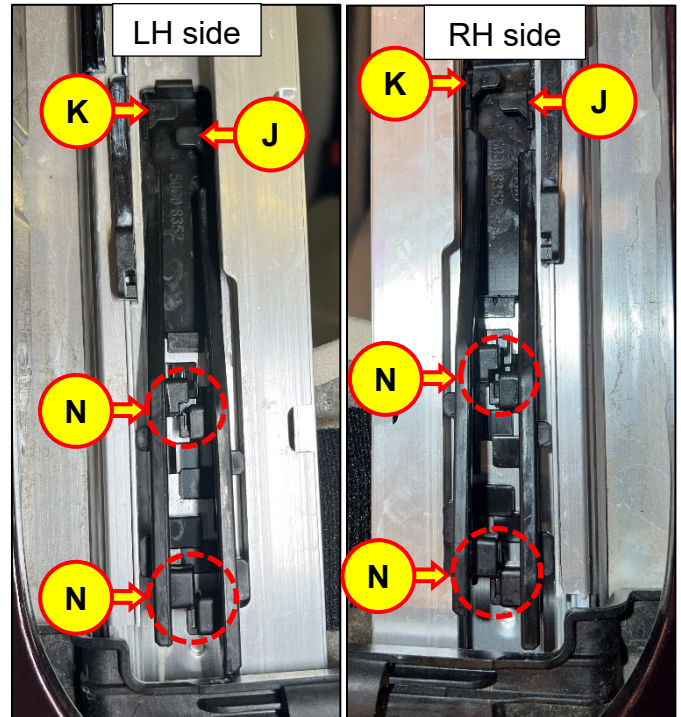
15. Install the new curve guide B (K) into the sunroof mechanism rail.

- Position curve guide B (K) ahead of curve guide A (J). Both curve guides should parallel with each other and the indicated locking tabs (N) should be aligned.
- Do not push both curve guides together until step 20.

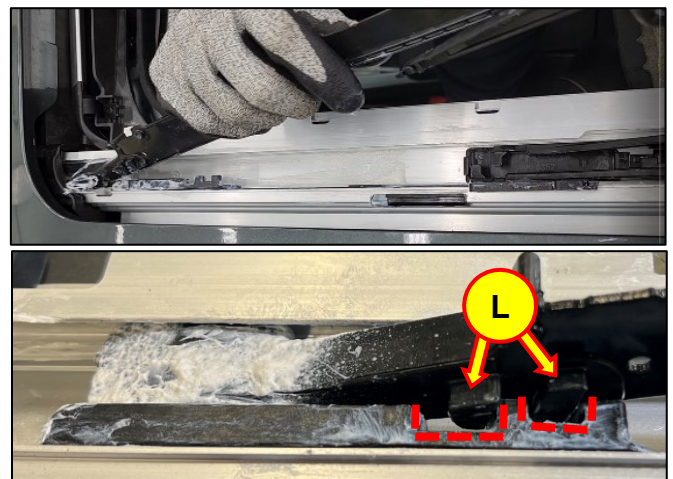
16. Install the new carriage bar (L) into the sunroof mechanism.

- The tabs on the new carriage bar (L) should align with the indicated slots in the sunroof mechanism.

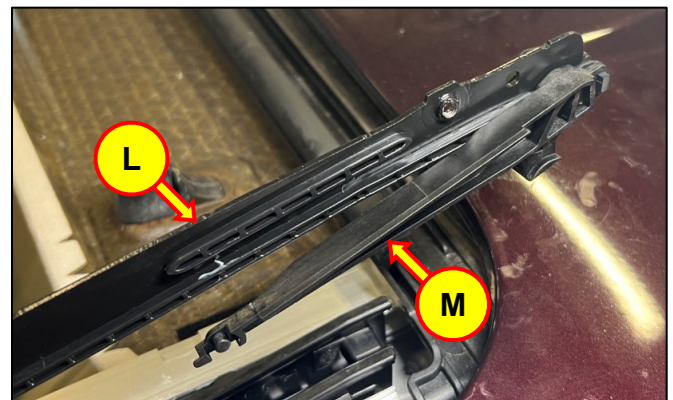
17. Install the new driving wedge (M) onto the new carriage bar (L).

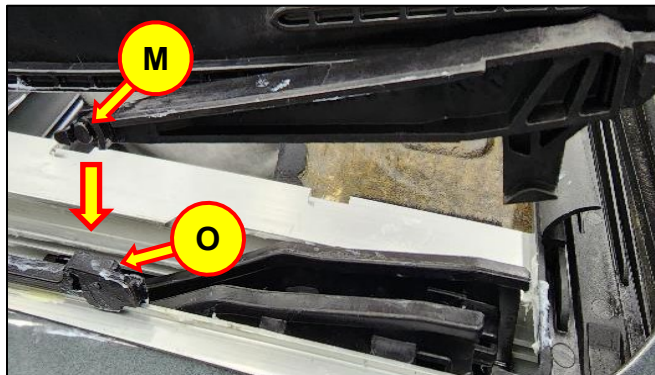
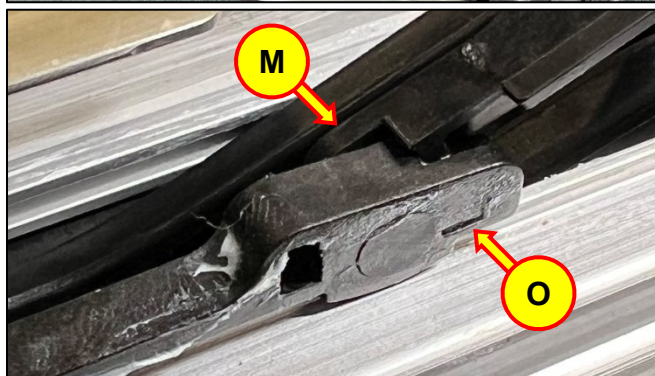
18. Install the locking tab of the new driving wedge (M) into the locking slide (O) of the sunroof mechanism.

- Move the new driving wedge (M) as needed to align the locking tab with the locking slide (O). It may also be necessary to lift the carriage bar at a 30° angle.

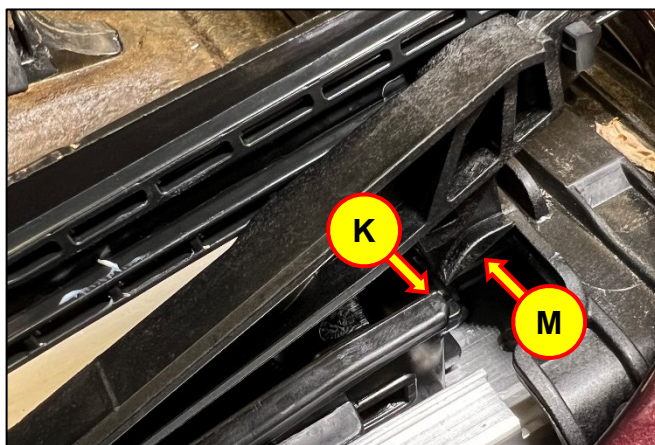
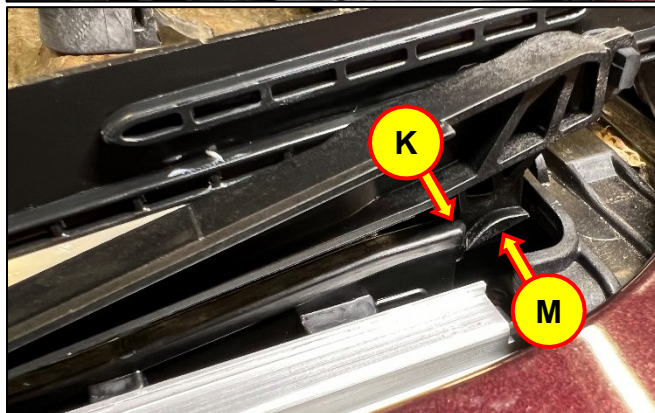
19. Lower the new driving wedge (M) and insert it in between both curve guides (K).

- Realign both curve guides (K) if they are moved out of position when installing the new driving wedge (M).

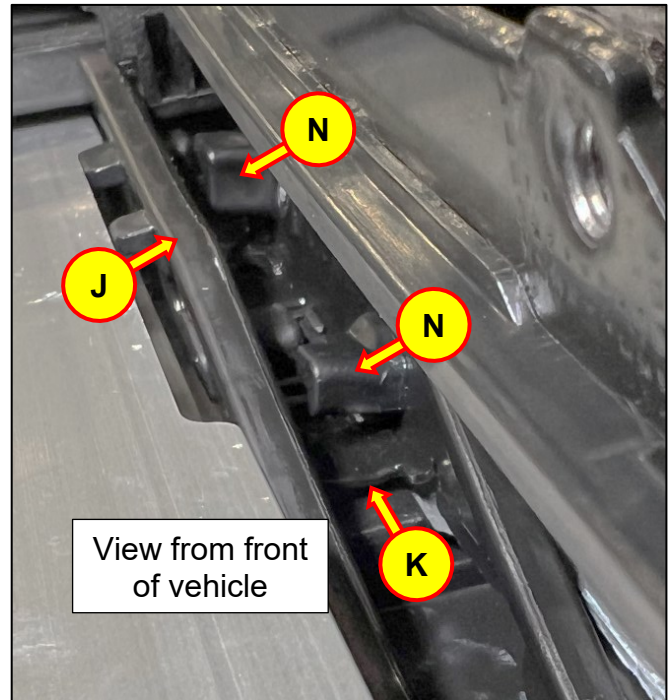
20. Lightly tap the indicated metal surface on curve guide B (K) with a flat head screwdriver to push it rearwards until it is fully seated with curve guide A (J).

- Ensure the locking tabs (N) of both curve guides are properly aligned beforehand.
- Do not tap on the locking tabs (N).
- Do not use excessive force when tapping on the metal surface of curve guide B (K).
- Damage to the curve guides may occur if the previous steps are not followed.

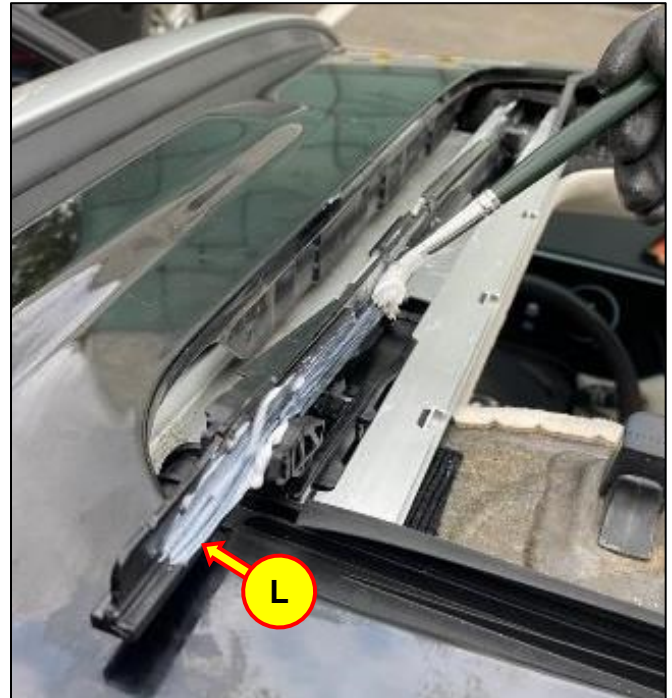
21. Apply white lithium grease to the new carriage bar (L).

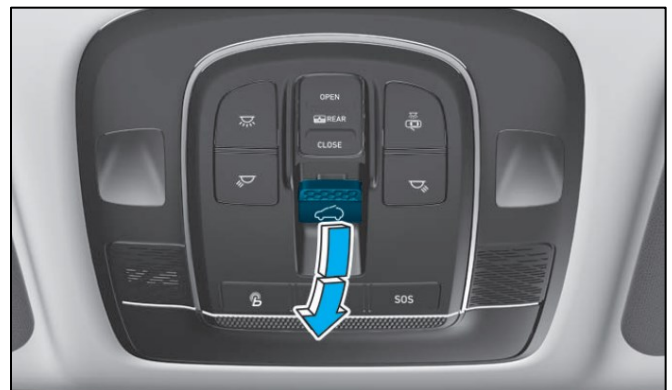
22. Perform the sunroof reset procedure and test for normal open/close and tilt functions of the sunroof mechanism.

Refer to the owner's manual for the complete sunroof reset procedure.

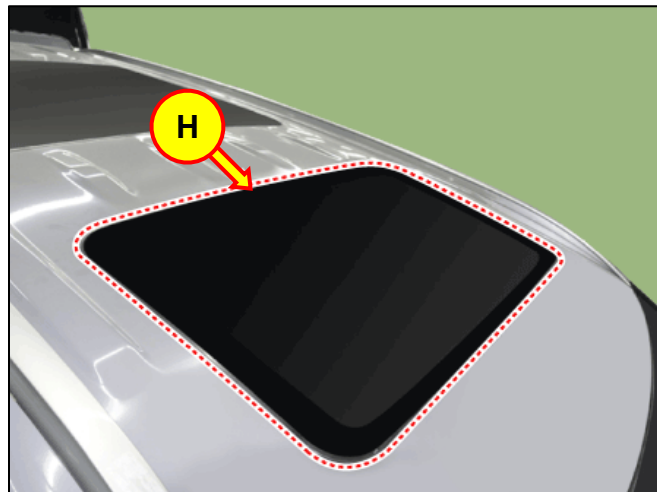
23. Place the sunroof mechanism in the tilt position.

24. Reinstall the sunroof glass (H).

- Ensure that the sunroof mechanism has been reset and fully tested before reinstalling the sunroof glass.

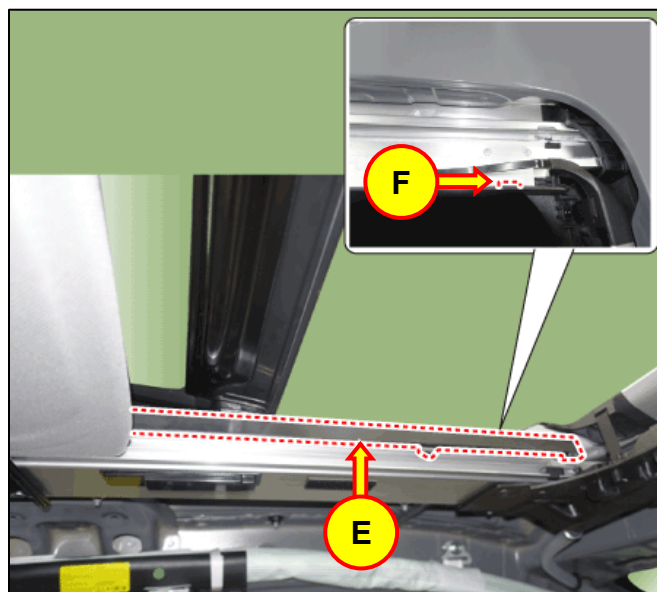
25. Reinstall the sunroof mechanism covers on both sides (E).
