**HYUNDAI**
Technical Service Bulletin

GROUP CAMPAIGN	NUMBER 23-01-034H
DATE APRIL 2023	MODEL(S) Genesis Sedan (BH) Equus (VI) Genesis Coupe (BK)

SUBJECT: UNDERBODY CORROSION PREVENTATIVE SERVICE
(SERVICE CAMPAIGN 991)

Description: In some areas, a vehicle's underbody may exhibit corrosion due to road salt usage. As a preventative measure, cavity wax coating is applied to the internal surfaces of underbody components, and an undercoating spray is applied to the bottom exterior surfaces of specified underbody components. This bulletin describes the procedure to perform this preventative service on certain Genesis Sedan (BH), Equus (VI), and Genesis Coupe (BK) vehicles.

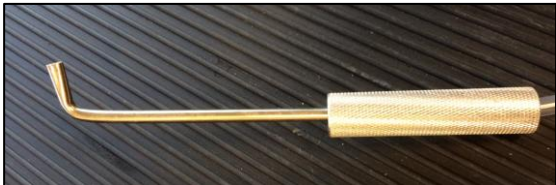
This nozzle is supplied with the wax gun.

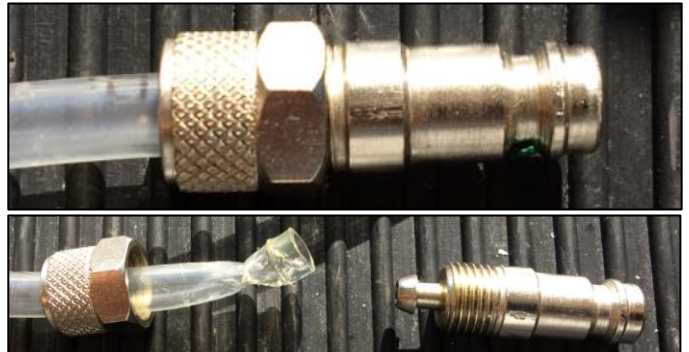
1. Unscrew the nut to remove the compression fitting from the nozzle assembly that originally comes with the wax gun.

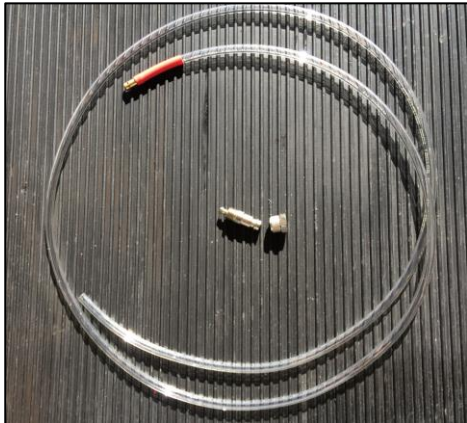
2. Attach the compression fitting to the tubing on the new nozzle assembly.

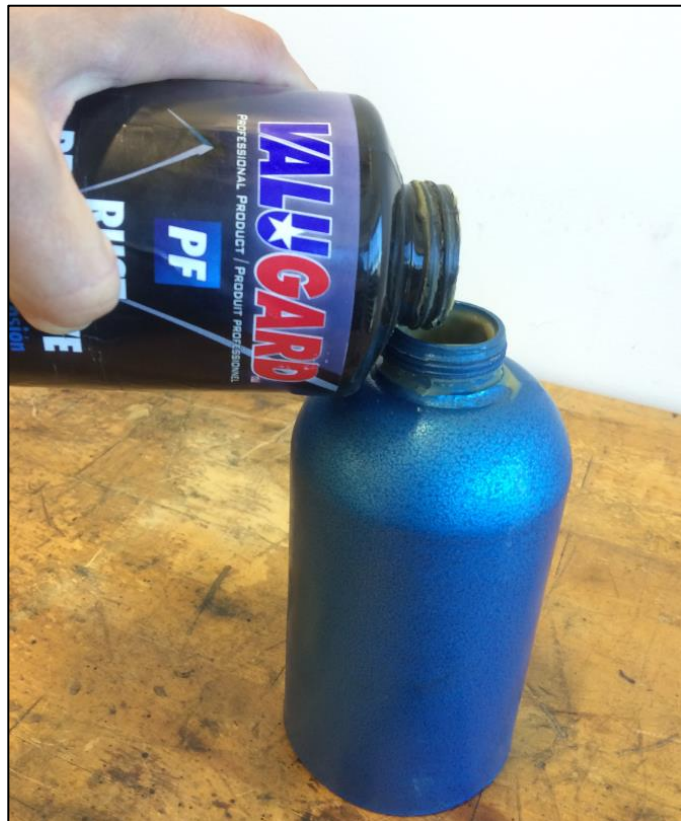
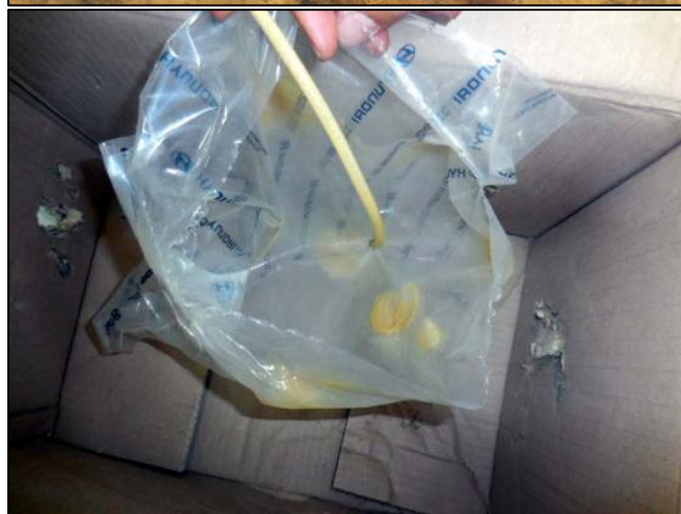
3. Fill wax gun reservoir with cavity wax.

Prime the wax gun by spraying the wax into a trash bag (or similar) until a light mist is visibly coming out of the nozzle.

Set air supply pressure to 70 psi.

Prime the wax spray gun to increase the flow when the mist is no longer visible.

To optimize the priming process, cover the nozzle with a rag and spray until the flow has increased.

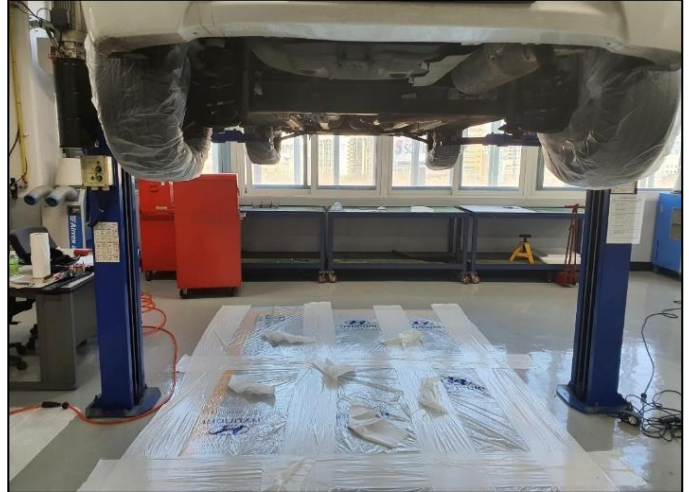
1. Lift the vehicle on a hoist.

Apply a plastic vinyl sheet on the floor.

If equipped, remove plastic undercovers to gain access to the front sub-frame, brake, and fuel tubes.

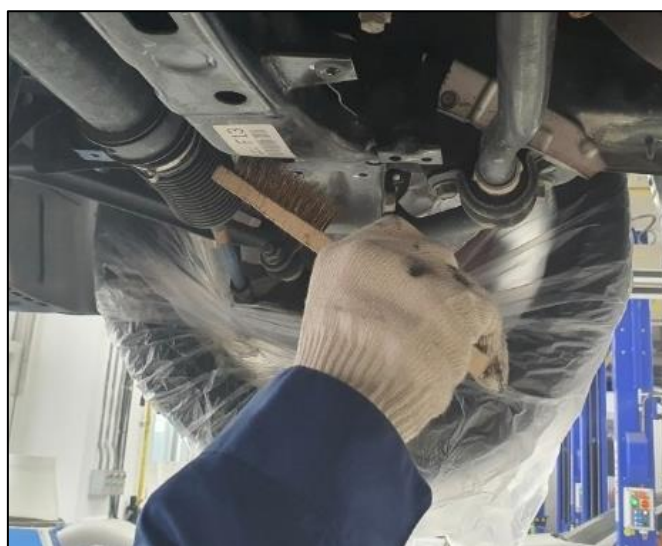
- 3. Use a wire brush to remove debris from the front sub-frame, rear sub-frame, rear upper arms, and rear lower arms.

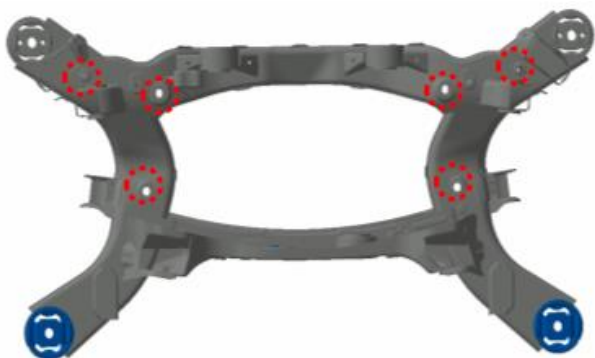
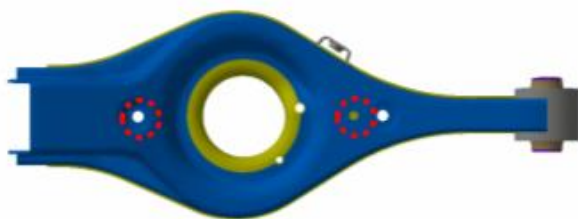
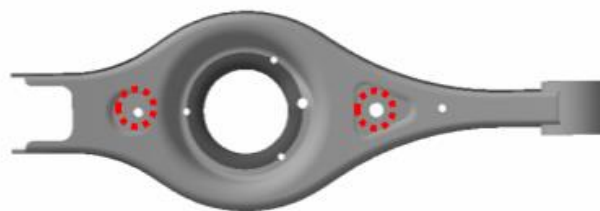
5. Remove the remaining debris by inserting an air nozzle into the interior cavity of the subframes and control arms. Then blow air in multiple directions.

Use the marked areas as a guideline to insert the nozzle. Additional access might be possible to remove more debris.

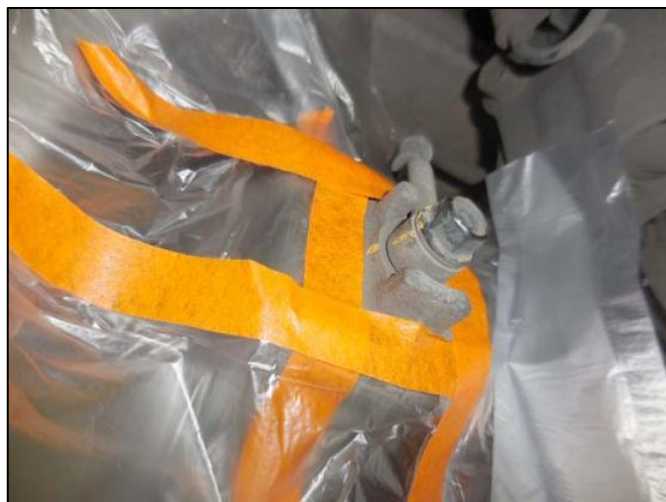
1. Wrap the brake assemblies with plastic bags to protect them from overspray. Use tape to secure the plastic in place. Leave the banjo fitting area exposed, as shown.

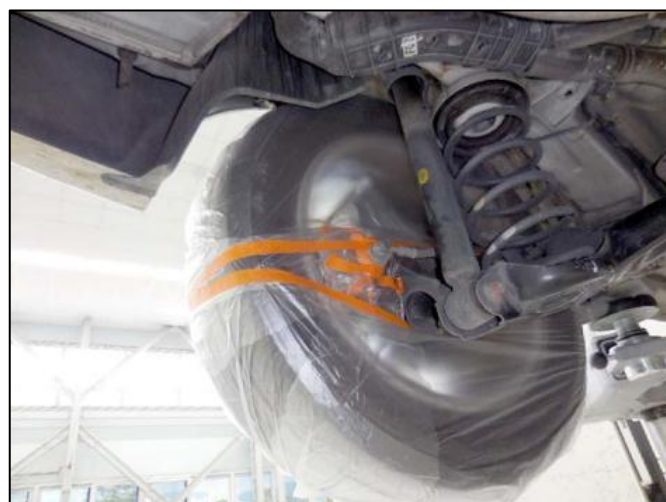
2. Wrap large plastic bags around the wheel/tire/brake assemblies to protect them from overspray. Use tape to secure the plastic in place.

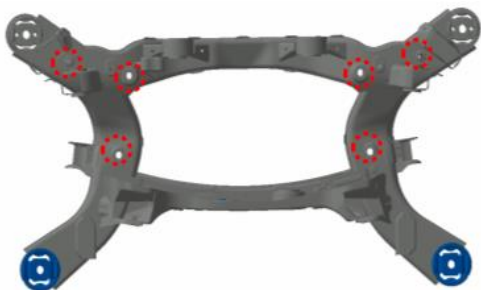
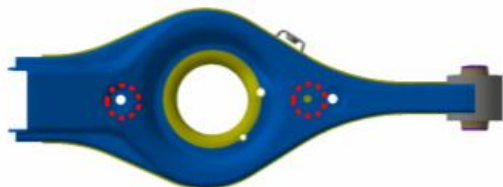
Generally for coating interior surfaces, insert the “inside” nozzle as deeply as possible at each point of entry. Spray the cavity wax while simultaneously rotating the nozzle, and slowly pulling the nozzle out. Continue this rotating/pulling motion until the pink tubing is seen coming out of the hole. The pink tubing indicates there is about 50mm of tubing left until the end of the nozzle. Stop spraying when the pink tubing is seen.

1. Use the marked areas as a guideline to insert the cavity wax nozzle. Additional access into the internal cavity of the components might be possible.

Wipe the excess wax off the exterior surfaces of the components.

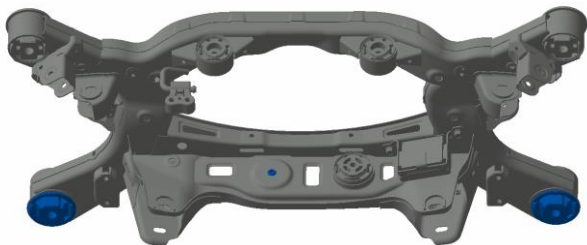
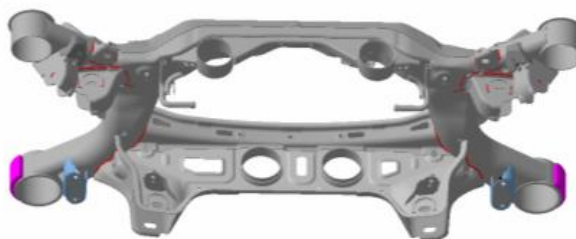
Spray the black undercoating on all exterior surfaces of the front and rear sub-frames, rear lower arms, front and rear brake caliper banjos, brake tube brackets, and the fuel & brake tubes. Refer to the following images.

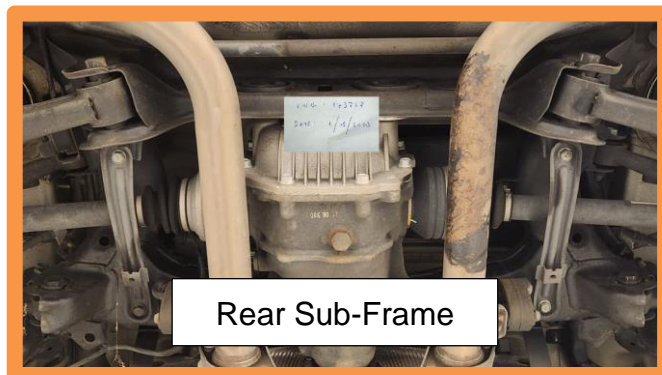
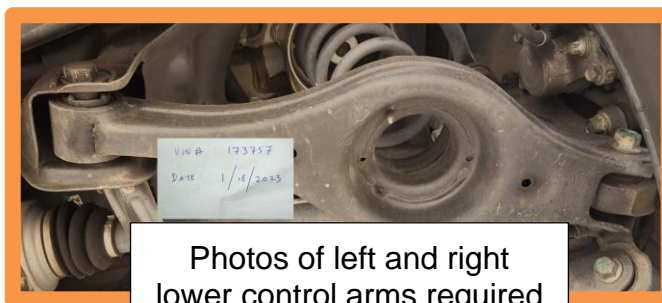
Using STUI, take clear photos of the following components after the undercoating is applied with the last 6 digits of the VIN and the date of repair on a piece of paper. See examples shown to the right.

1. Front sub-frame
2. Rear sub-frame
3. Left rear lower control arm
4. Right rear lower control arm
5. Left rear upper control arm (BK only)
6. Right rear upper control arm (BK only)
