## SERVICE ACTION: TFT SOFTWARE UPDATE

**BMW  
MOTORRAD**

Model	Model Description
K53/12	R 1250 R
K54/12	R 1250 RS

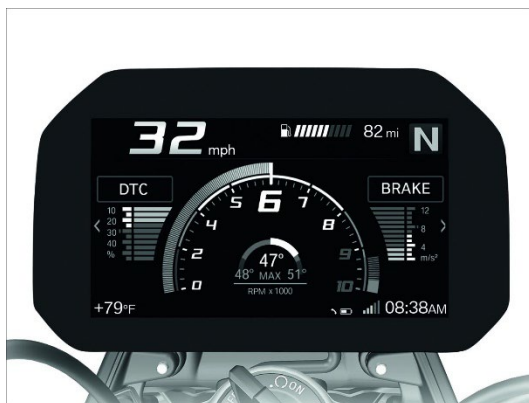
Overview of “Sport” view

The “Sport” view can be activated with a vehicle software update to I-level K001-23-07-500 in the TFT display (available with ISTA version 4.41.3x, planned to be release end of May 2023.).
