# Technical Service Bulletin

**20 EVAP charcoal filter line (N80) - ticking/thumping noise in passenger compartment (rear) - V6 3.0 TFSI**  
20 23 60 2067759/2 May 5, 2023. Supersedes Technical Service Bulletin Group 20 number 23-57 dated April 25, 2023, for reasons listed below.

Model(s)	Year	VIN Range	Vehicle-Specific Equipment
Q8	2019 – 2023	All	Not Applicable

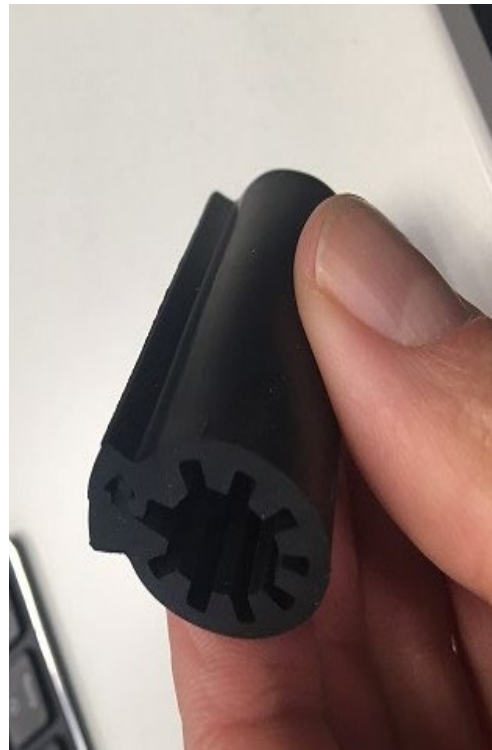
*Figure 1: Sleeve 4KD 201 255.*

1. Fit sleeves (figures 1, 2) with part number 4KD 201 255 on the activated charcoal filter line (figure 3, item 8).

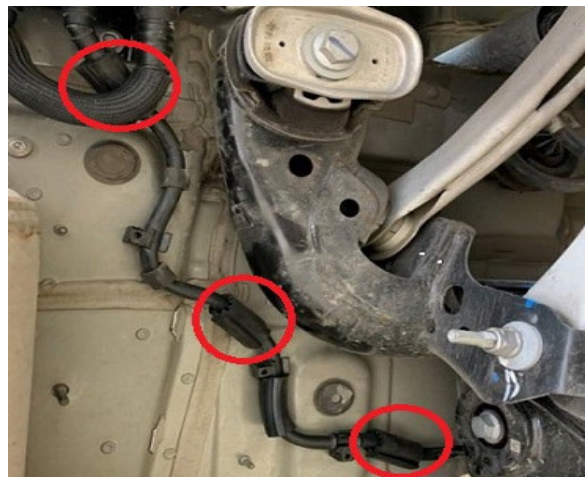
*Figure 2: Sleeves installed on the activated charcoal filter line.*

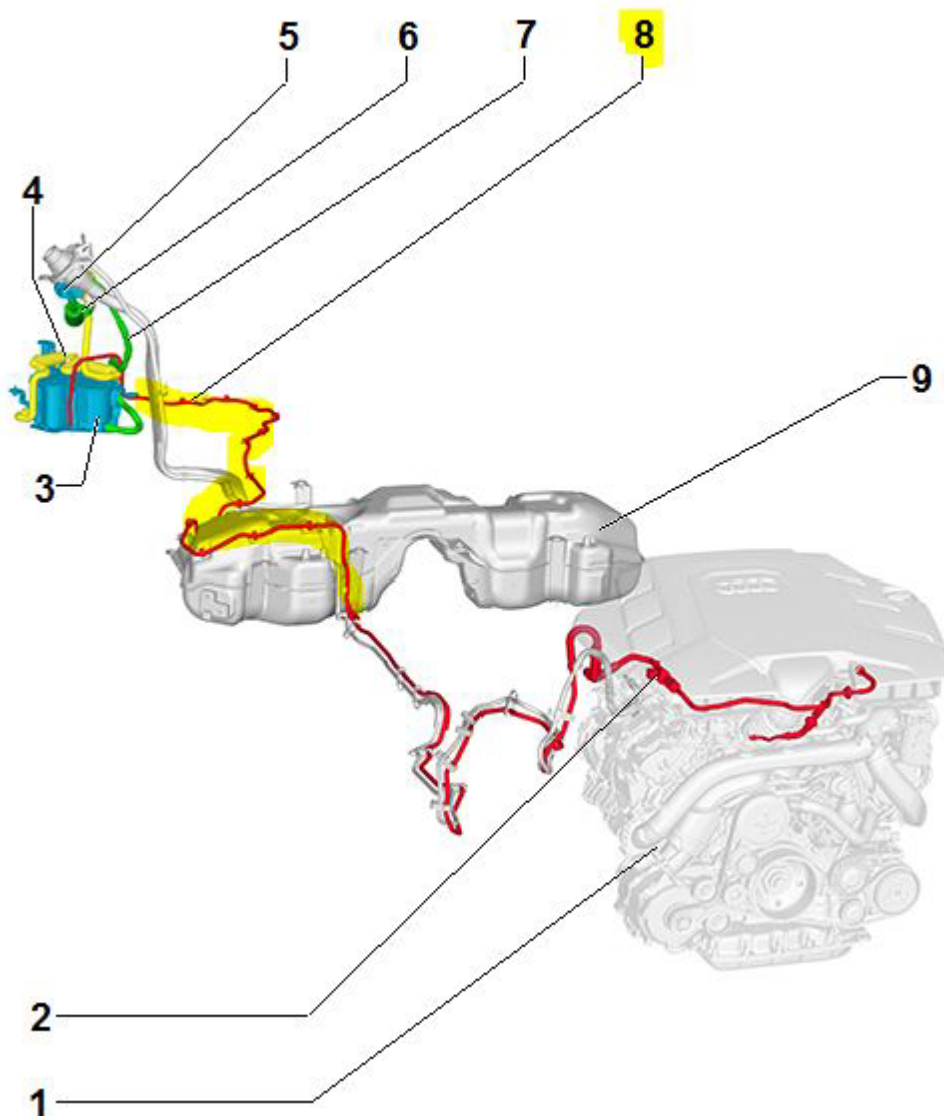
The activated charcoal filter solenoid valve (N80) vibrates the activated charcoal filter line; this results in a ticking and/or thumping noise.

*Figure 3: Sleeve installation location is highlighted.*

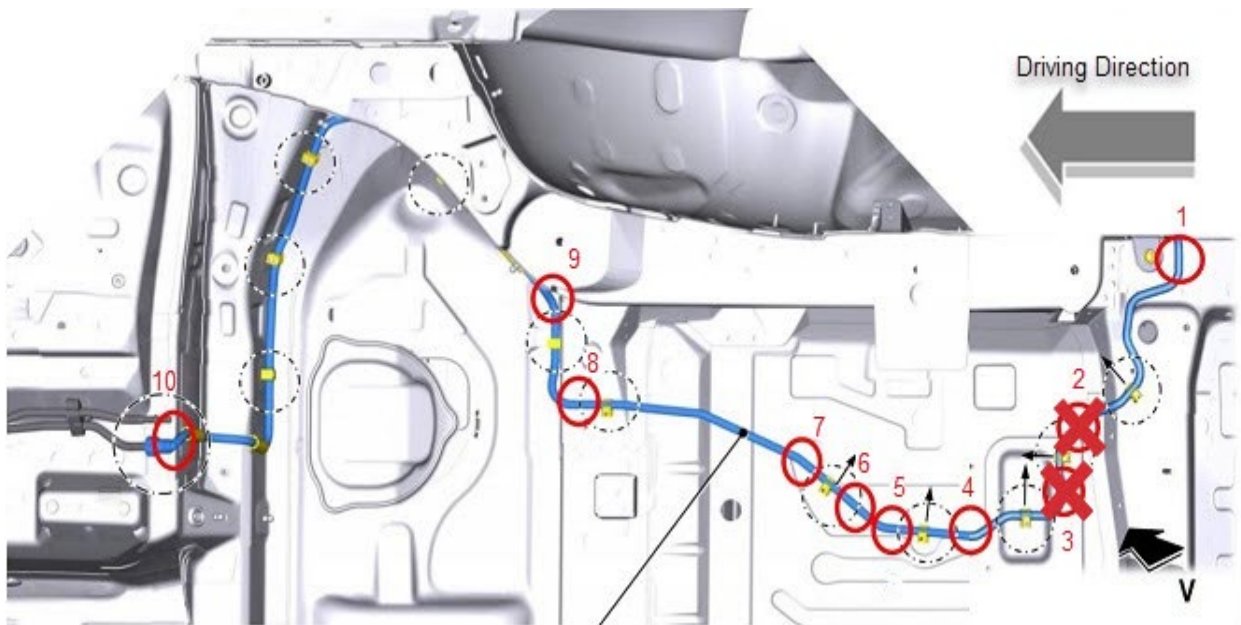
**Figure 5:** Vehicles with air suspension and without rear wheel steering (PR no. 1BK, 0N1) - 8 sleeves.

2. The number of sleeves depends on the equipment version of the vehicle (PR number) when it was manufactured. Use the following overviews (figures 4, 5, and 6) to determine how many sleeves are required and their positions.

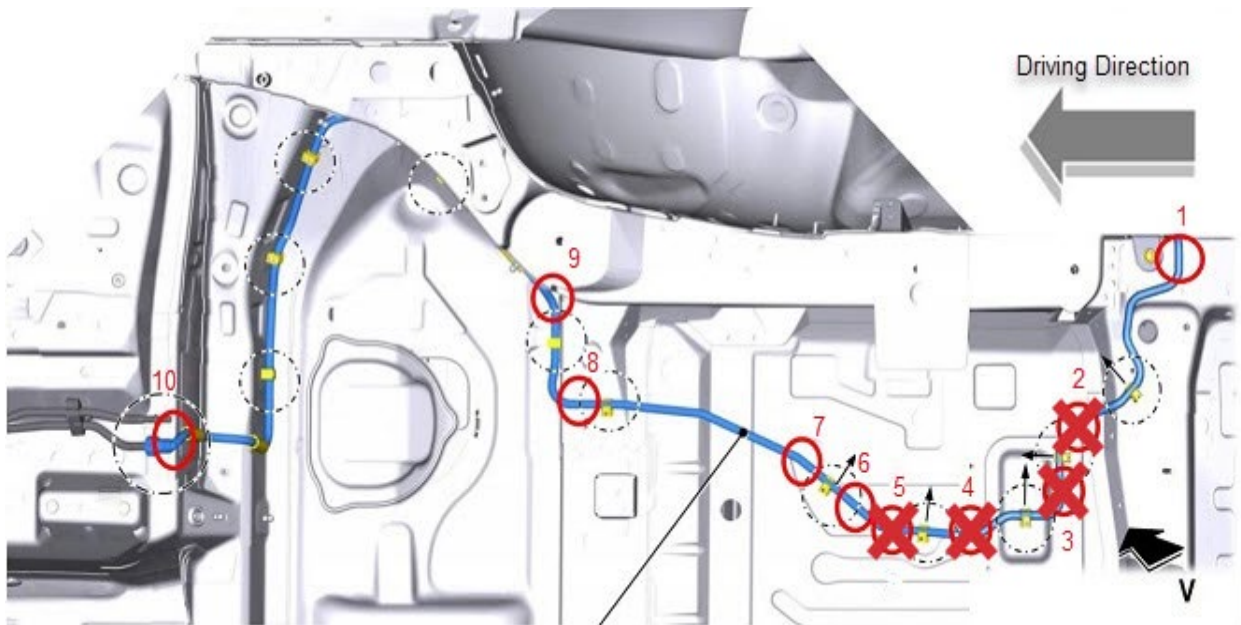
Figure 6: Vehicles with air suspension and with rear wheel steering (PR no. 1BK, 0N5) - 6 sleeves.
