SERVICE BULLETIN

APPLICABILITY: 2015-22 MY Outback & Legacy

Air Bag Curtain Module Mounting Clip & Spacer Clip SUBJECT:

NUMBER: 17-18-23 **DATE:** 05/08/23

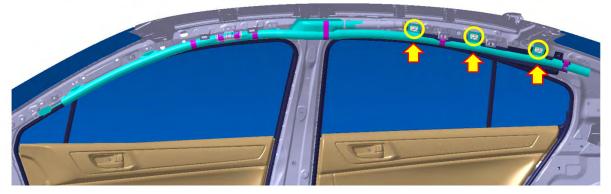
2015-19 MY Legacy

CLIP LOCATIONS:
