## Technical Service Bulletin

| <b>CAMPAIGN</b> | <b>23-01-015H-1</b> |
| <b>July 2023</b> | <b>NEXO (FE)</b> |

**SUBJECT:** STACK COOLANT PUMP REPLACEMENT  
(SERVICE CAMPAIGN T8W)

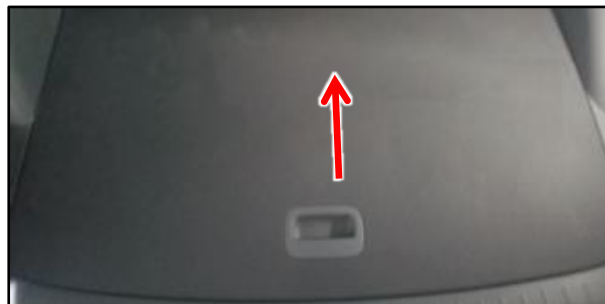
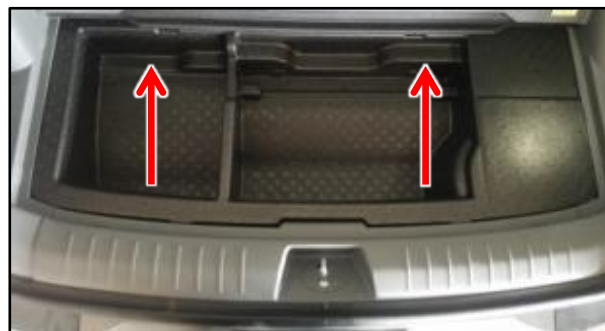
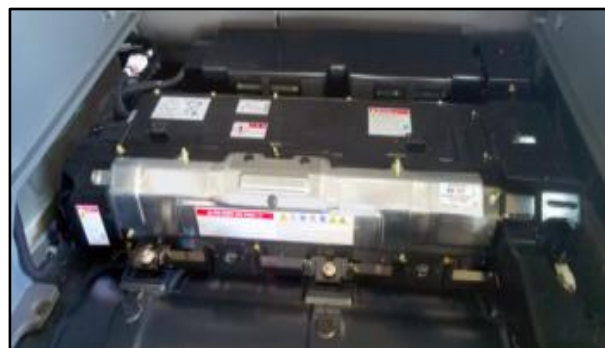
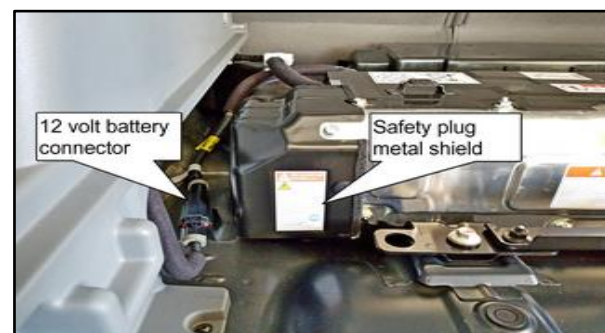
1. In the rear cargo area, remove the floorboard and cargo tray to access the 12-volt battery connector and high-voltage battery safety plug.

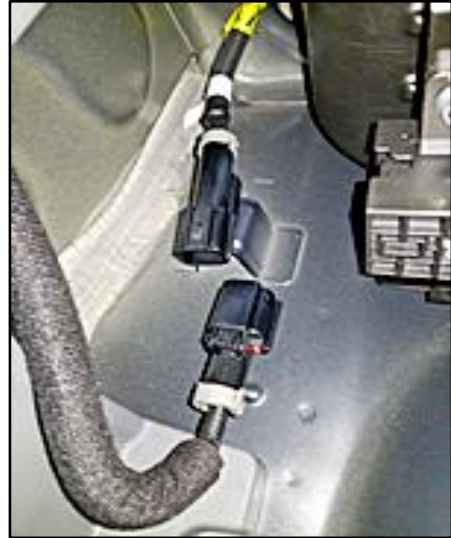
2. Disconnect the 12-volt battery negative (-) connector.

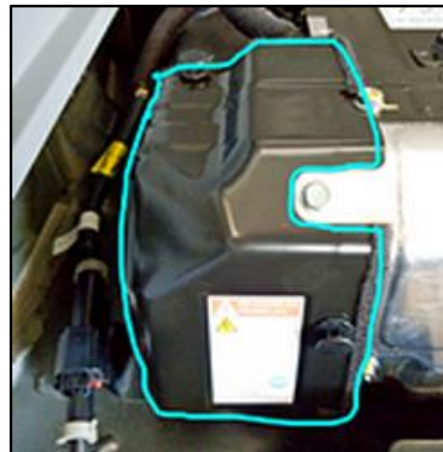
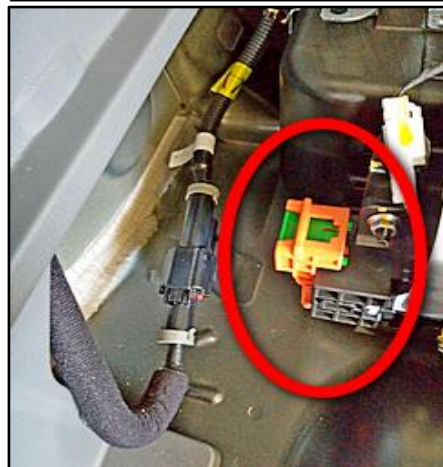
3. Remove the metal shield to access the high voltage safety plug.

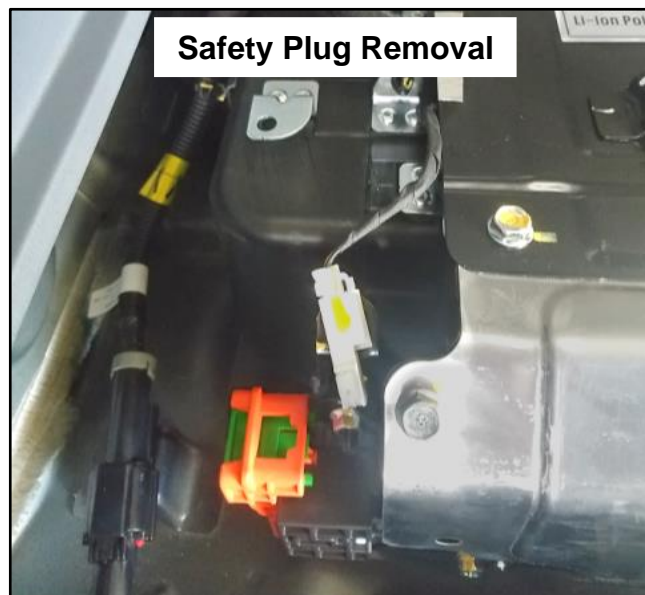
4. Follow A - D below to remove the orange high voltage safety plug.

Store the removed safety plug in a secure location outside and away from the vehicle.

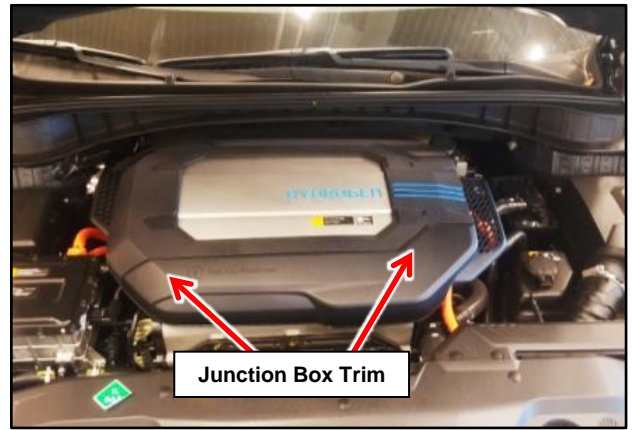
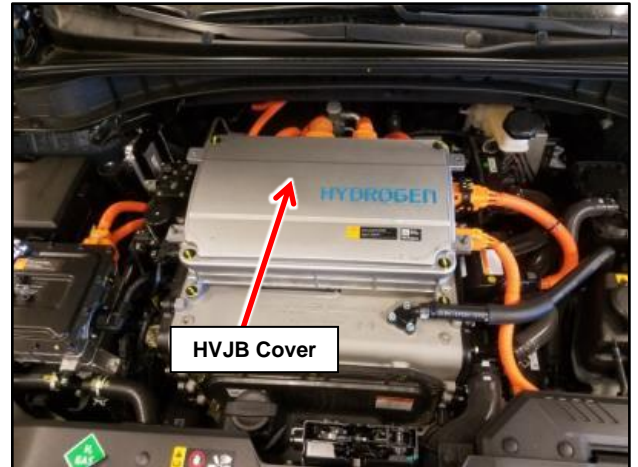
6. Open the hood. Remove the junction box trim and cover.

**High Voltage Junction Box (HVJB) cover:**

**Assembly bolt torque:**

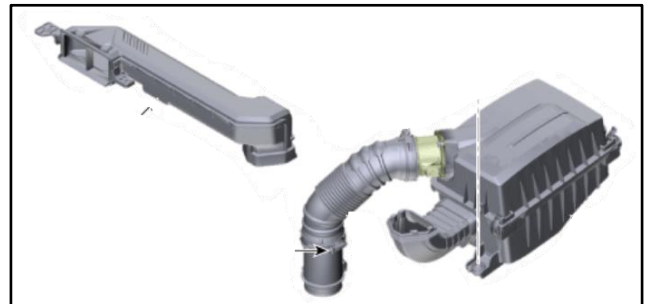
3. Remove the air cleaner assembly.

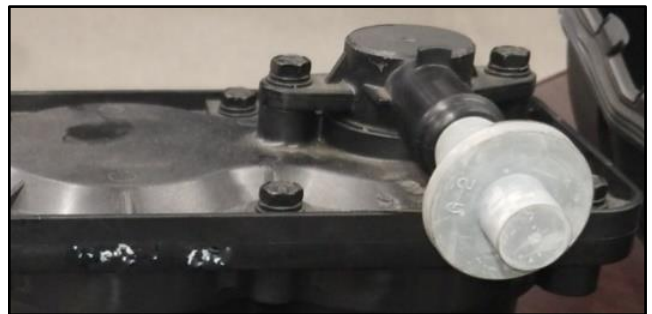
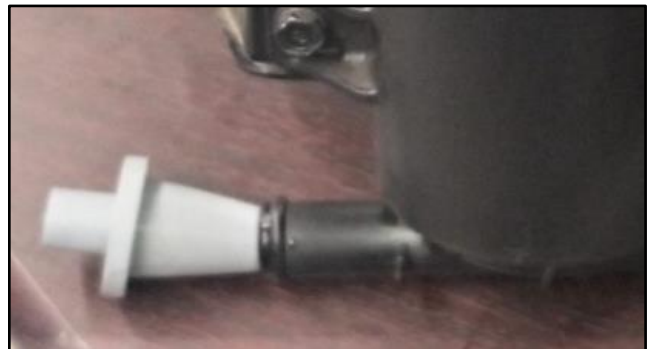
5. Remove the stack coolant ion filter as an assembly (C). DO NOT remove filters from canister.

To prevent loss of coolant from filter canister, insert a tapered plug into the upper hose fitting on the filter canister, then remove the lower hose from filter canister and insert a tapered plug into lower hose fitting on the filter canister.

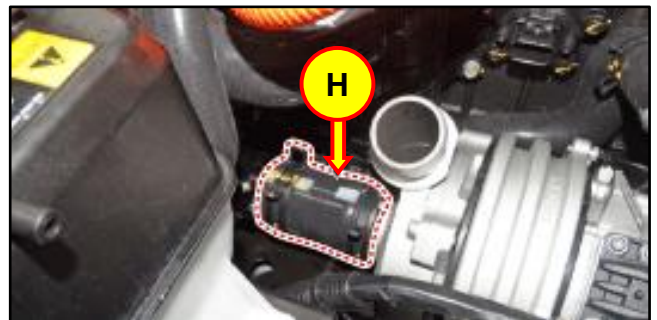
9. Disconnect the stack coolant pump inlet hose clamp (H).

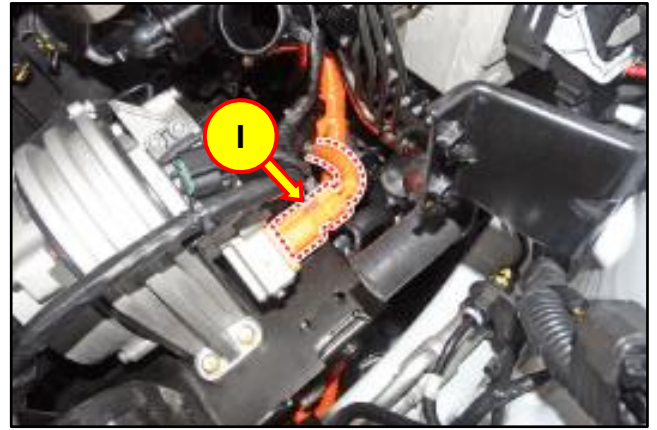
10. Disconnect the stack coolant pump high voltage cable connector (I).

- (1) Remove the connector locking pin.
- (2) Press on the 1<sup>st</sup> holding point.
- (3) Insert a screwdriver into the 2<sup>nd</sup> holding point and remove the high voltage connector by pulling on the connector.

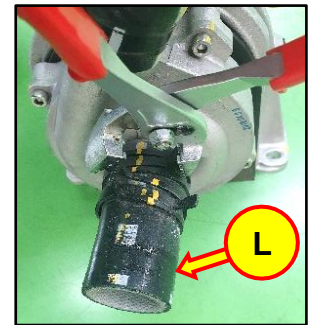
13. Remove the stack coolant pump hose (K).  
Remove the inlet and outlet hose (L).

Do not discard the stack coolant pump hose. The pump hose will be installed onto the replacement stack coolant pump.

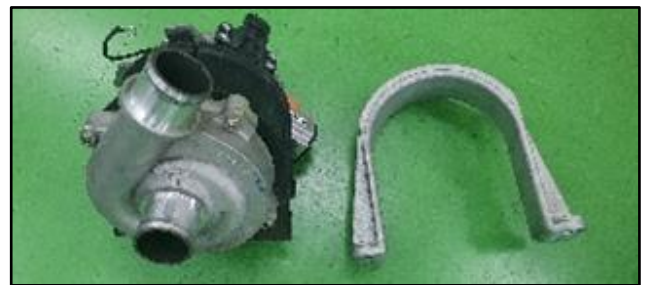
15. Remove the pump bracket (N).

Do not discard the pump bracket. The pump bracket will be installed onto the replacement stack coolant pump.

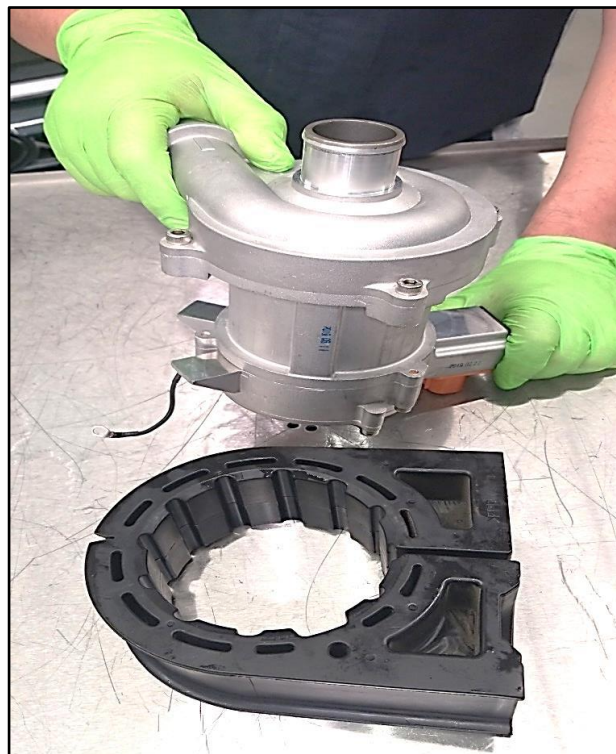
17. Attach the rubber bushing to the new stack coolant pump.

The rubber bushing and stack coolant pump housing are indexed with a land and groove.

Align the groove in the rubber bushing with the land on the stack coolant pump housing.

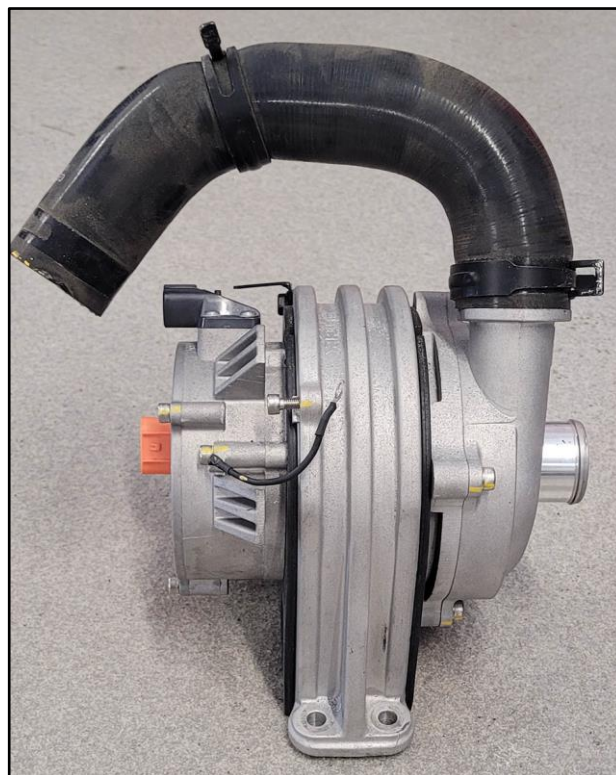
18. Attach the pump bracket and hose from the original stack coolant pump to the new stack coolant pump.

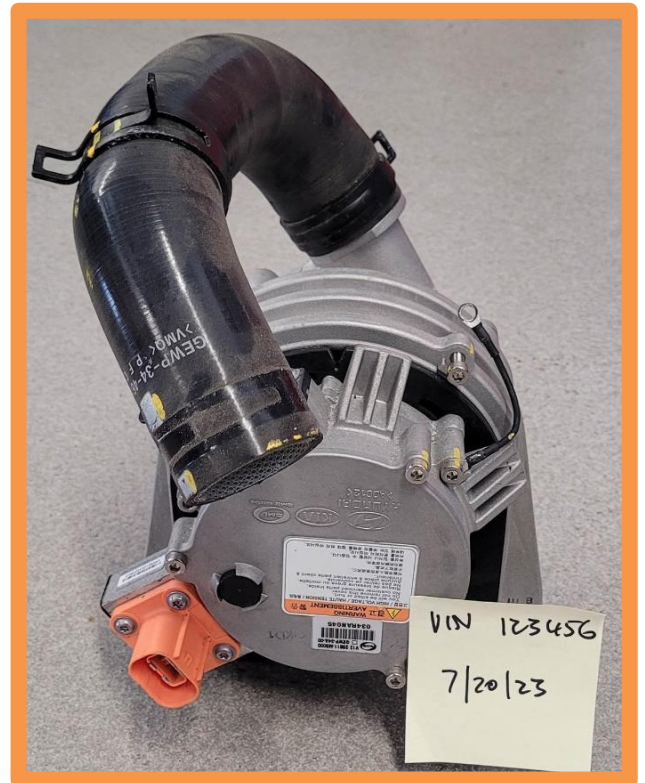
19. Before installing the replacement stack coolant pump to the vehicle, use STUI to photograph the labels on the replacement stack coolant pump and submit photo through STUI.

Using STUI, photograph the stack coolant pump labels. Include in the photo a piece of paper containing the last 6 digits of the VIN and date of repair. Ensure the photo is in focus and clearly captures the stack coolant pump labels, especially the part number, and note.

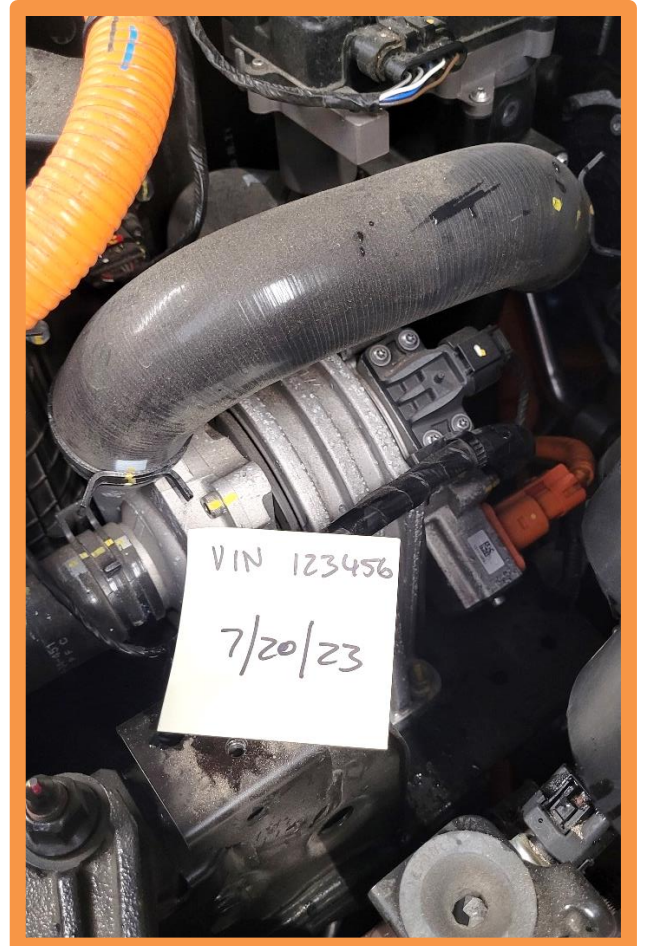
20. Install the replacement stack coolant pump to the vehicle.

Using STUI, photograph the stack coolant pump installed in the vehicle. Include in the photo a piece of paper containing the last 6 digits of the VIN and date of repair. Ensure the photo is in focus and captures the stack coolant pump and note.
