Technical Service Bulletin

91 MIB3: pop-ups for massage functions are not displayed when the massage button is pressed

91 23 16 2069596/2 July 24, 2023. Supersedes Technical Service Bulletin Group 91 number 23-82 dated March 22, 2023 for reasons listed below.

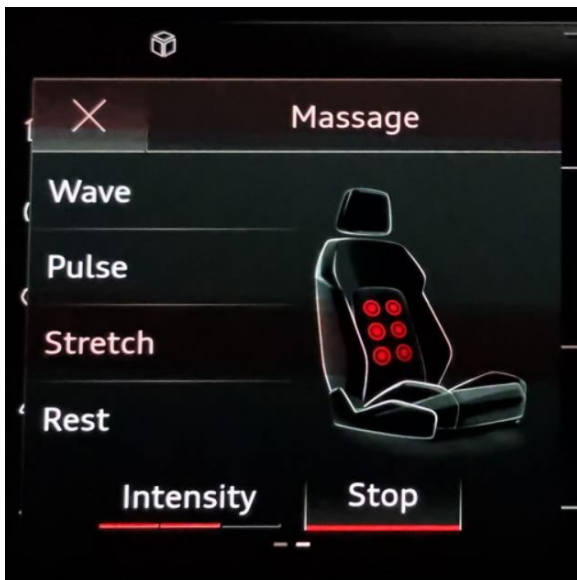
Figure 1: Massage pop-up.

The pop-up message for the seat massage function is no longer displayed on the MMI screen when the massage button is pressed (Figure 1).

1. Follow all instructions in TSB 2011732: *00 Software Version Management (SVM), operating instructions*.
2. Update the Electronic Central Electrical (BCM) control unit -J519- (address word 0009) using the SVM action code as listed in the table below, if necessary:
