ID # CBR-2297

Volvo Chassis - Nonfunctioning 12v Accessory Power Supply - Model Year (MY) 2017 To Present

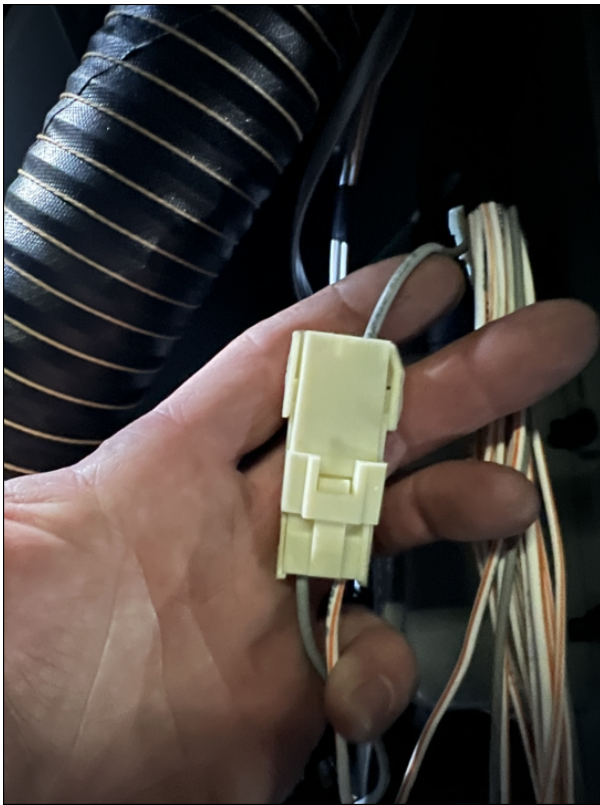
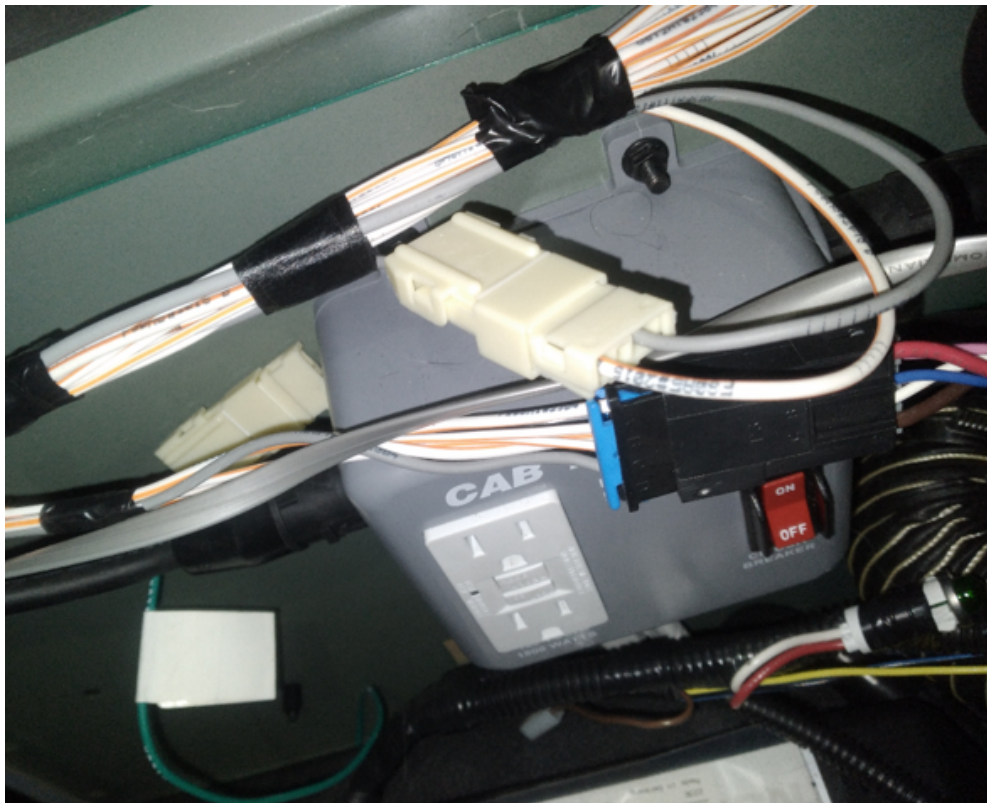
If you have a nonfunctioning underbunk 12v accessory power supply and fuse F80 is blown please inspect the under-bunk connector as seen in the images below.

This connector should not be connected together. These connectors are not used.

Male connector wire ID	FA107#1318
Female connector wire ID	F80A5#2019B
	FA111#1304

Live UI ct the connector, replace fuse 80, and verify the repair.
