15-23-01 - Head Gasket Leakage

Release date: 8/17/2023

| Applicable Vehicles | | | | | |
|---|---|---|---|---|---|
| Taos | 2022 - 2023 | 1.5T (DNKA) | All | - | Engine Code DNKA 234 458 |
| Jetta | 2022 - 2023 | 1.5T (DNKA) | All | - | Engine Code DNKA 234 458 |

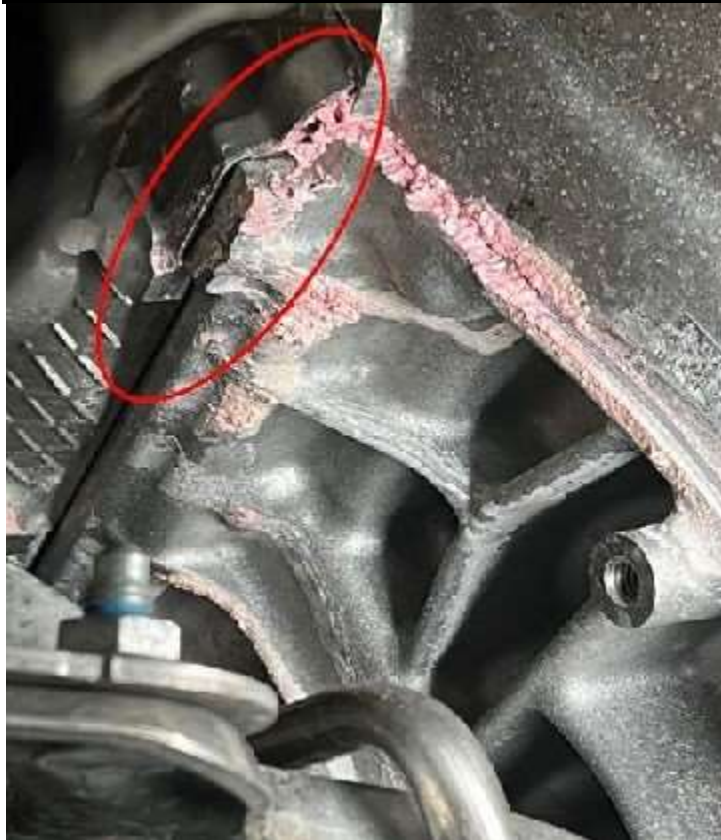
Original engine production head gasket design can lead to coolant leaks.

If a coolant leak is found between the cylinder head and engine block, at the back of the engine below the turbo as indicated in Figure 1. and Figure 2., the head gasket must be replaced per Elsa Pro instructions.
