Technical product information

Topic	DTC C10BCF6 and/or DTC C12E2F2 stored in address 0003 - Parking brake warning in DIP
Market area	Australia E04 Bentley rest Asia and Australia (6E04),China 796 VW Import Comp. Ltd (Vico), Beijing (6796),Germany E02 Bentley rest Europe (6E02),Japan E03 Bentley Japan (6E03),Korea, (South) E08 Bentley South Korea (6E08),United Arab Emirates E06 Bentley Middle East and Africa (6E06),United Kingdom E01 Bentley UK (6E01),United States E05 Bentley USA and rest America (6E05)
Brand	Bentley
Transaction No.	2071166/1
Level	EH
Status	Approval
Release date

New Continental GT/GTC and New Flying Spur

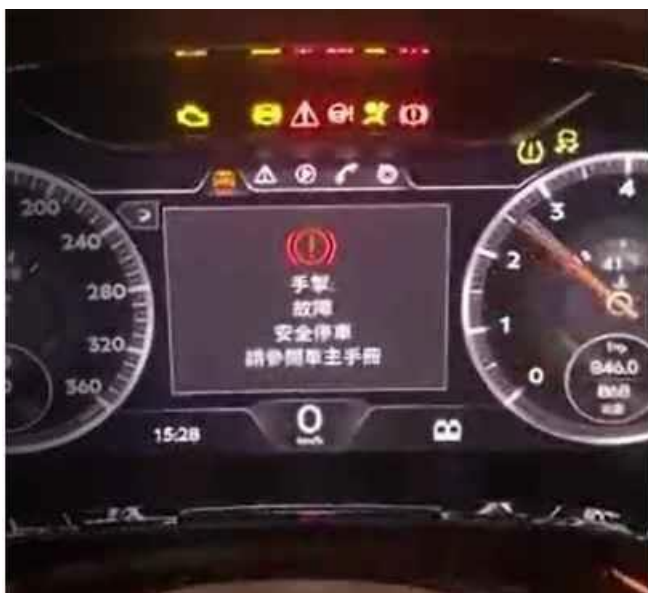
Figure 1

Parking brake warning light evident within the DIP (See example shown in Figure 1)

- 1) Raise a technical DISS query ensuring a current ODIS log is attached
