Service Bulletin

Bulletin No.: 21-NA-210

Subject: Information on A/C Evaporator Rubber Hose Cracking

Brand:	Model:	Model Year:		VIN:		Engine:	Transmission:
		from	to	from	to		
Chevrolet	Bolt EV	2017	2023	—	—	—	—
	Bolt EUV	2022		—	—	—	—

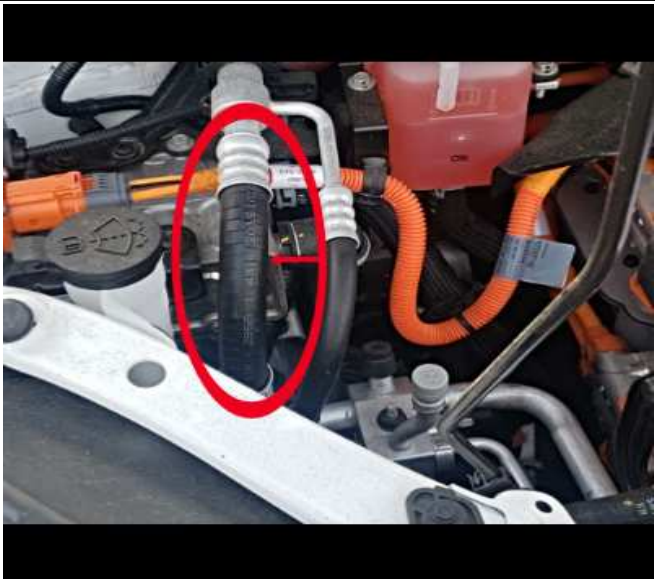
<p style="text-align: right; font-size: small;">5902726</p> <p>Some customers may comment about visible cracks on the outermost rubber layer of the air conditioning evaporator hose with no A/C performance concern, as shown in the picture above.</p>
Cause	This condition may be caused by exposure of the outermost layer of the hose to the outside environment (ozone).
Correction	Please communicate to the customer that the air conditioning evaporator hose is functioning as designed and this is a normal condition of their vehicle. Please share this information with the customer, including a copy of this bulletin.

No repairs should be attempted for this concern.
