Service Bulletin

Bulletin No.: 12-08-51-002P

Subject: Spray-in Bed Liner General Information and Repair Procedures

Models: 2013-2014 Chevrolet Silverado HD 2500/3500 Series
2014 Chevrolet Silverado 1500
2015-2024 Chevrolet Colorado, Silverado
2013-2014 GMC Sierra HD 2500/3500 Series
2014 GMC Sierra 1500
2015-2024 GMC Canyon, Sierra
2022-2024 GMC HUMMER EV
2020 Holden Colorado
Equipped with Spray-in Bed Liner (RPO CGN, PDL)

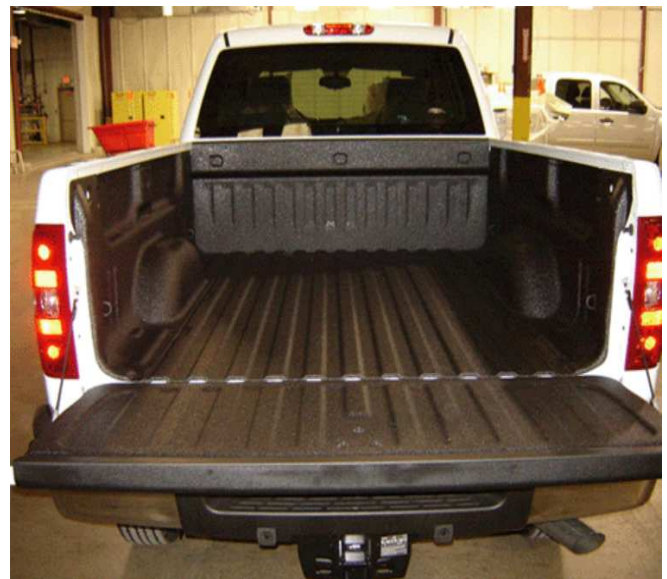
2968662

Entire bed

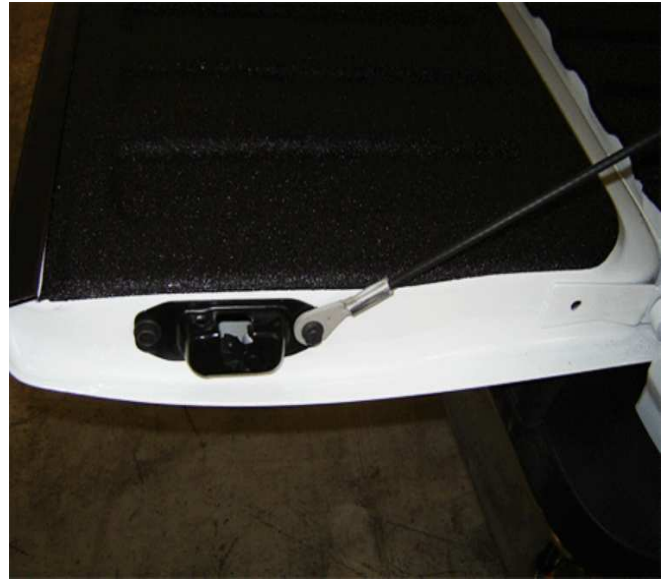
2968672

Tailgate side view

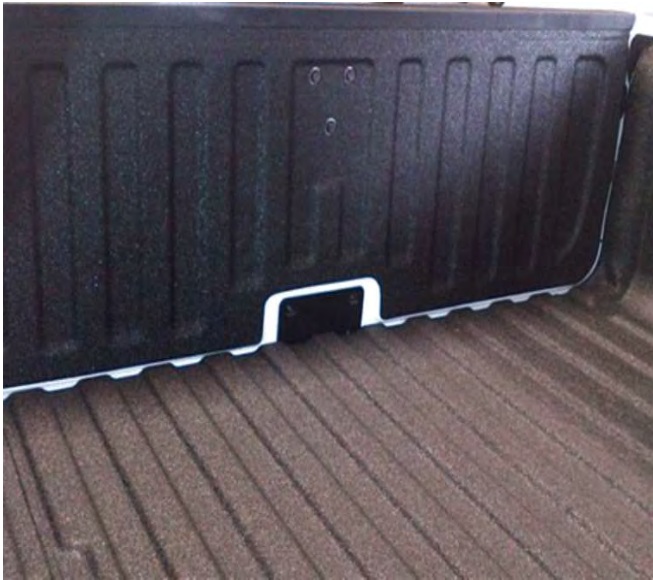
2968668

Tailgate with Rear Vision Camera (gate in closed position)

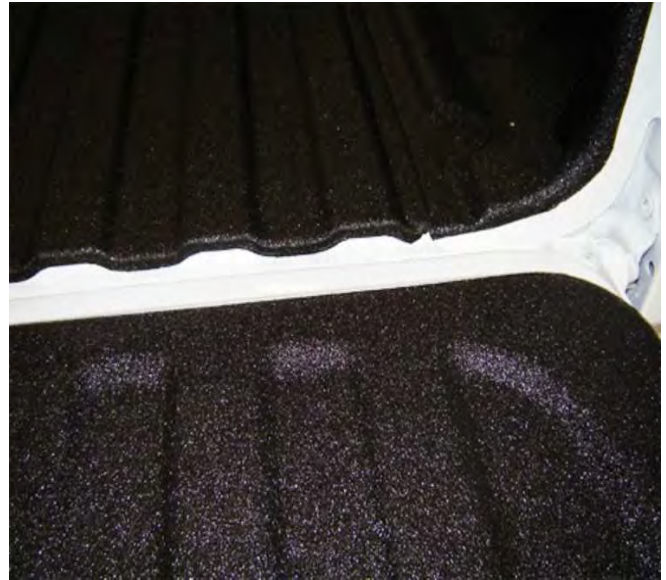
2968673

Lower tailgate and bed floor

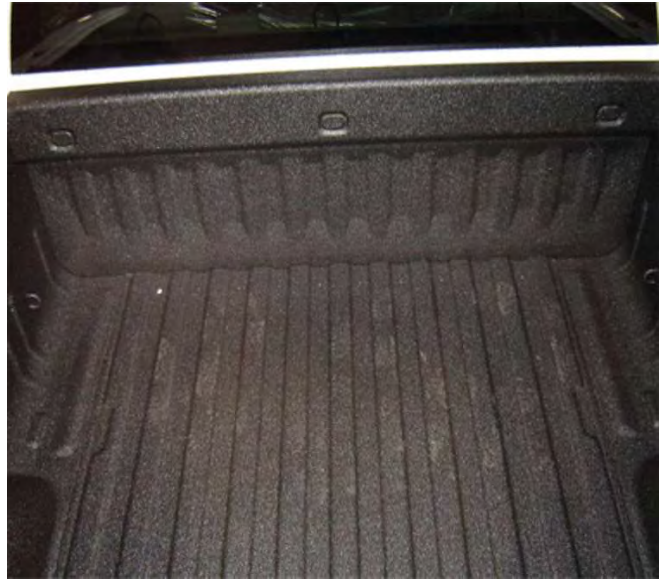
2968676

Bed header panel

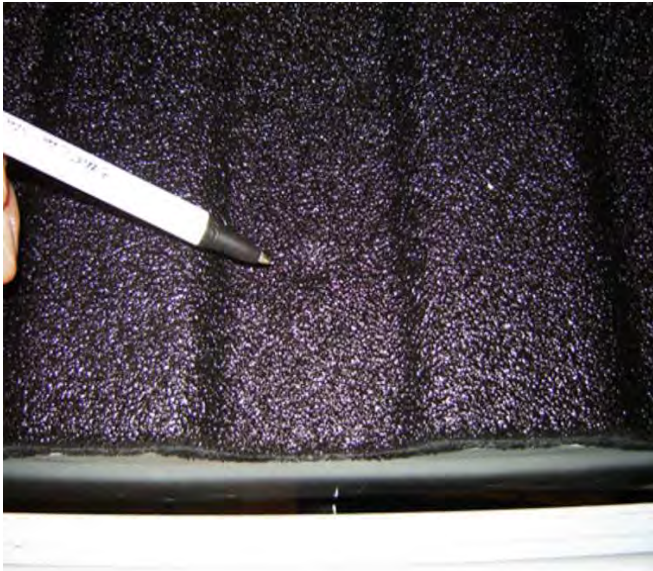
2968675

Because the bed liner material is sprayed on evenly, any variation in the bed such as seam sealer or spot welds in the sheet metal will show underneath the spray on coating. This is an expected condition. The coating does not completely fill in these variations.

Spot weld under bed liner example

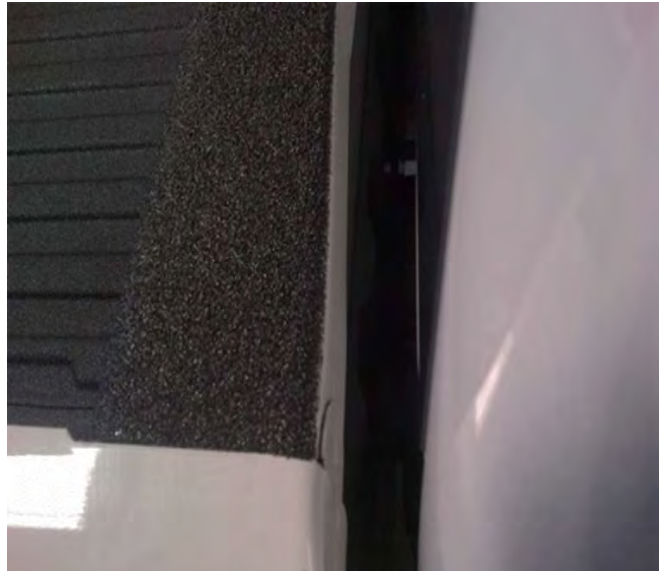
2968678

Bed header panel close up

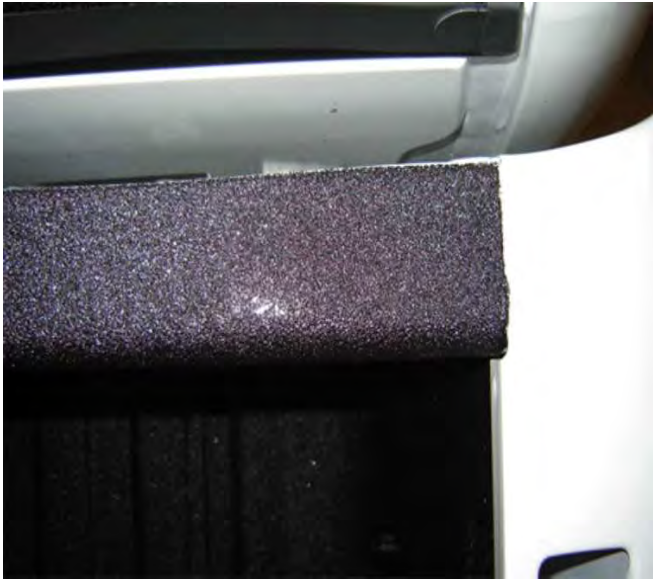
2968682

Bed header panel/side panel joint

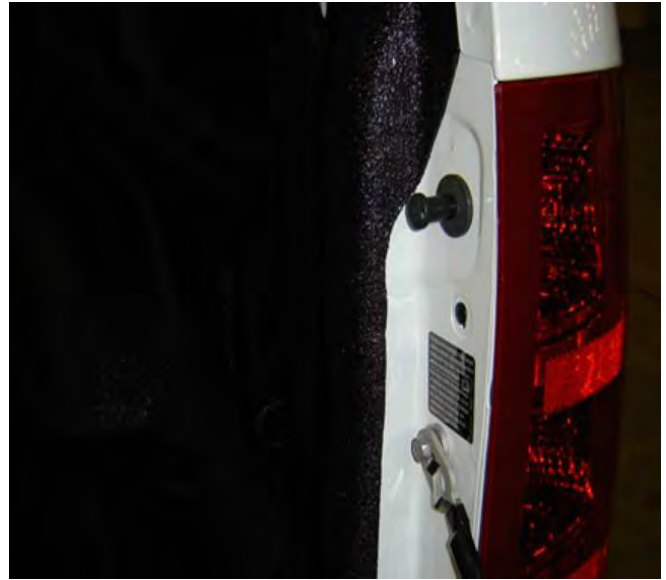
2968690

Tailgate opening view

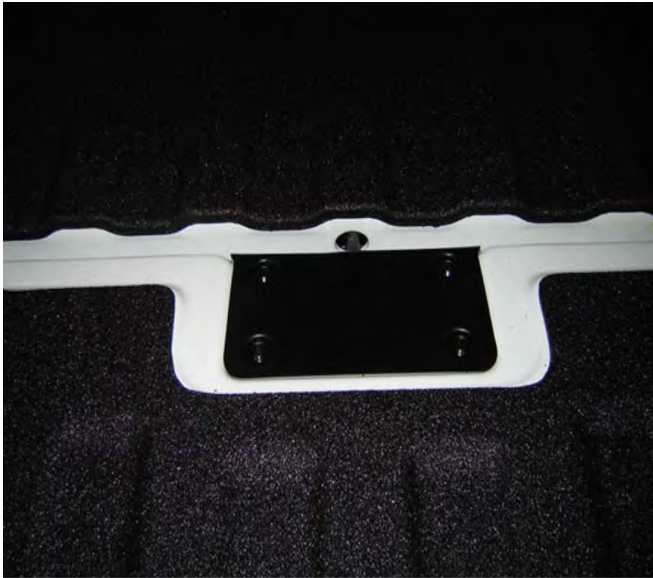
2968687

Bed floor (with rear camera access panel, gate open)
