# Technical Service Bulletin

## 74 Damage assessment guidelines for textile seat covers

74 23 26 2071893/1 October 25, 2023.

Model(s)	Year	VIN Range	Vehicle-Specific Equipment
All Audi models	2008 – 2023	All	With textile seat covers

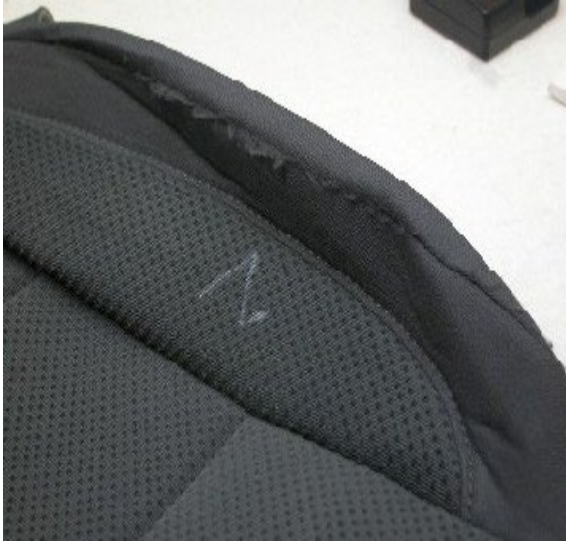
**Figure 1. Fluffing**

Description	Possible cause/damage location	Warrantable
Fibers protrude from the upholstery fabric like fur, long fibers become matted or form knots, always large and long-fibred (5-10 mm).	Mechanical damage caused by sharp-edged objects, for example. Seat bolster area.	<b>No</b>

**These are not warrantable defects and cannot be claimed under warranty (Figures 1-12).**

**Clean the seat covers with a neutral cleaner and a soft cloth.**

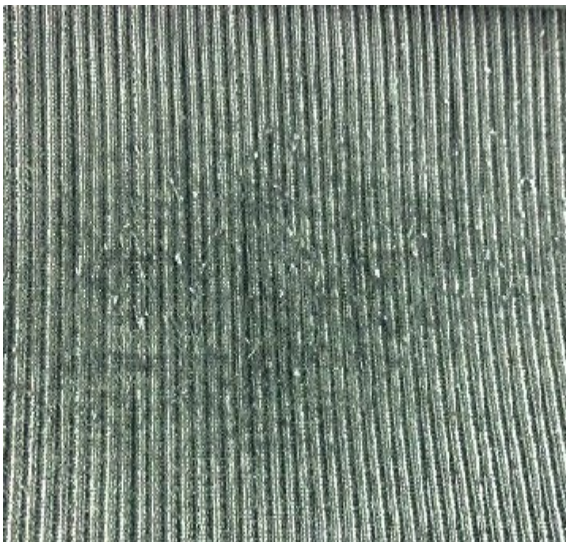
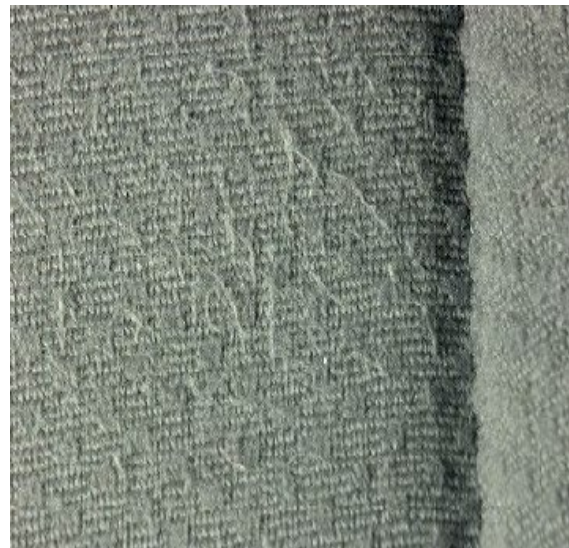
<p>Fibers protrude from the upholstery fabric like fur, long fibers become matted or form knots, always large and long-fibred (5-10 mm).</p>	<p>Chafing with the hook side of a Velcro fastener. Backrest area, rear seat surfaces (trouser pockets, mobile phone pouches).</p>	<p><b>No</b></p>
----------------------------------------------------------------------------------------------------------------------------------------------	----------------------------------------------------------------------------------------------------------------------------------------	------------------

**Figure 3. Fluffing**

**Figure 4. Fluffing**

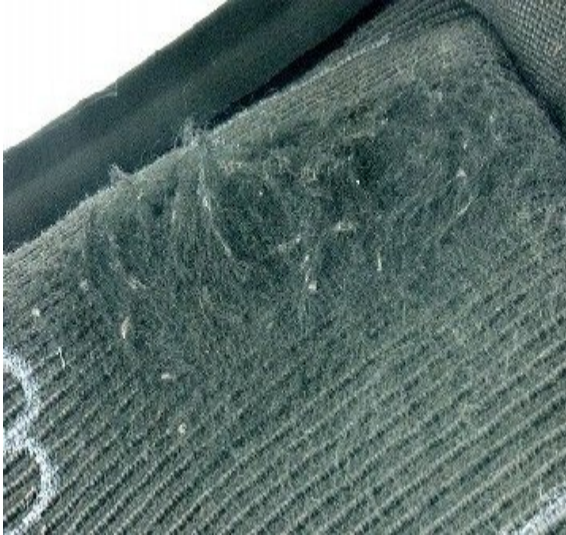
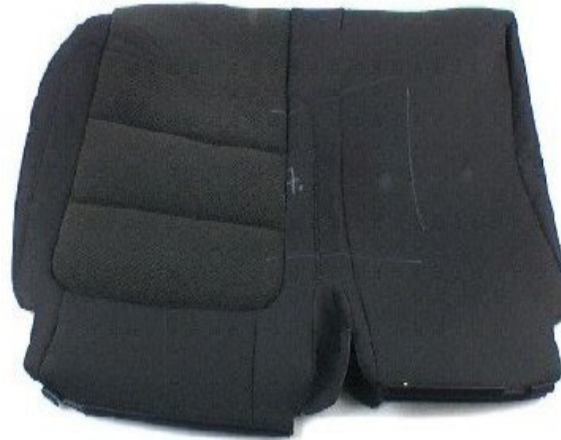
<p>Fibers protrude from the upholstery fabric like fur, long fibers become matted or form knots, always large and long-fibred (5-10 mm).</p>	<p>Cleaning with a brush. Various areas.</p>	<p><b>No</b></p>
----------------------------------------------------------------------------------------------------------------------------------------------	--------------------------------------------------	------------------

**Figure 5. Fluffing**

**Figure 6. Fluffing**

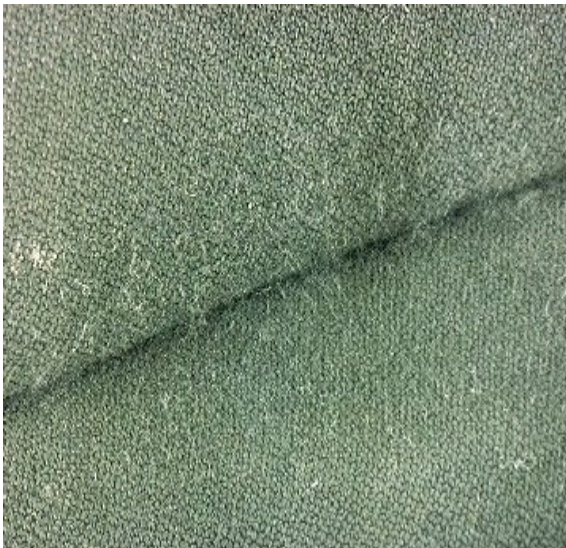
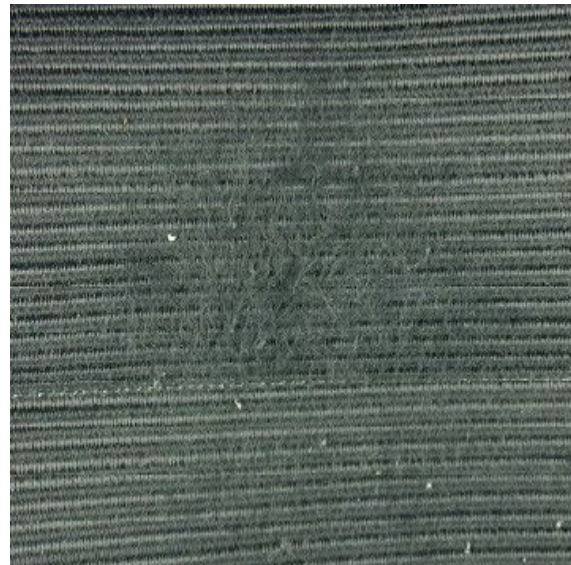
Fibers protrude from the upholstery fabric like fur, long fibers become matted or form knots, always large and long-fibred (5-10 mm).

By pushing a box or a wicker basket.  
Rear seat bench or front passenger seat surfaces.

**No**

**Figure 7. Fluffing**

**Figure 8. Fluffing**

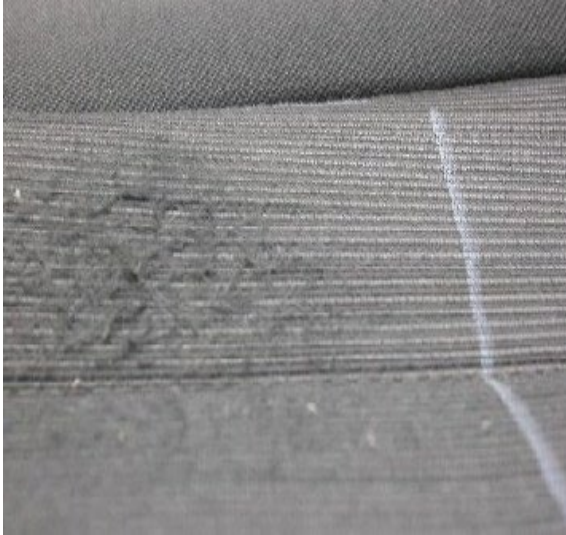
**Figure 9. Fluffing**

Fibers protrude from the upholstery fabric like fur, long fibers become matted or form knots, always large and long-fibred (5-10 mm).

Mechanical damage caused by cleaning (check for stains on the backside).  
Various areas.

**No**

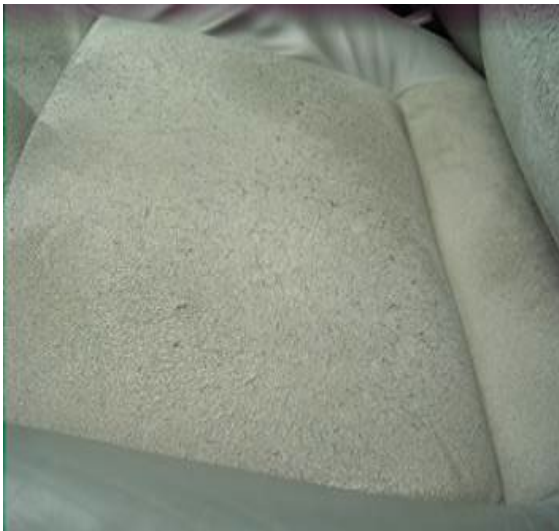
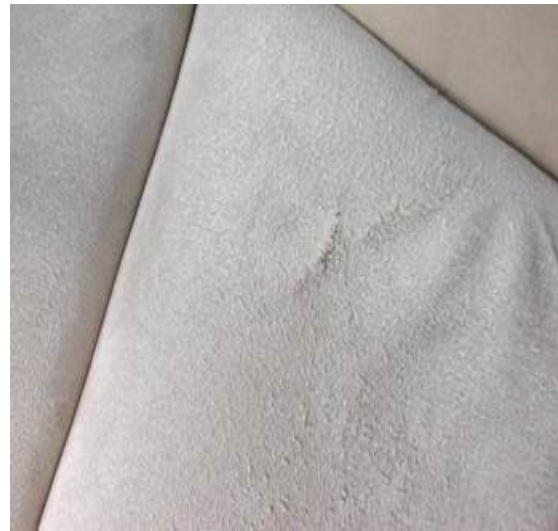
<p><b>Alcantara</b> Fibers protrude from the upholstery fabric like fur, long fibers become matted or form knots, always large and long-fibred (5-10 mm).</p>	<p>Mechanical damage caused by incorrect cleaning agent/cleaning method. Various areas.</p>	<p><b>No</b></p>
-------------------------------------------------------------------------------------------------------------------------------------------------------------------	-------------------------------------------------------------------------------------------------	------------------

**Figure 10. Fluffing on Alcantara seat covers**

**Figure 11. Fluffing on Alcantara seat covers**

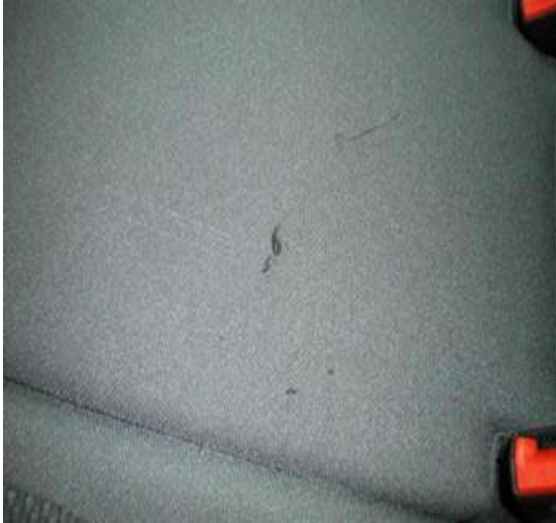
<p><b>Pulled Threads</b> Single or multiple threads protrude from the upholstery fabric, either as a single thread or as a loop.</p>	<p>Mechanical damage caused by sharp-edged, pointed objects, for example. Various areas.</p>	<p><b>No</b></p>
------------------------------------------------------------------------------------------------------------------------------------------	--------------------------------------------------------------------------------------------------	------------------

**Figure 12.** *Pulled threads*

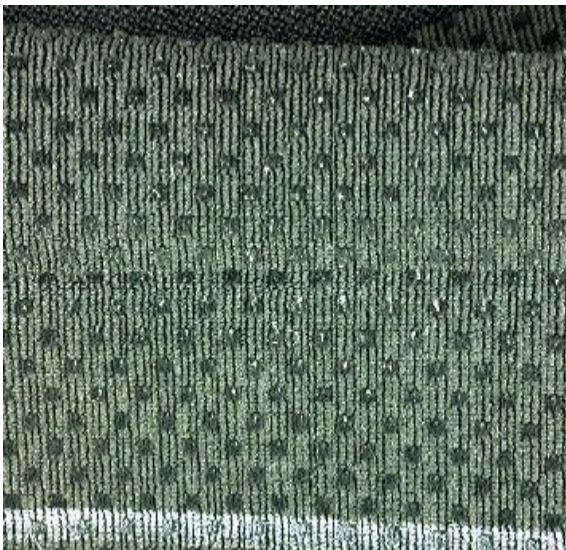
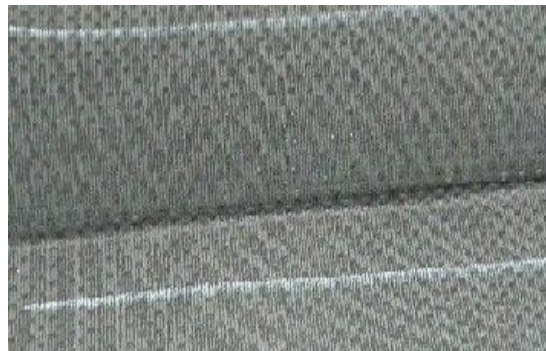
Always occurs due to the insufficient wear resistance of the upholstery material. Short fibers are pulled out of the textile, which then form small knots due to further chafing (internal knotting). If these knots are formed from external fibers, for example, customer clothing, this is referred to as external knotting.

Description	Possible cause/damage location	Warrantable
Small fiber knots that are firmly attached to the surface.	Wear characteristics of fabric not in accordance with specifications. Please remove the knots with a dry safety razor. Various areas.	<b>Yes</b>

**Figure 13.** *Knotting*

**Figure 14.** *Knotting*

**These complaints may be claimed under the normal warranty if applicable (Figures 13-14).**

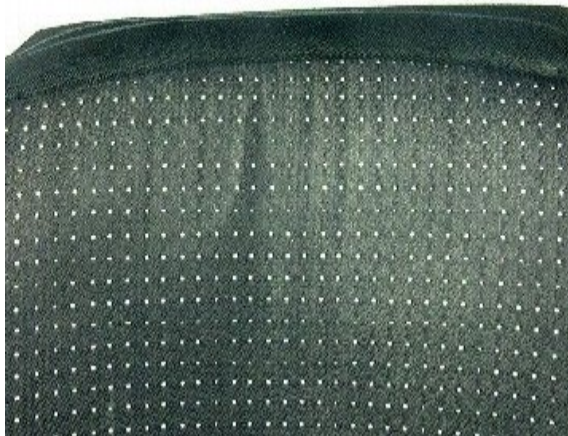
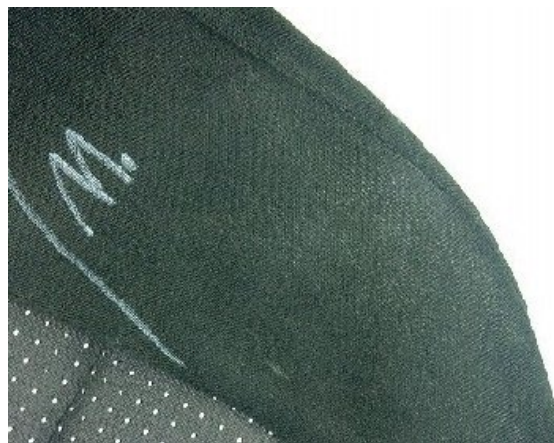
Surface greying or lightening is also caused by the insufficient wear characteristics of the upholstery material. Individual fibers are chafed or damaged, but not pulled out of the material. The spliced fiber ends appear as greying or lightening of the surface, which can easily be mistaken for dirt.

Description	Possible cause/damage location	Warrantable
Lightening/greying of surface, spliced fiber ends.	Wear characteristics of fabric not in accordance with specifications, not to be confused with dirt.  On prominent, heavily used areas of the seat.	<b>Yes</b>

*Figure 15. Lightening/greying of surface*

*Figure 16. Lightening/greying of surface*

**These complaints may be claimed under the normal warranty if applicable (Figures 15-16).**
