Technical product information

New Continental GT/GTC, New Flying Spur and Bentayga - Low Oil Pressure Warning During Early Vehicle Life - W12 only

Release date: 03-Oct-2023

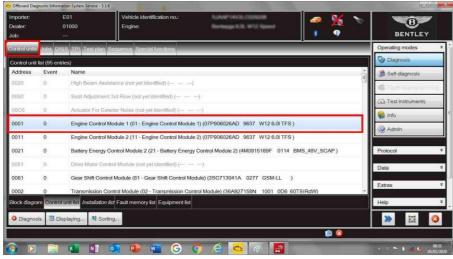
Figure 1

- Select "Start Diagnosis" and follow the on screen prompts.
- Select "Control units" and then "Engine Control Module 1 (01 Engine Control Module 1)" Figure 1.

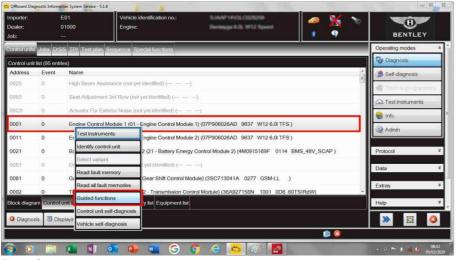
• "Right click" on "Engine Control Module 1 (01 – Engine Control Module 1)" and select "Guided functions" – Figure 2.

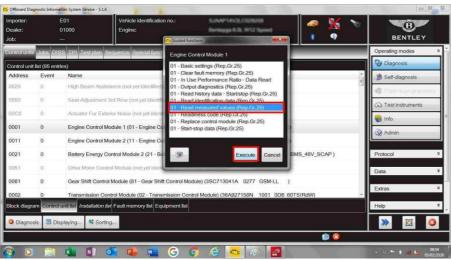
Figure 3

• Select "Read measured values" and then "Execute" – Figure 3.

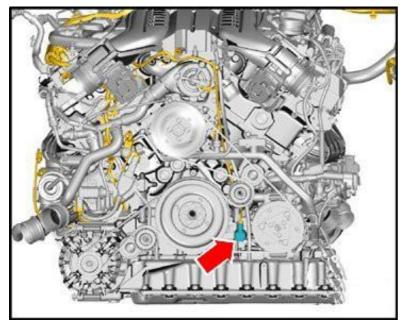
- The engine lubricating oil should be drained through a fine gauze filter, once fully drained check the engine oil filter and fine gauze filter for contaminants or particles IMPORTANT – Regardless of findings place the engine oil filter and gauze filter into a clean sealed container and retain for possible analysis IMPORTANT: Take clear photos of any contaminants or particles found
- Remove the Valve for Oil Pressure Control N428 (Refer to Figure 7 for fitting location) When the valve has been removed carefully
 examine it and the associated location on the engine for any signs of internal contamination, debris or damage.

- Should NO contamination, debris or damage be found Refit N428
- Replace engine lubrication oil and filter Refer to Repair Group 17 Engine Lubrication / 6.0L W12 TSI / Engine oil and filter To renew.
