Service Bulletin

Bulletin No.: PIT4931C

Subject: A Door May Not Open With The Outside Handle And/Or The Inside Handle

Models: 2010 - 2013 Buick LaCrosse
2010 - 2013 Chevrolet Camaro, Equinox
2010 - 2013 GMC Terrain

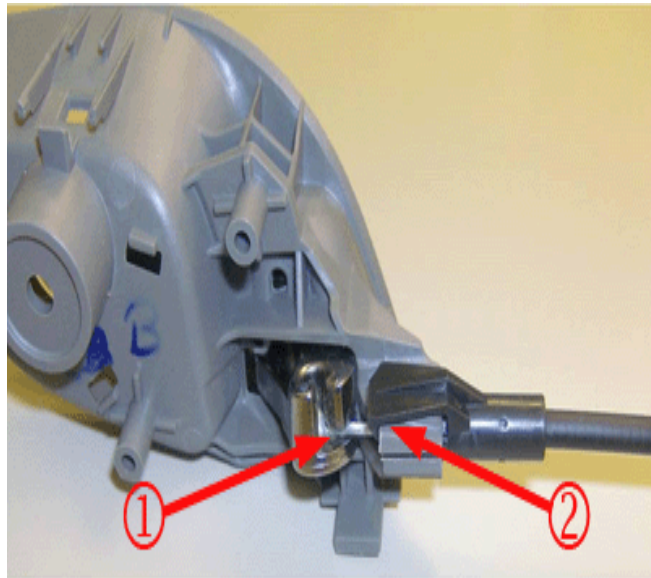
2348348

Correctly Installed

The picture above shows a properly installed door handle cable, with the cable end properly installed in the slot (1). This picture also shows the door handle cable is fully engaged to the door handle assembly (2).
Kinked

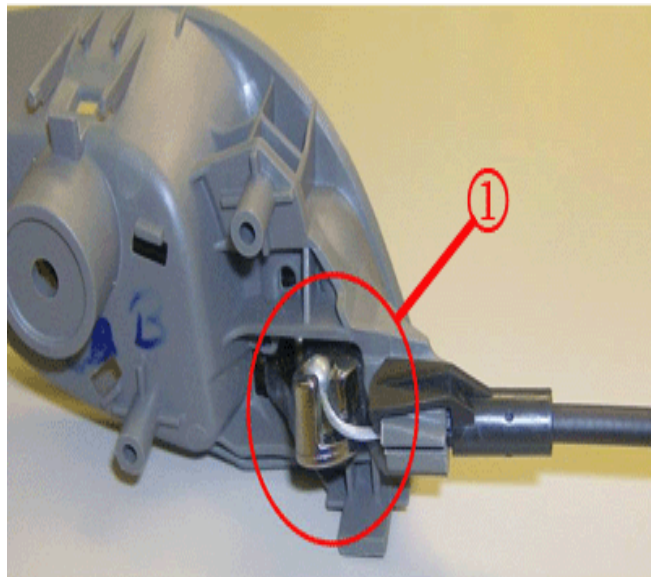
2348350

The above picture shows the inside door handle cable kinked at the inside door handle (1). If the cable is kinked, it will need to be replaced.
Incorrectly Installed

While removing the door trim panel, inspect inside handle cable to inside handle connection. Reference the attached pictures for incorrectly installed cable. If the cable is kinked, or cable end is damaged, it must be replaced. If the cable is not damaged, carefully disconnect from the inside handle and remove trim.

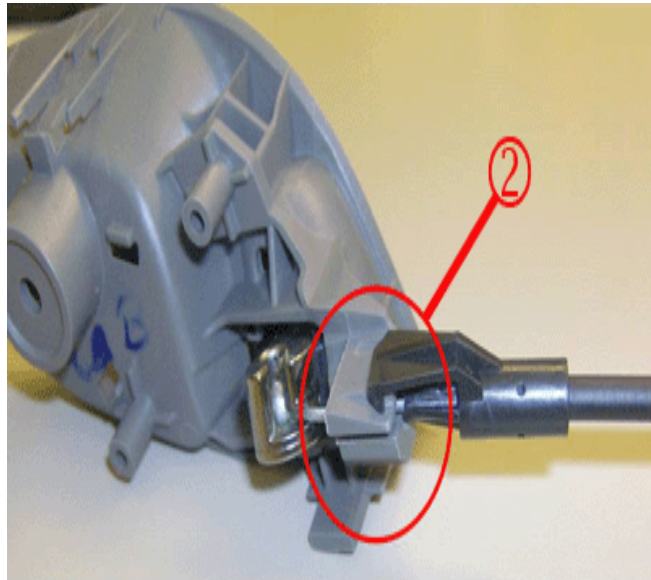
2348349

The above picture shows the inside door handle cable not fully seated to the outside door handle (2). If this concern is found, it is only necessary to push the door handle cable on to the inside door handle, to make sure it is fully seated.

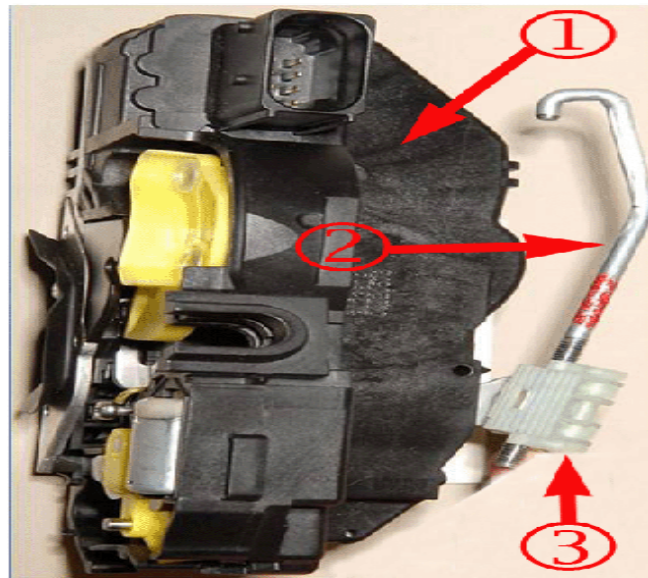
2348347

1. Door Latch Assembly.
2. Outside Handle Rod.
3. Clip (attached to outside release lever on latch)

Visually inspect the outside handle rod connection to the latch (1). Typically with a properly adjusted outside handle rod, there will be approximately an equal amount of exposed threads on both sides of the clip. To assure proper connection, disconnect the outside handle rod (2) from the white plastic clip (3) on the door latch assembly. Cycle the inside lock knob up and down at least 3 times. Make sure that the white plastic clip and lever are in the full up position while reinserting the rod into the clip.
