TECHNICAL SERVICE BULLETIN

Rattle Noise From The Exhaust

23-2341

Ford	
2021-2023 F-150 Raptor

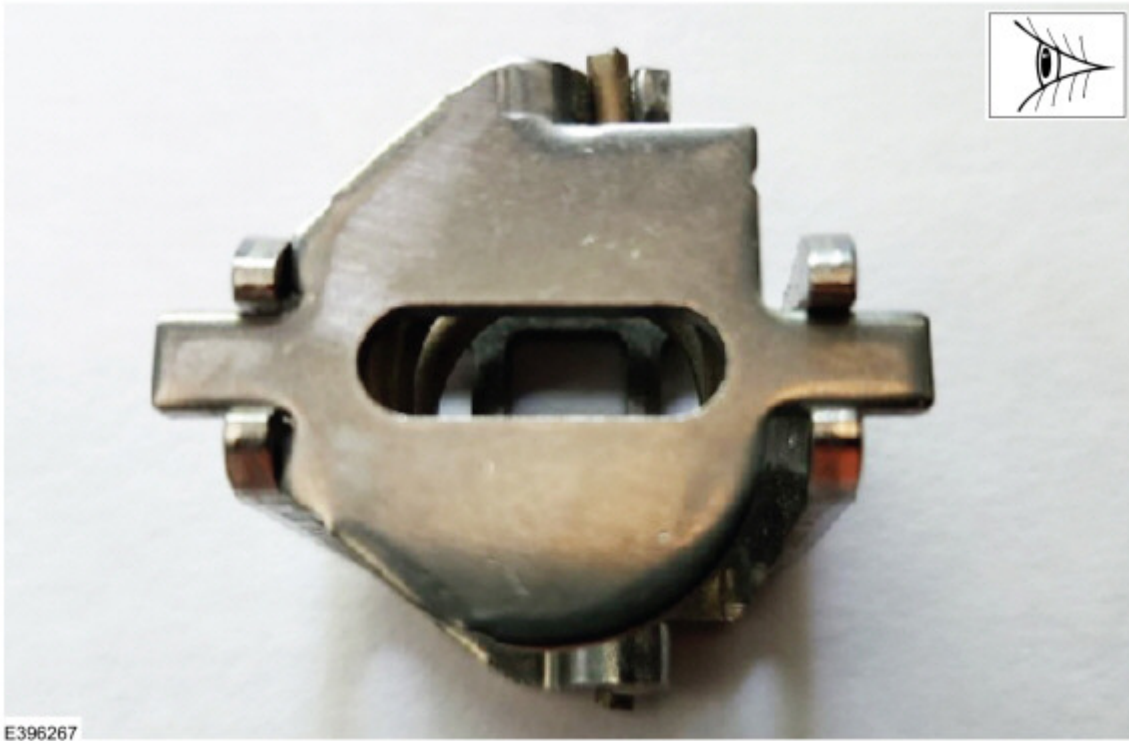
Figure 1

(1). Position the bottom of the service exhaust tailpipe actuator valve spring (Figure 1) on the top of the exhaust tailpipe actuator valve shaft. The top of the service exhaust tailpipe actuator valve spring with the rectangle shaped opening, should be facing upwards. Refer to Figures 1-2 for orientation.

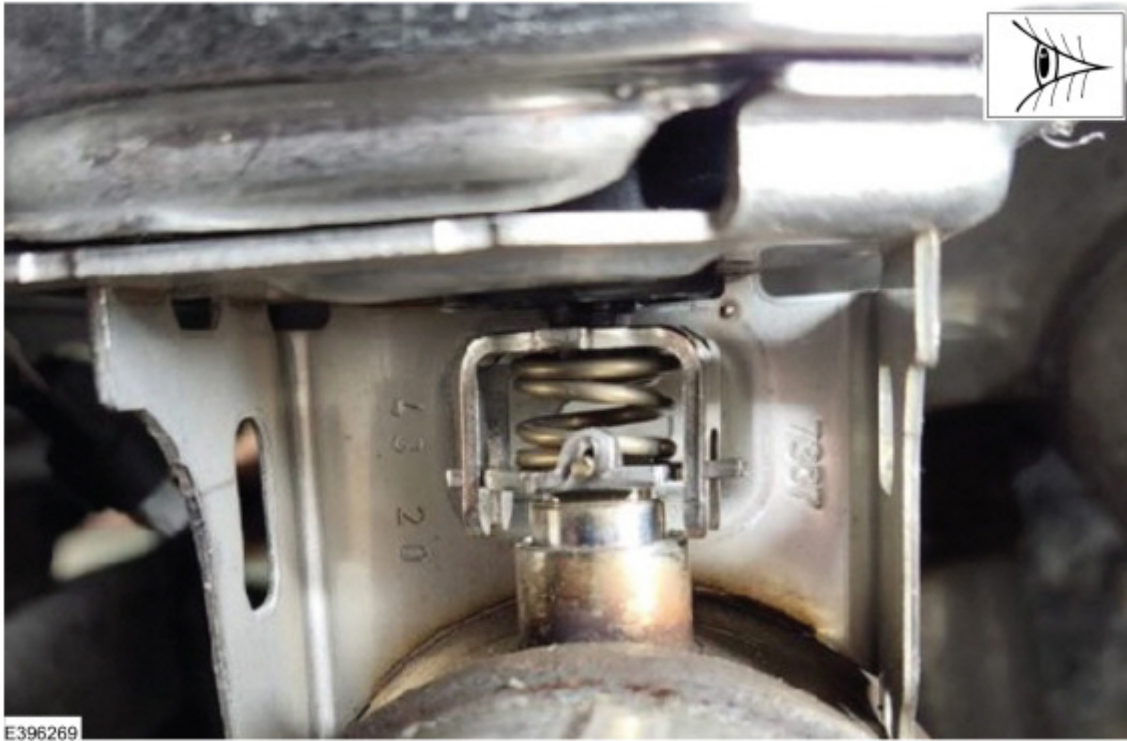
Figure 3

(3). Carefully inspect the service exhaust tailpipe actuator valve spring to make sure that the actuator and exhaust tailpipe actuator valve shafts are properly seated. A properly installed service exhaust tailpipe actuator valve spring should appear as shown in Figure 3.
