Cayenne (E3.I) - GTS & Turbo Low Fuel Pressure

Vehicles Affected

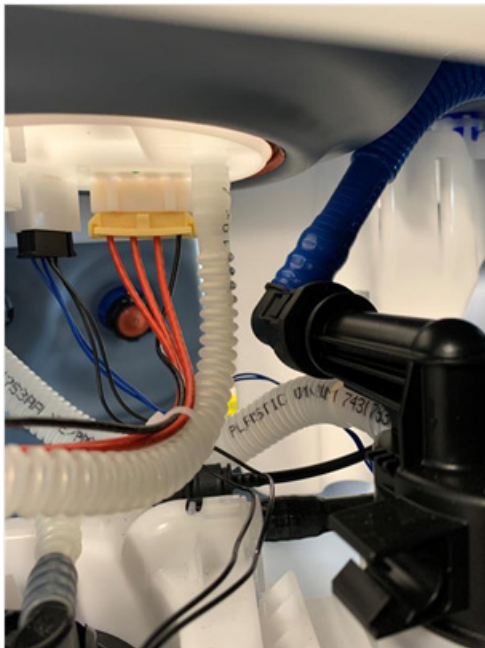
Figure 1

These faults can result from the low-pressure fuel system operating outside its pressure tolerances. In the 3D model, there is a clearance of approximately 19 mm (See Figure 1). It is possible for the component to vibrate over time, which could lead to the fuel line to be damaged, causing a leak in the fuel line (See Figure 2).

In cases with the above mentioned faults, please remove and replace the fuel tank and low pressure fuel pump in accordance with the information in the table below.
