Technical Service Bulletin

40 Shock absorber leaks: assessment aid

40 13 34 2018194/5 September 23, 2013. Supersedes Technical Service Bulletin Group 40 number 10-04 dated April 1, 2010 for reasons listed below.

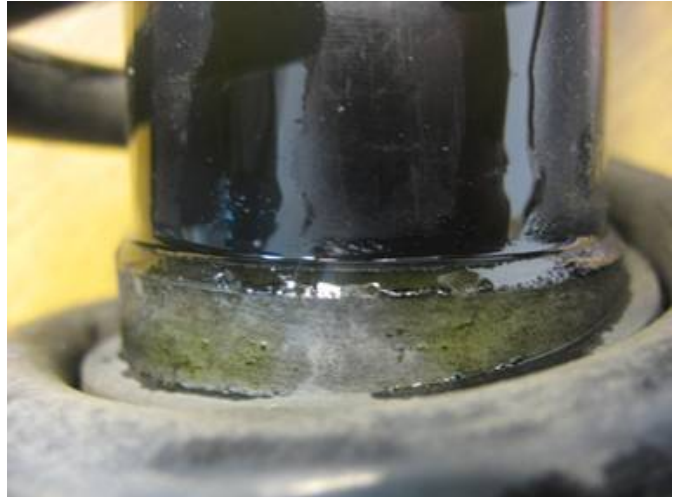
A leaking shock absorber is characterized by a wet film of oil running down the pipe (Figure 1 and Figure 2).

Figure 1. A leaking shock absorber.

Leaking shock absorbers need to be replaced.

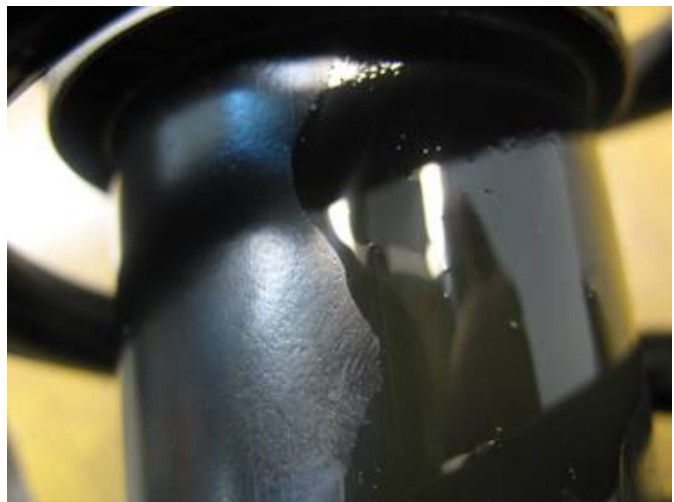
Figure 2. A leaking shock absorber.

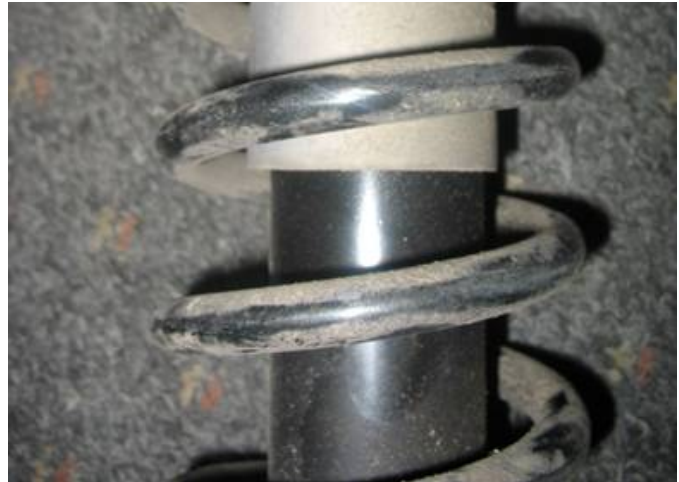
A light film of dried oil or oil marks on the pipe beneath the dust guard are not a clear indicator of a leaking shock. These marks are a result of residue from when the shock was filled during production, or of slight condensation in the seal area. This small amount of oil is for lubrication and it reduces wear on the seal.

Figure 3. A shock absorber that is not leaking.

This condition does not affect the shock absorber. No repair is necessary.
