Technical product information

Bentayga

Front or rear door(s) - Soft close function failure - DTC B122D29 is evident

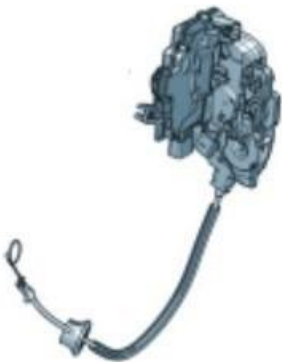
Note: For reference purposes Figure 1 shows an example of a door latch

- Request permission via DISS to replace the door latch **IMPORTANT:** Attach a short video confirming the issue is still evident
- Referring to Rep.Gr 57 (front) or Rep.Gr 58 (rear) replace the applicable door latch
