SSM76110 - L460 / L461 NC11 SHOWROOM FUSE REMOVAL - MY24 ONLY

Retailer voice: Battery fault on IPC when vehicle stored in showroom.

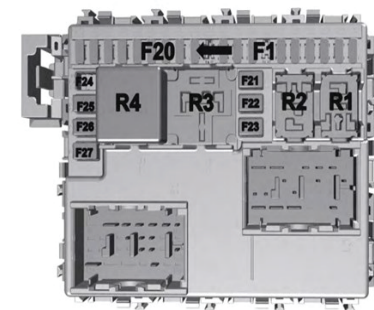
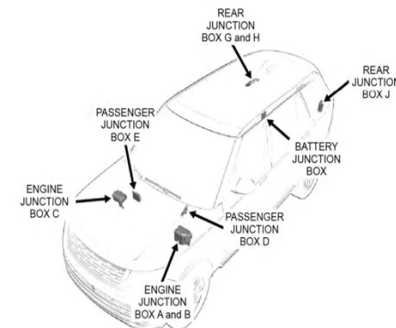
PASSENGER JUNCTION BOX - D

- Fuse F16 (5A) within the Passenger Junction Box D (KL30 Supply) must be removed along with others described in **TOPIx 101-02: Showroom preparation**.

- NC11 vehicle on display e.g. in a showroom while being supported by a showroom 12v support unit, it requires an additional fuse to be removed to prevent the MHEV (48v) battery draining and causing the cells to drop to a non-recoverable level.
- Vehicle activity resulting in the 48v battery cells depleting to a point where they cannot be recovered.
