**WPQ7 - Replacing Front Left and Right Backrest Covers and Headrest Covers (Workshop Campaign)**

Vehicle Type: **911 Dakar (992)**

Model Year: **As of 2023 up to 2024**

Equipment: **Full bucket seat (M-no. Q1K)**

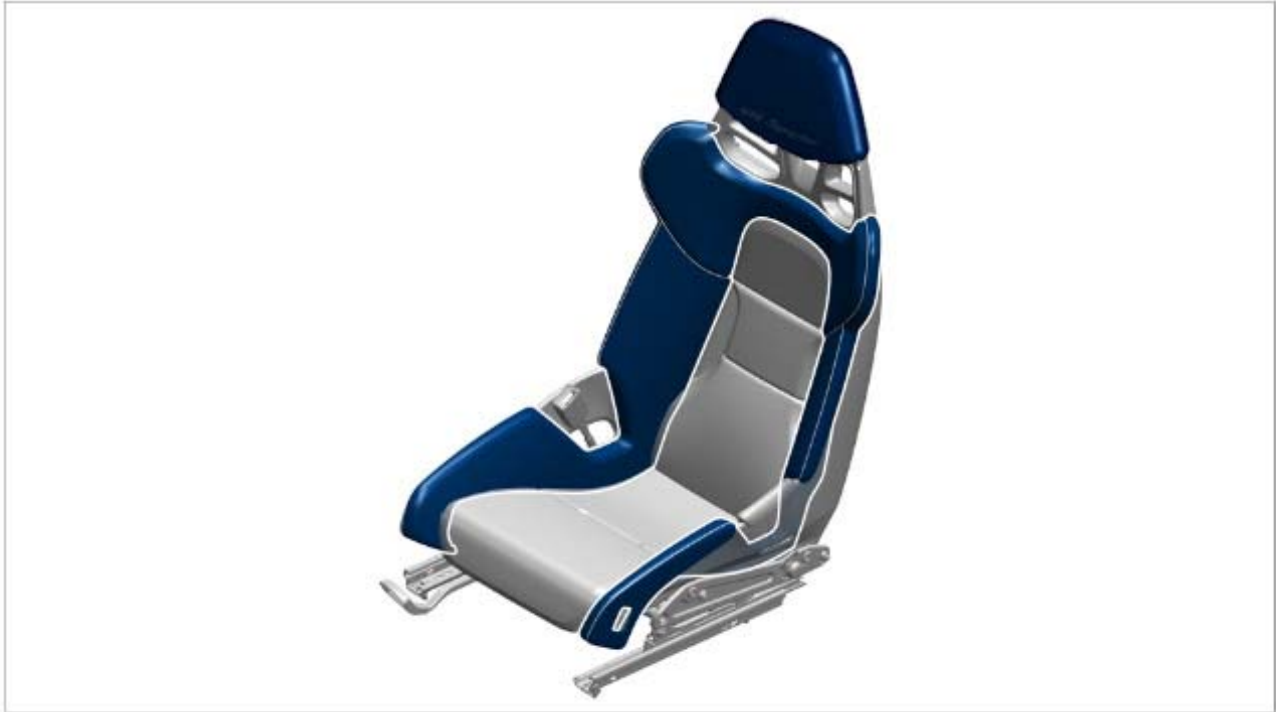
*Removing and installing headrest cover on full bucket seat*

- Front left and right backrest cover and headrest cover (**Replace**)

- 2 Replace front backrest cover on both front seats. ⇒ *Workshop Manual '74191941 Remove and install front backrest cover (sports bucket seat)'*
- 3 Replace headrest cover on both front seats. ⇒ *Workshop Manual '74211910 Remove and install headrest covering'*
- 4 Install front seats. ⇒ *Workshop Manual '72011941 Remove and install front seat (sports bucket seat)'*
- 5 Enter the campaign in the Warranty and Maintenance logbook.
