Technical Service Bulletin

94 Functional issue with switching of lights in rear lid, B146C29

94 24 78 2070964/2 April 11, 2024. Supersedes Technical Service Bulletin Group 94 number 23-68 dated November 17, 2023 for reasons listed below.

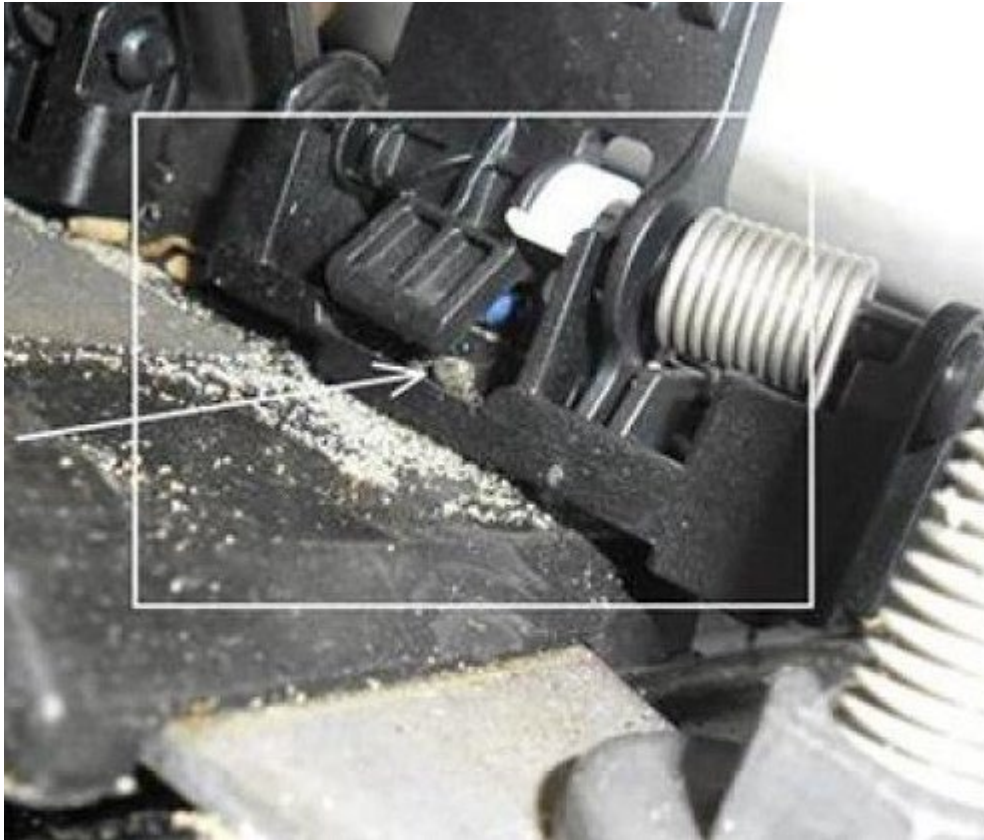
The taillights do not switch correctly when the rear lid is opened or closed due to foreign bodies in the area of the latch or the rear lid sensor.

Figure 1: Dirt and debris interfering with the operation of the rear lid sensor.

1. Check the area of the rotary latch for coarse dirt such as stones or other loose foreign bodies (Figure 1-2).

2. Please remove coarse dirt such as stones or other loose foreign bodies from the area of the latch or the rear lid sensor and then check whether the taillights switch correctly.
3. If this is not the case, check the measured value block in the convenience control unit (diagnostic address 0046) to see whether the sensors are working properly and perform any other required repair work.

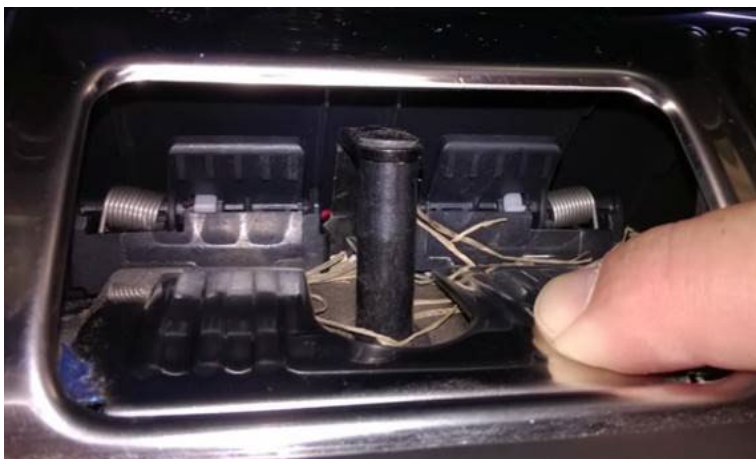
Figure 2: Dirt and debris interfering with the operation of the rear lid sensor.
