Vehicle drops at rear axle, vehicles with electronic rear axle level control or AIRmatic

Topic number	LI32.22-P-048597
Version	7
Design group	32.22 Air suspension
Date	02-27-2012
Validity	Model 212.0## with air suspension (SA code 489) Model 212.2## (station wagon) Model 218 with air suspension (SA code 489)
Reason for change	Check for water in system added under Remedy. Part number for compressor and valve unit added.
Reason for block

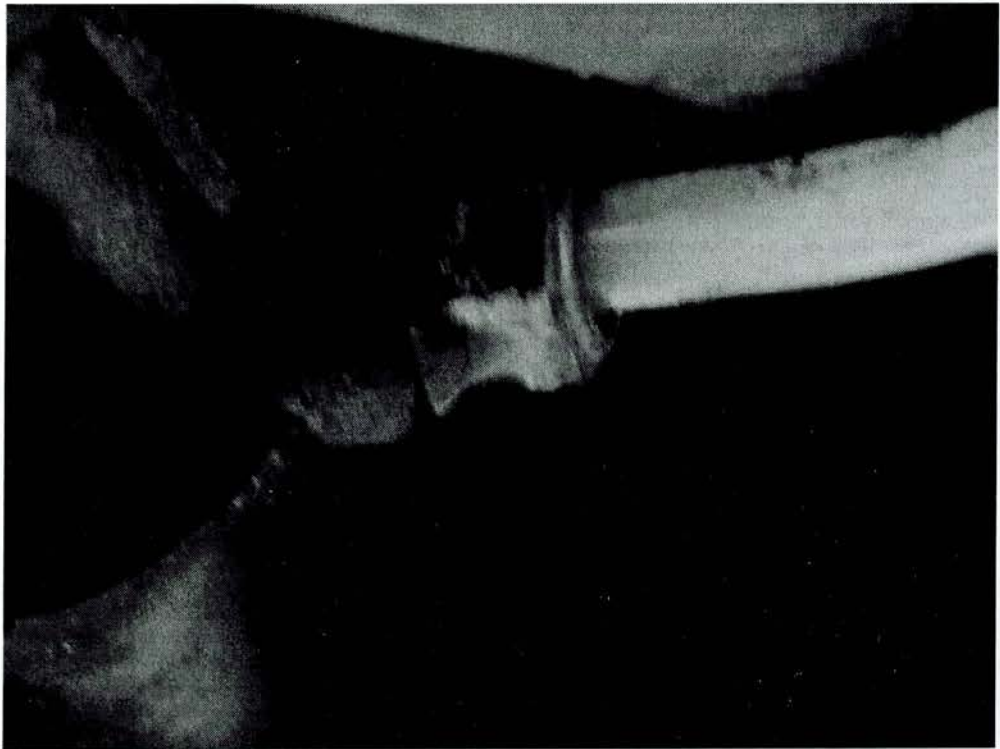
1.JPG:

If water runs out (Figure 1) or if water droplets are visible at the pressure line connection of the

1. Unscrew AIRmatic pressure line between compressor and valve unit.

compressor or valve unit (Figure 2), the compressor and valve unit must be replaced.
