01 MIL on (DTC P310B, P129F, P008B, P129E, P008A, P2540, P0087)

01 12 45 2027417/3 March 16, 2012. Supersedes Technical Service Bulletin Group 01 number 11 – 34 dated November 9, 2011 for reasons listed below.

## Technical Service Bulletin

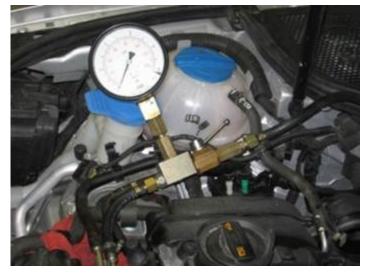
d. Measure actual low-side fuel pressure via mechanical gauge (VAG 1318) on the low pressure supply line in the engine compartment (Figure 1).

Figure 1. VAG 1318 gauge installed on an A3 2.0L TFSI.

- 5. Add 1 bar to the value obtained from the mechanical gauge to calculate the adjusted gauge measurement value.
- 6. Compare the adjusted gauge measurement value to the Actual Value stored in MVB 103 field 1.
- 7. If the MVB 103 field 1 value deviates more than ±1.0 bar from the adjusted gauge measurement value, then the DTC was likely triggered by a faulty G410 low-side fuel pressure sensor. In this case, document the adjusted gauge measurement value and MVB value on the Repair Order and perform the Sensor replacement procedure below.

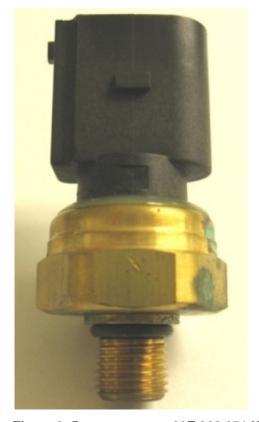
Figure 2. Pressure sensor 06E 906 051 K.

Replace the G410 low-side fuel pressure sensor.

- 2. Clear DTCs and verify that the problem was eliminated.
- 3. Run Basic Settings 103 to adapt system.
- 4. Do not replace the high pressure fuel pump, electrical fuel pump, fuel pump control module, or fuel filter unless problem persists and further diagnosis indicates a malfunction of any of these components.
