Technical Service Bulletin

57 Door cannot be opened from outside, it can only be opened from inside

57 12 65 2029151/2 May 14, 2012. Supersedes Technical Service Bulletin Group 57 number 12 – 64 dated March 30, 2012 for reasons listed below.

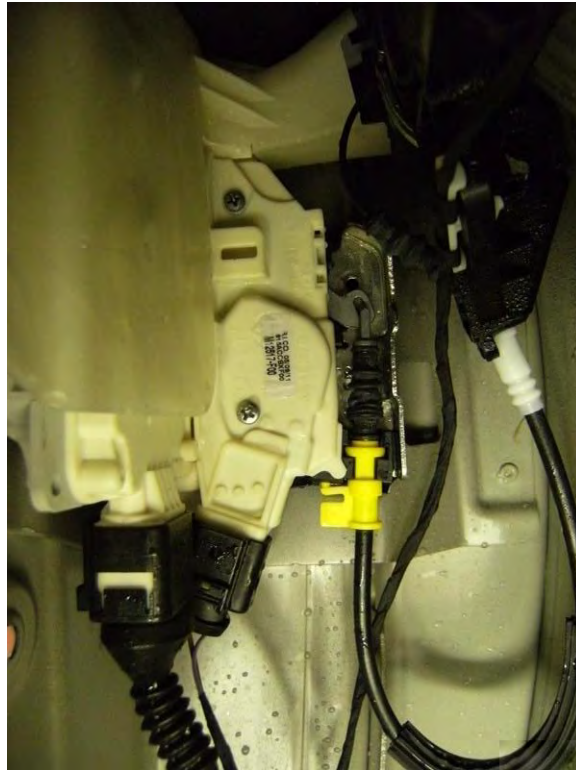
When fitting the Bowden cable from the mounting bar to the door lock the cable can get kinked. In some cases this can increase the inner friction of the strand in the Bowden cable. As a result, the door lock stays in pressed position or does not completely return to its zero position. (Figure 1).

Figure 1. Bowden cable routing.

1. Remove/install the latch carrier (“bow” according to ETKA) and Bowden cable together, as a set, according to the repair manual:

Tip: Do *not* separate the Bowden cable from the latch carrier (“bow” according to ETKA). Ensure the Bowden cable does *not* get further damaged during the removal. When a parts request is made, pack the lock and the Bowden cable in such a way that an analysis is possible and additional damage is prevented.

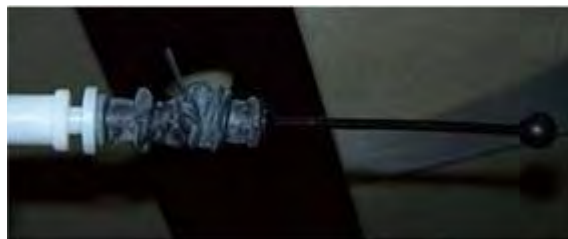
When the Bowden cable gets twisted during the installation the rubber grommets can get distorted. Consequently, the Bowden cable has a too high inner friction and the door lock does not move to the zero position. (Figure 2).

Figure 2. Distorted rubber grommets.

- c. Do *not* twist the Bowden cable after the installation. To achieve this, turn neither the lock nor the mounting bar.

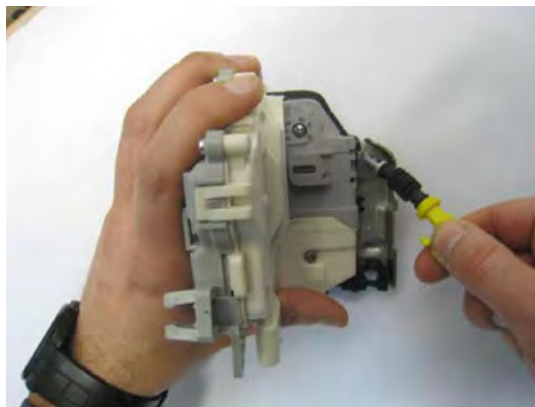
2. Assemble the latch carrier (“bow” according to ETKA) / Bowden cable assembly and the door lock together according to the steps below, **before** installing into the vehicle:
 - a. Position the Bowden cable by holding the yellow sleeve in the lock.

Figure 3. Holding the yellow sleeve in the lock.

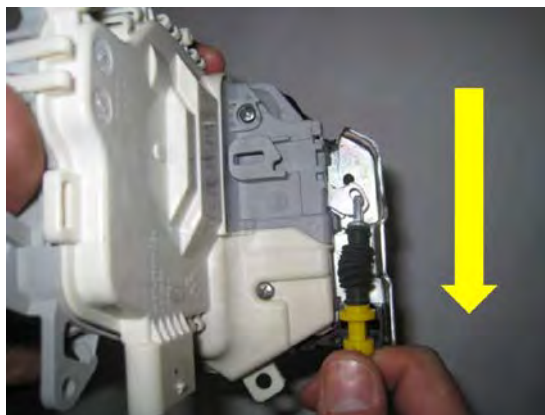
- b. Pull down the Bowden cable by holding the yellow sleeve. The locking mechanism is pulled along and the Bowden cable is locked.
Slot in the yellow locking mechanism to the left

Figure 4. Pulling down the Bowden cable.

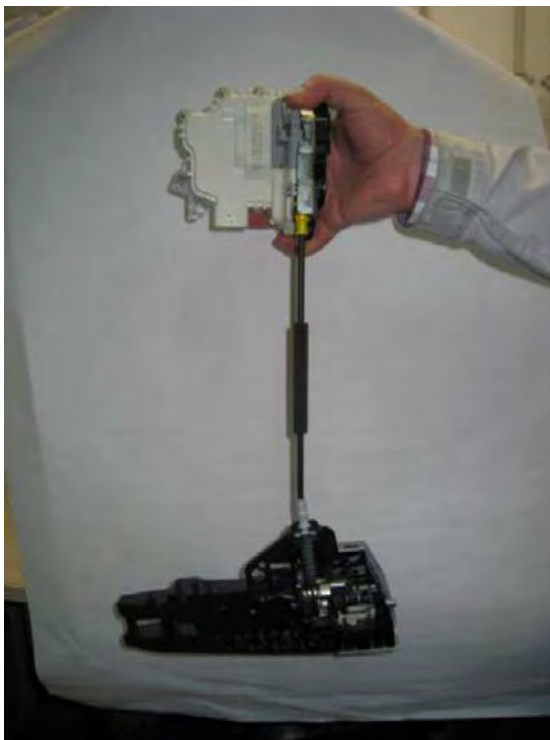
Figure 5. Do not turn the lock or the mounting bar.
