L-SB-0059-12

Accelerator Pedal Sensor Assembly Service Precaution

Service Category Engine/Hybrid System

Section Engine Control

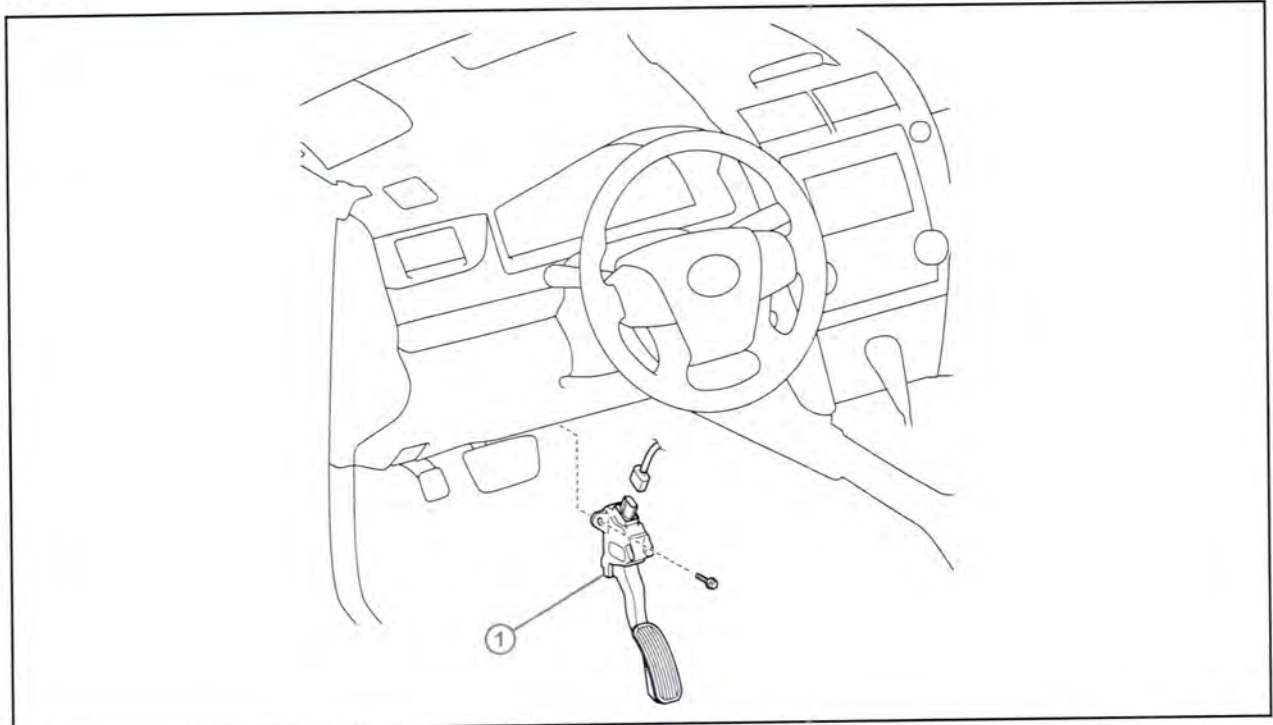
Figure 1.

This accelerator pedal does not require lubrication. Do NOT apply oil or other lubrication to the accelerator pedal sensor assembly. If applied, the accelerator pedal sensor assembly must be replaced.

1	Accelerator Pedal Sensor Assembly
---	-----------------------------------
