<b>HYUNDAI</b>   NEW THINKING. NEW POSSIBILITIES. <b>Technical Service Bulletin</b>	GROUP	NUMBER
	<b>AUTOMATIC TRANSMISSION</b>	12-AT-018
	DATE	MODEL
	<b>AUGUST 2012</b>	<b>Sonata (YF)</b>
<b>SUBJECT:</b>	<b>AUTOMATIC TRANSAXLE SHIFT LEVER - ACCESSORY POWER REMAINS ON IN PARK</b>

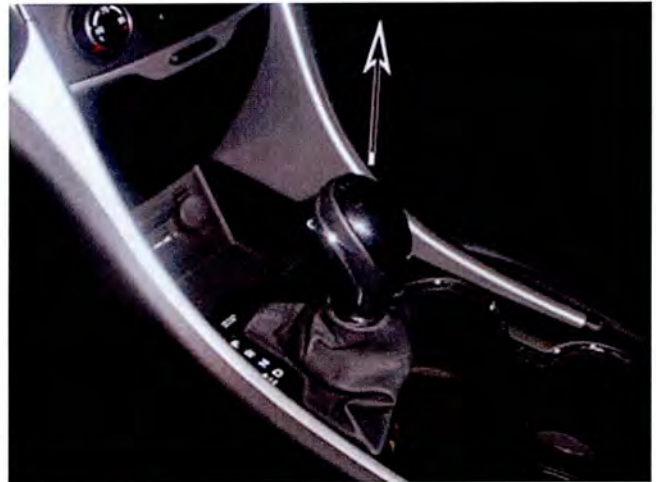
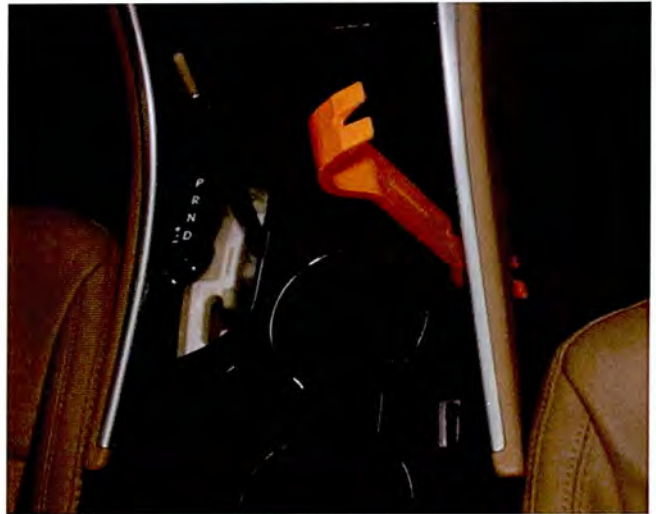
2. Using a plastic trim tool, remove the left and right side panels

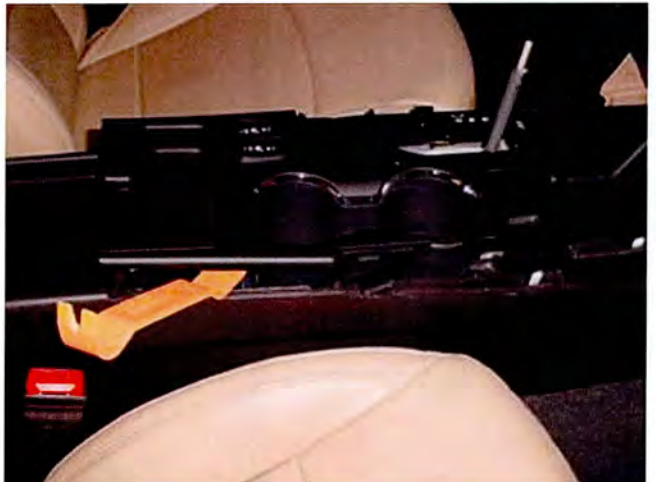
3. Use a plastic trim tool to remove the top cover
