TECHNICAL BULLETIN
JTB00297NAS1
06 SEP 2013

SECTION: 204-04

Tire Pressure Monitoring System - Improved Diagnostics and Service Information

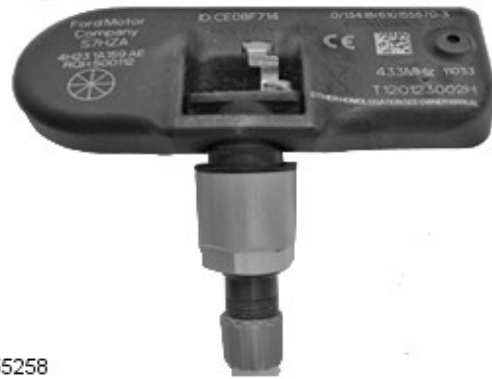
E155258

4. **TG1B Sensor** - non-serviceable valve stem

- Part number C2D21601; currently fits:
 - F-TYPE (X152)

- XJ (X351, original-fit sensor from VIN V21616)

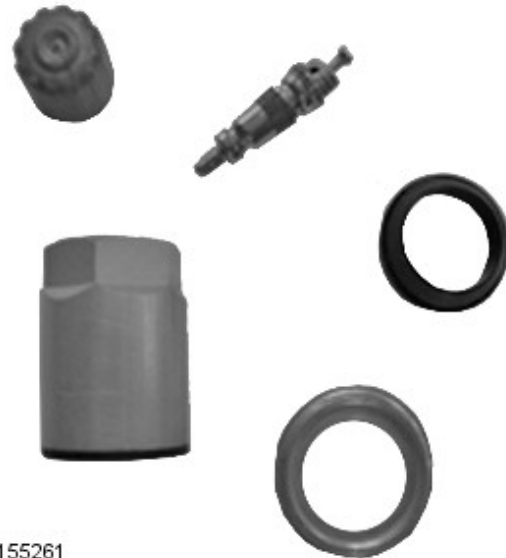
E155261

5. TG1B Service kit - hardware and seals only; no valve stem

- Part number C2D29155; currently fits:
 - F-TYPE (X152)
 - XJ (X351, original-fit sensor from VIN V21616)

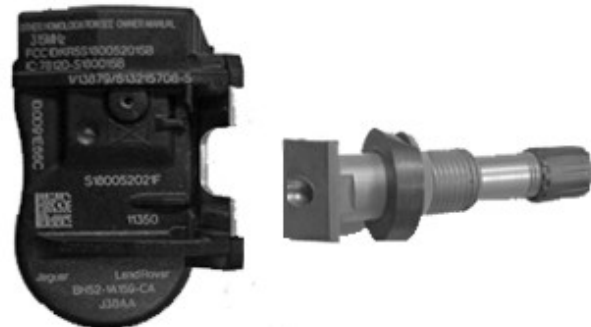
E155257

NOTE: XJ (X351) V00047-V21615 original-fit sensor with serviceable valve stem; sensor no longer available

TG1C Sensor - serviceable valve stem; **no longer available**

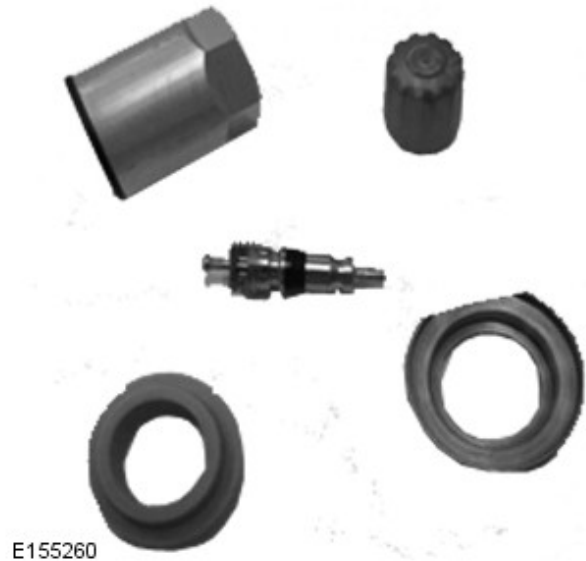
TG1C Service kit - hardware and seals **only**; no valve stem

- Part number C2D29156; currently fits:

- XJ (X351, V00047-V21615 original-fit sensor with serviceable valve stem only)

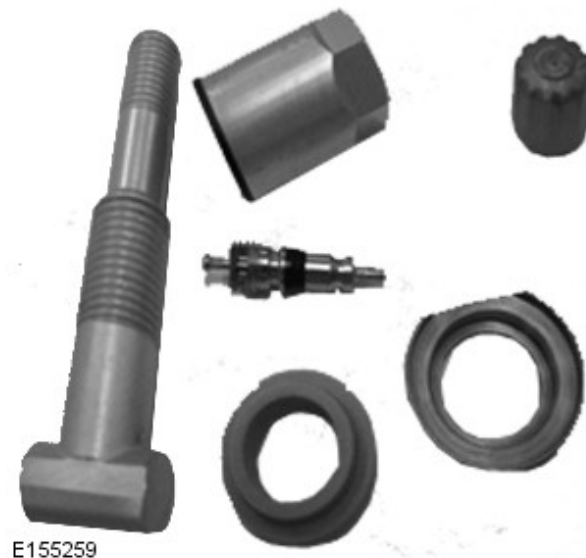
TG1C Service kit - hardware, seals, and valve stem

- Part number C2D29157; currently fits:
 - XJ (X351, V00047-V21615 original-fit sensor with serviceable valve stem only)
