SB-10054055-7195

Title: Oil Dipstick Clip Breaking

Applies To: CT660

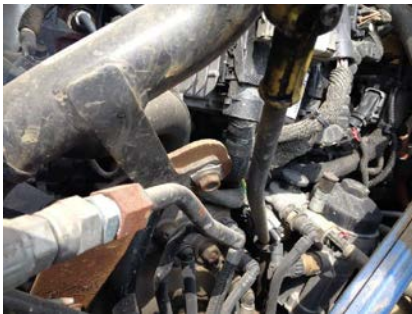
Oil Dipstick tube P clip, and power steering line P clamp may break due to road vibration.

Install a more robust set of clips.
