SP 8-600-003
SERVICE PROGRAM

SB-10056211-8786

Autocar Xpert HVAC Performance Upgrade

This Service Program is one of three different programs providing instructions to upgrade the HVAC on certain Autocar Xpert vehicles. Your vehicle may or may not be affected by this Service Program. Confirm your vehicle's VIN against the list beginning on page 25. If your vehicle's VIN is not present on the list you may want to consult Service Program SP 8-600-001 or SP 8-600-002.

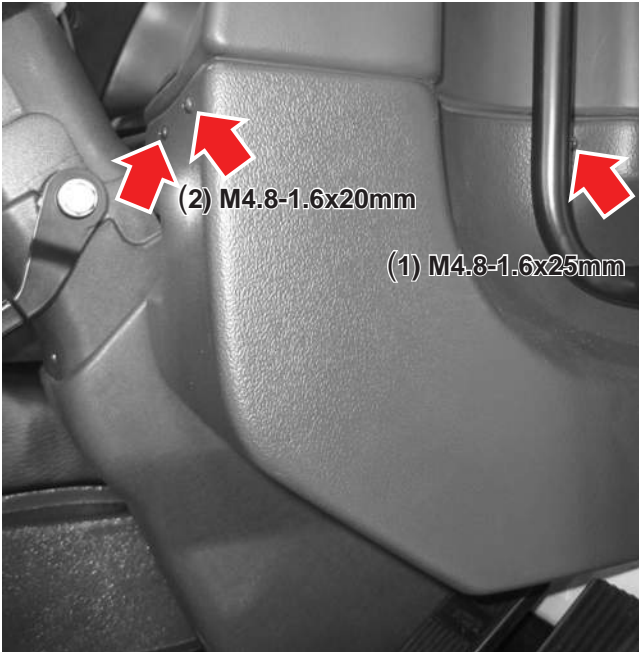
Figure 1-1

1. Remove the three sheet metal screws and set aside for reinstallation (see Figure 1-1).

2. Remove the trim panel and set aside for reinstallation (see Figure 1-1).

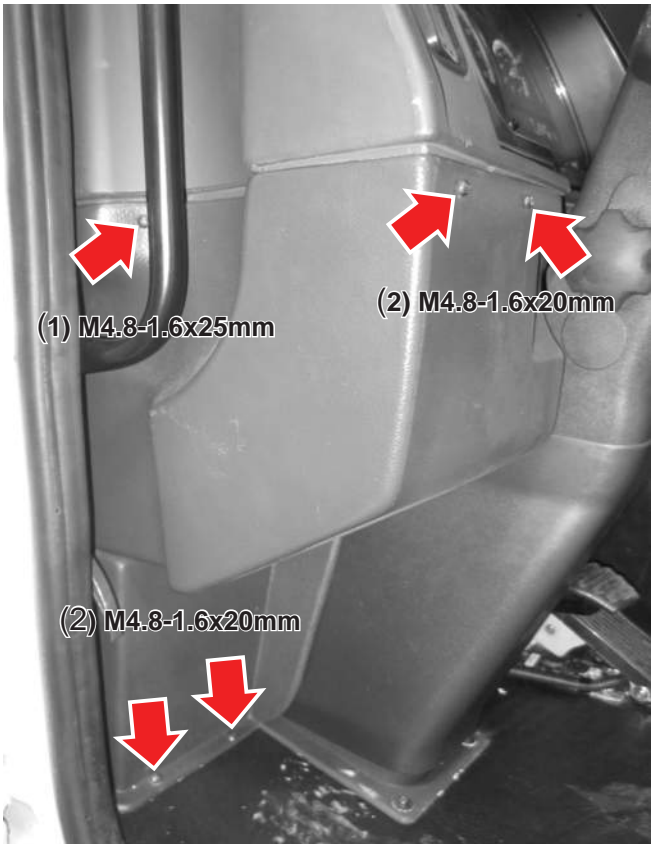
Figure 2-1

1. Remove the five sheet metal screws and set aside for reinstallation (see Figure 2-1).
2. Remove the trim panel and set aside for reinstallation (see Figure 2-1).

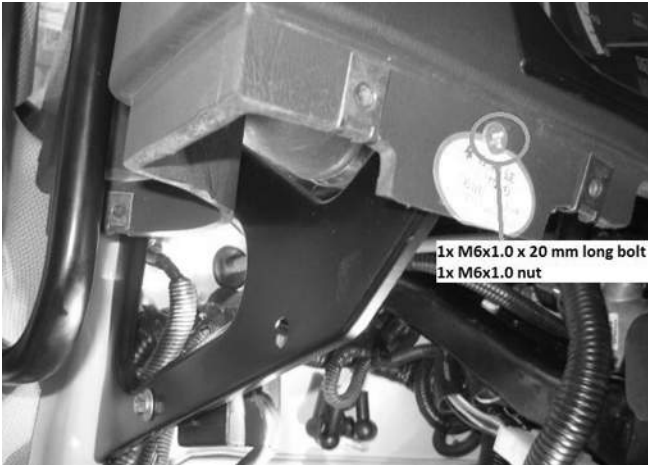
Figure 3-1

1. Remove the bolt/nut assembly on both LH and RH sides of instrument panel and set aside for reinstallation (see Figure 3-1).

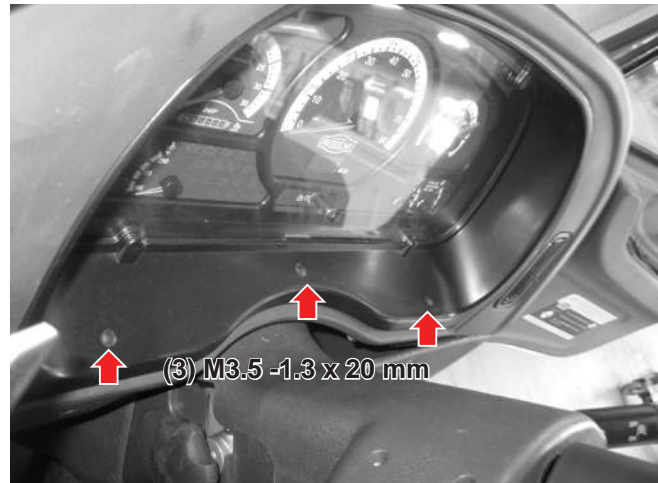
Figure 4-1

1. Remove the three screw plugs and set aside for reinstallation (see Figure 4-1).
2. Remove the three screws and set aside for reinstallation (see Figure 4-1).
3. With all screws completely removed, pull the lower portion of the cluster outwards (see Figure 4-1).
4. Pull the cluster downward to unhook the upper tabs (see Figure 4-1).

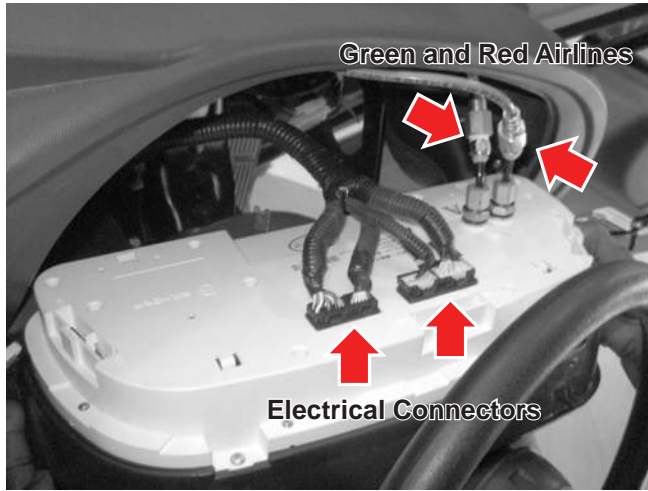
Figure 4-2

5. Using quick-release mechanism on fittings, unhook the green and red airlines from the cluster (see *Figure 4-2*).
6. Disconnect the four electrical connectors from the cluster (see *Figure 4-2*).
7. Remove the instrument cluster and set aside for reinstallation.

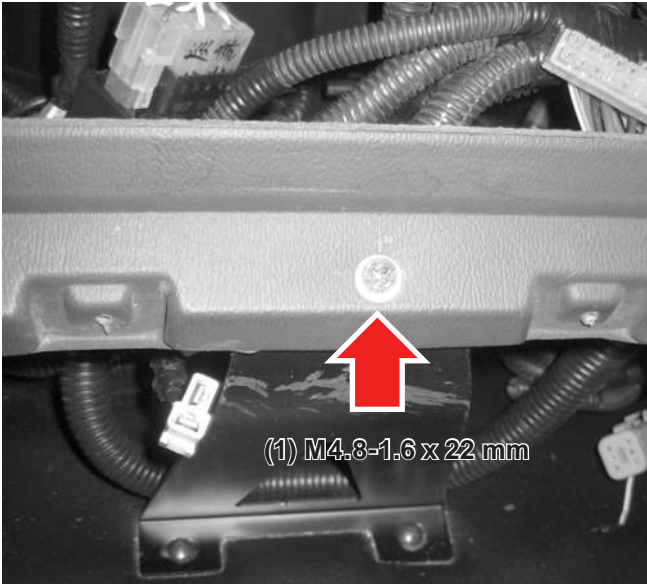
Figure 6-1

1. Remove the screw and washer and set aside for reinstallation (see *Figure 6-1*).

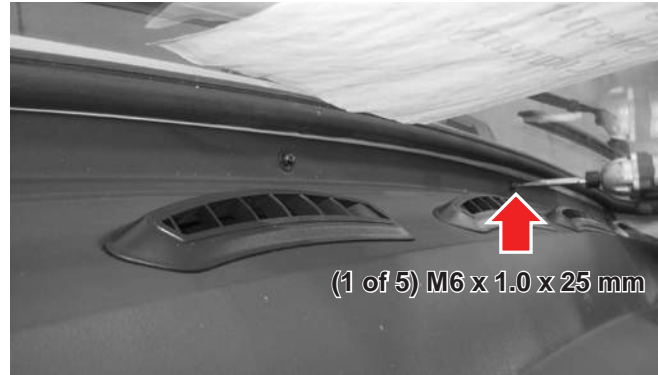
Figure 7-1

1. Remove the screws and washers and set aside for reinstallation (see *Figure 7-1*).

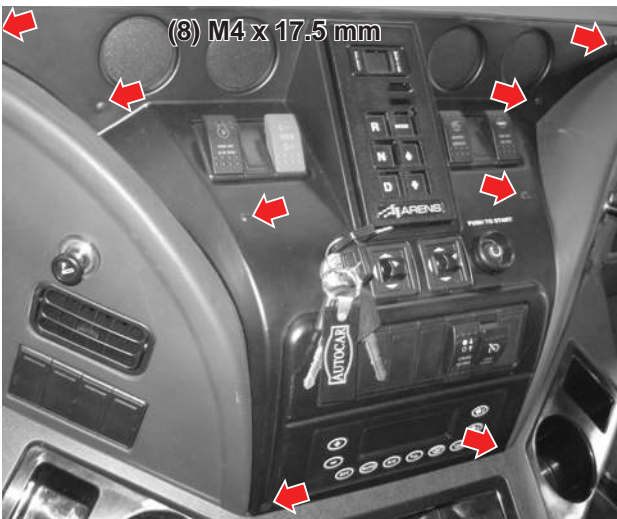
Figure 8-1

1. Remove the eight screw caps and set aside for reinstallation (see Figure 8-1).
2. Remove the eight M4 screws and set aside for reinstallation (see Figure 8-1).

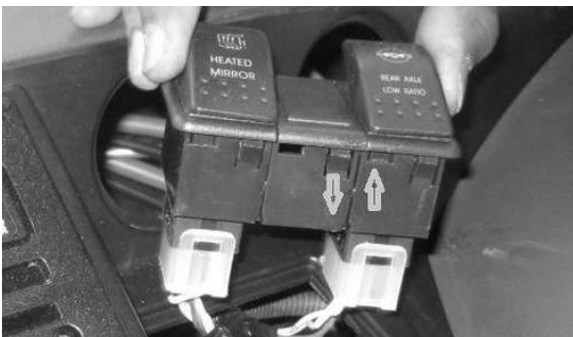
Figure 8-2

3. Pull switches out of their slots and break them apart by pushing one down and the other up (see Figure 8-2).

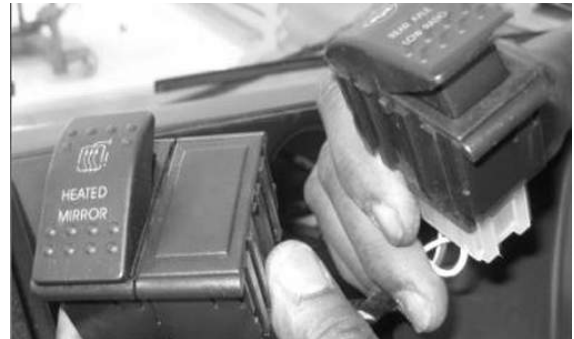
Figure 8-3

4. Push switches through the slots so that the center console panel can be removed (see Figure 8-3).

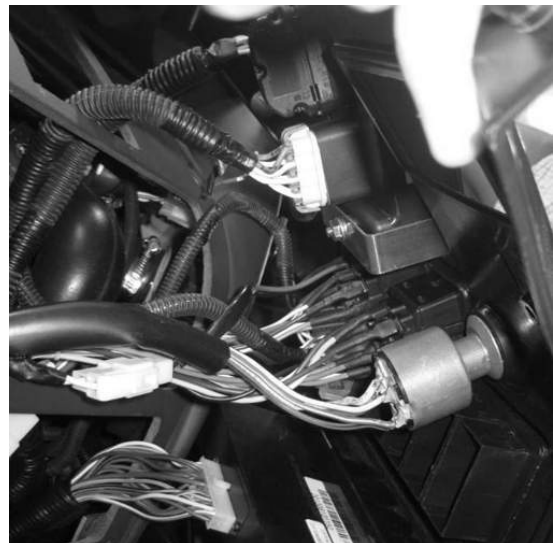
Figure 8-4

5. Disconnect the transmission shift selector connectors, the mirror switch connectors, the ignition barrel connector, push to start button connector, and the HVAC controller connector and set aside for reinstallation (see Figure 8-4).

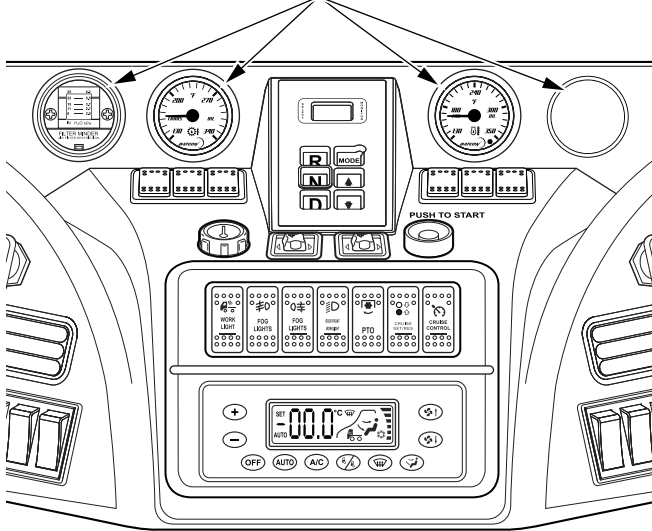
Figure 8-5

6. Remove the gauge panel caps and set aside for reinstallation (see Figure 8-5).

Optional Gauge Locations/Caps

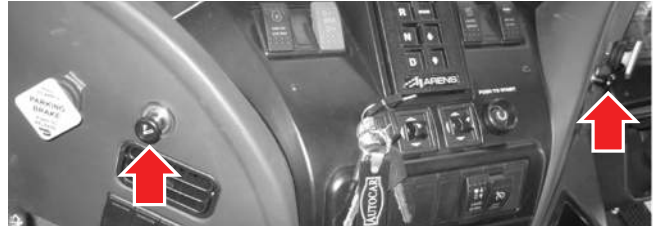
Figure 8-6

8. Locate the terminals/connectors behind the lighters through the access holes in the center portion of the upper dashboard panel (see Figure 8-6).

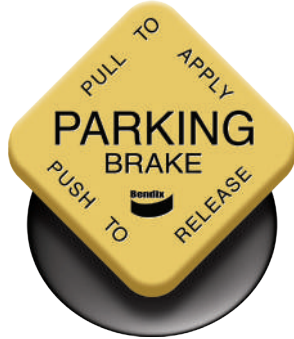
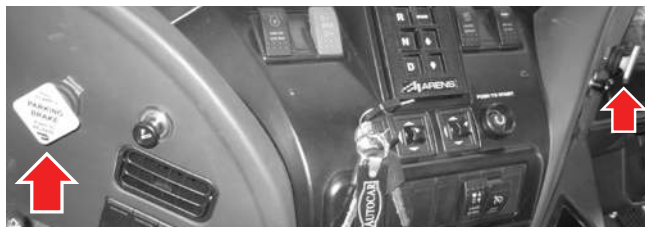
Figure 9-1

In order to remove the main instrument panel, the two park brake valves must be removed (see Figure 9-1).

1. Pull back the rubber grommets and find the yellow handle locating pins (located at the base of the park brake valve yellow handle) (see Figure 9-1).
2. Carefully hammer out the locating pins with a small punch.
3. Remove the yellow handles.
4. Remove the nut clamping the valves to the dashboard and push the valves through into the dashboard and set aside for reinstallation.

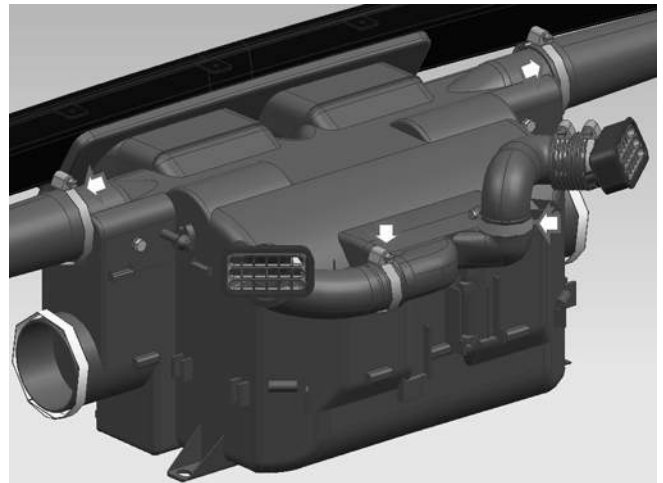
Figure 10-1

1. Disconnect the ducting at the HVAC unit end on at all three connection points (see Figure 10-1).

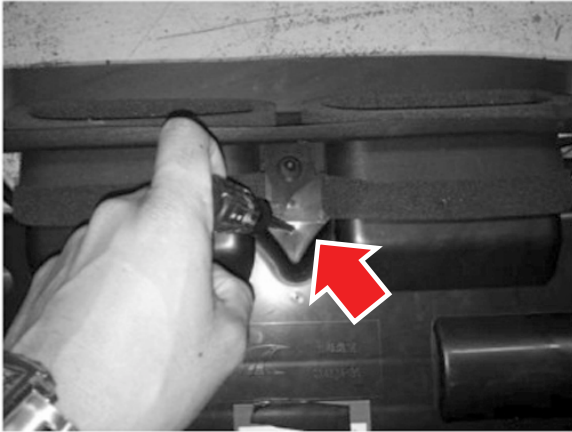
Figure 11-1

1. Remove the screw from the HVAC housing and set aside for reinstallation (see Figure 11-1).

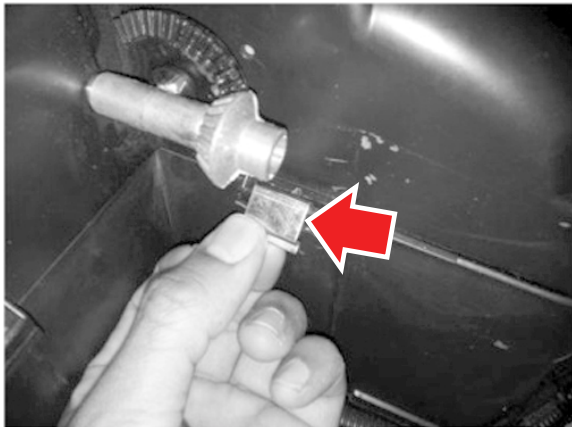
Figure 11-2

2. Remove retaining clips securing the head of the HVAC unit along its perimeter and set aside for reinstallation (see Figure 11-2).

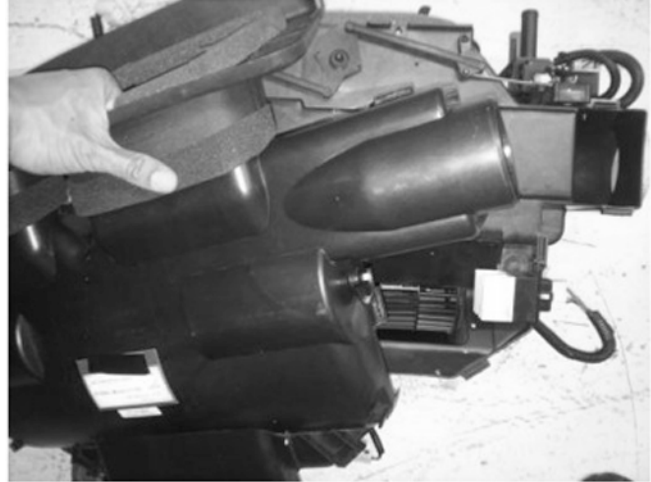
Figure 11-3

3. Remove the HVAC unit head (see Figure 11-3).

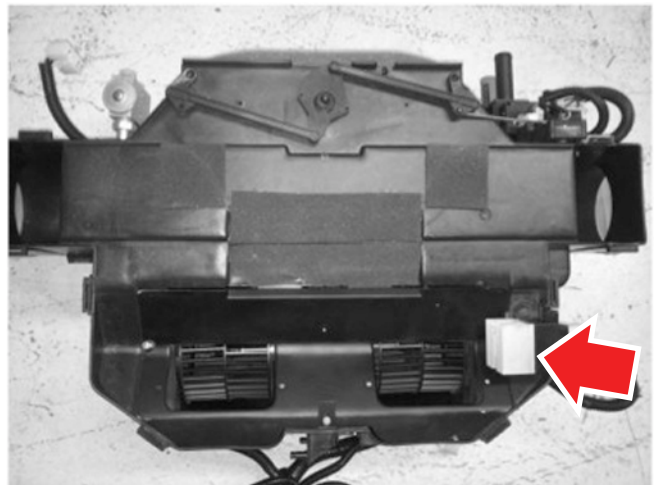
Figure 11-4

4. Remove the blower motor fan speed control module (see Figure 11-4).

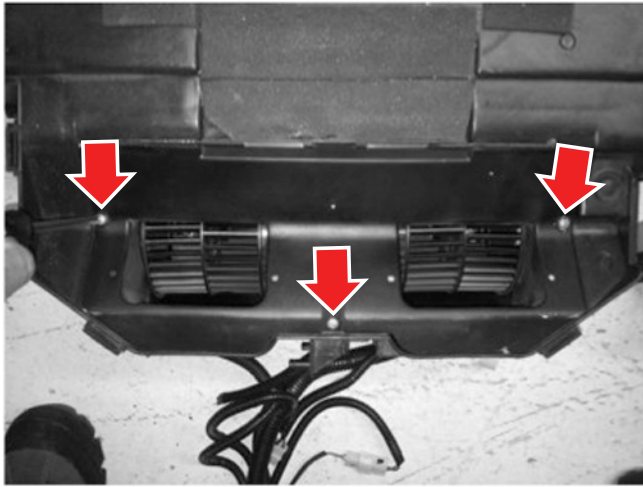
Figure 11-5

5. Remove the three screws which secure the HVAC motor in the housing (see Figure 11-5).

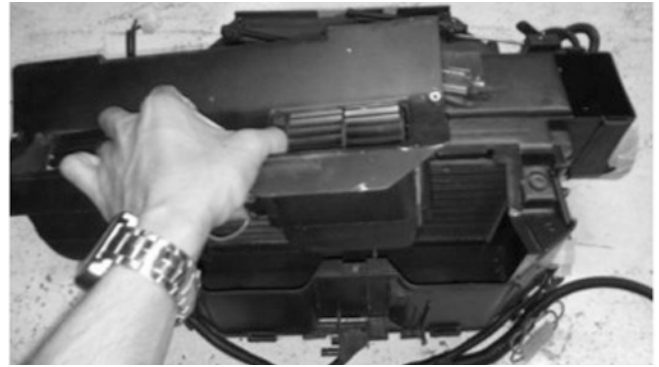
6. Remove the motor and discard (see Figure 11-6 and Figure 11-7).

Note: Before the motor can be removed, detach the terminals from the motor power connector so that the wires can be fed through the housing.

7. Install the new motor (A6000098-001) by performing step 11-1 through step 11-6 in reverse order.

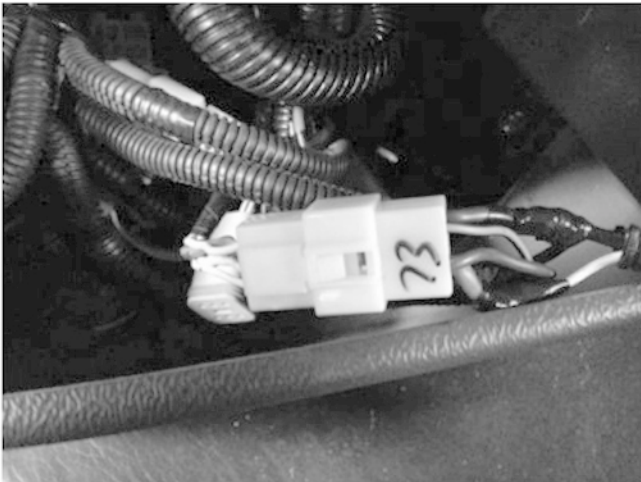
Figure 12-1

The new HVAC controller (A6030018-001) requires that a capacitor (A6000099-001) be added to the HVAC harness.

1. Locate connector number 73 (it is located in the area below the LH cup holder in the lower instrument panel skirt which at this point has not been reinstalled – the wires on the female side of the connector are blue, gray, red and purple) (see *Figure 12-1*).

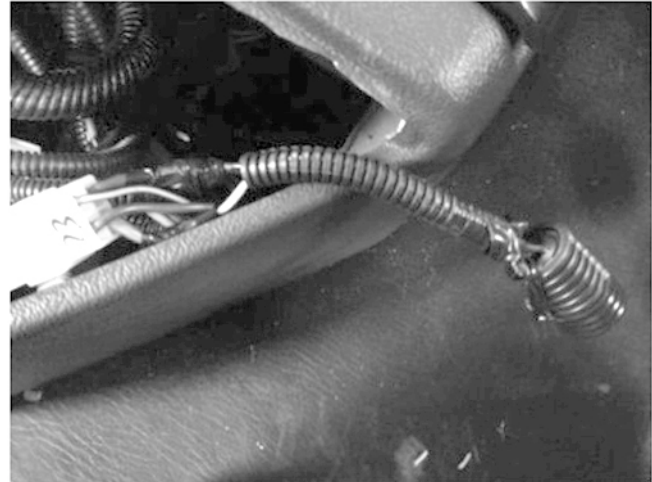
Figure 12-2

2. Splice in the capacitor to the purple and red wires with a soldering iron. Positive (+) to the red wire and Negative (-) or (black electrical tape) to the purple wire. Cable tie capacitor to the HVAC harness (see *Figure 12-2*).

8. Set fan speed to the third speed level and check instrument cluster for stop or check engine lights. If either of these lamps is illuminated, check that capacitor has been installed correctly.

Note: *If at any point the stop or check engine lights illuminate, check that the capacitor has been installed correctly.*

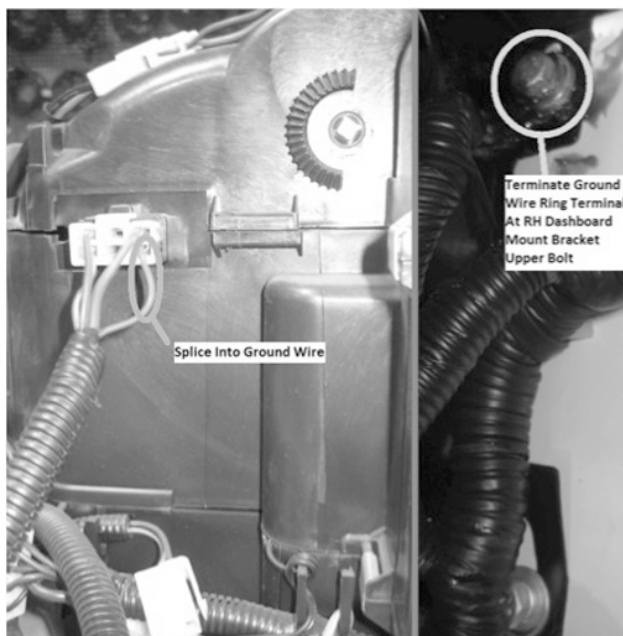
Figure 13-1

The new blower motor draws a higher current than the discarded unit. Additional grounding is required. This is achieved by adding a ground wire that terminates directly at the cab ground stud in the cab's bulkhead.

1. Splice the new ground wire (A6000100-001) to fan speed control module's lower RH purple wire using a soldering iron (smaller purple wire on RH side of the HVAC housing) (see *Figure 13-1*).
2. The ring terminal on the ground wire must terminate at the RH dashboard mount bracket at the upper mount bolt (see *Figure 13-1*).

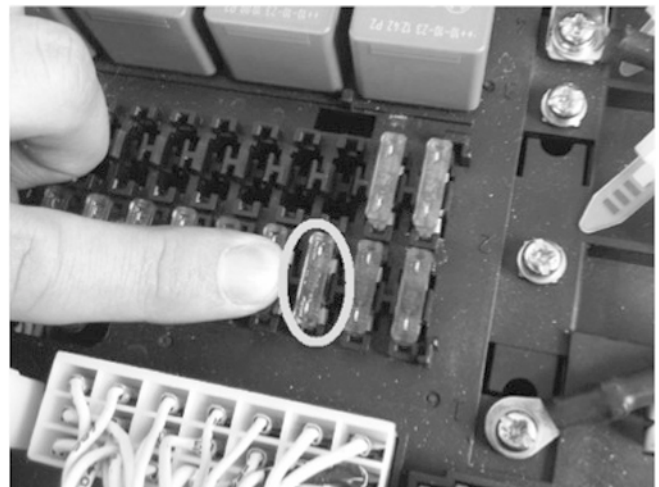
Figure 14-1

1. Locate the LH fuse box behind the LH seat.
2. Remove the 20 Amp fuse from slot F39 (refer to label under fuse bank cover) (see *Figure 14-1*).
3. Install the new 25 Amp fuse (A8700026-025) to location F39 (see *Figure 14-1*).

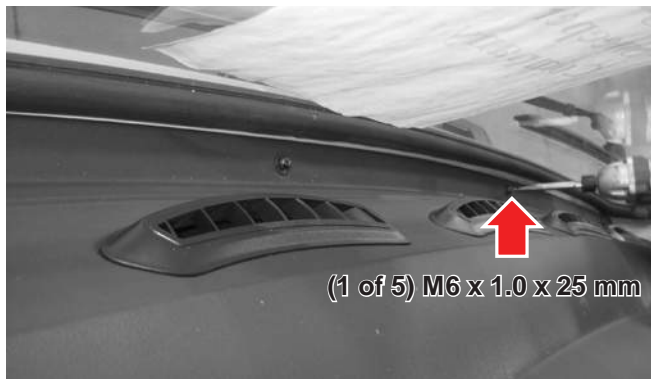
Figure 15-1

1. Reinstall the instrument panel.
2. Reinstall the screws and washers (see Figure 15-1).

Note: Ensure all the screws have been partially fastened before tightening any of them; use a small screw driver or poking tool to line up the holes in the panel and in the sheet metal.

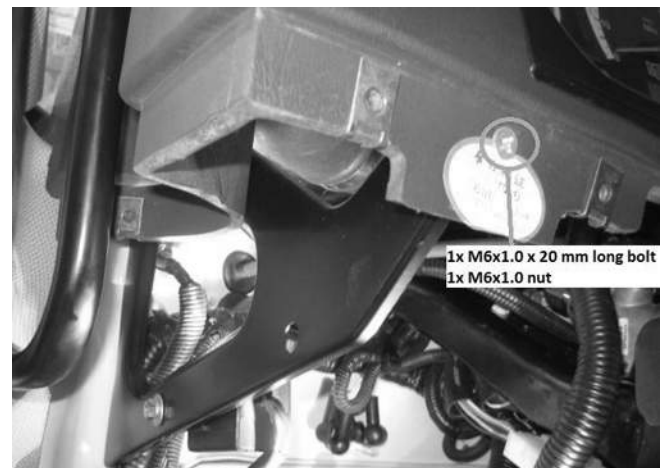
Figure 16-1

1. Reinstall the bolt/nut assembly on both LH and RH sides of the instrument panel (see Figure 16-1).

Note: The support brackets are slotted – push instrument panel upward while performing step 16-1 to ensure instrument panel is at top of adjustment range.

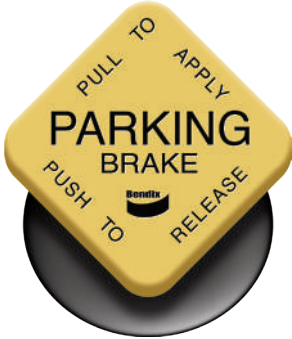
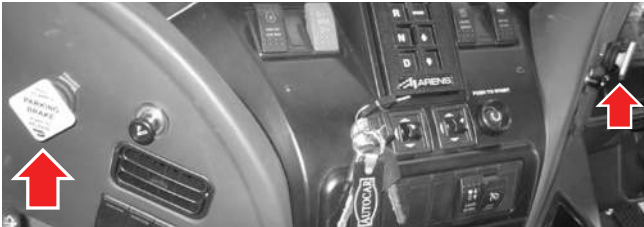
Figure 17-1

1. Push the valves through the holes in the dashboard.
2. Clamp the valve to the dashboard using the clamping nut.
3. Push the handles onto the valves.
4. Carefully hammer in the handle locating pins.
5. Pull the rubber grommet over the valve handle's shaft.

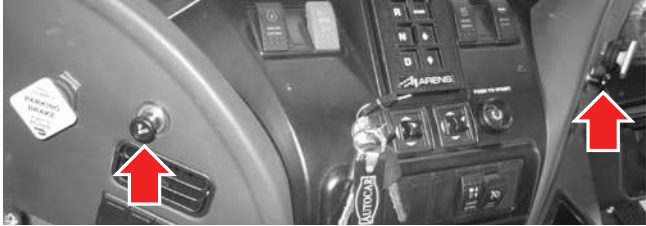
Figure 18-1

1. Locate the lighter harness terminals under the dashboard.
2. Connect the lighter harness connector to the back of the lighter.

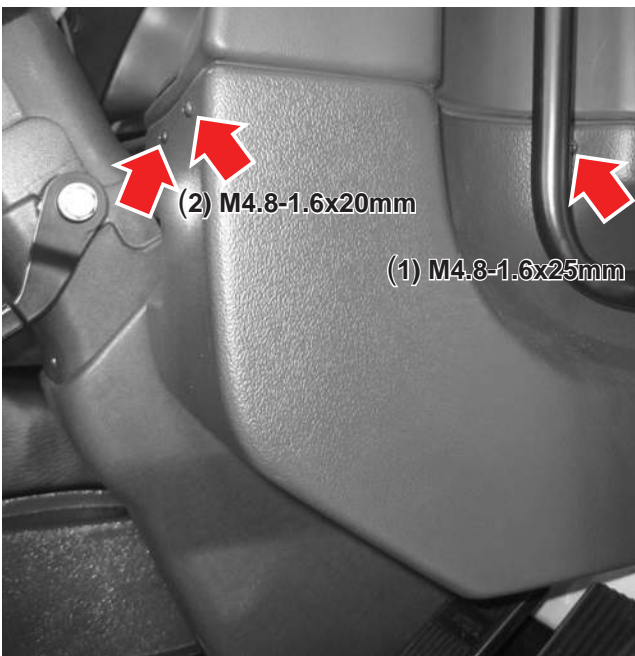
Figure 19-1

1. Align the lower RH instrument panel trim panel with mounting spring nuts on the upper instrument panel (see Figure 19-1).
2. Reinstall the three sheet metal screws, ensuring they are driven through the spring nuts (see Figure 19-1).

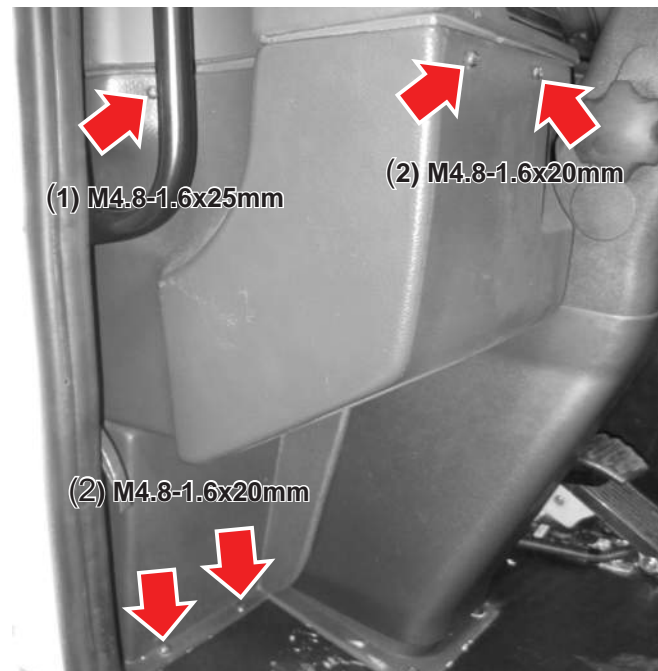
Figure 20-1

1. Align the lower LH instrument panel trim panel with mounting spring nuts on the upper instrument panel (see Figure 20-1).
2. Reinstall the three upper sheet metal screws, ensuring they are driven through the spring nuts (see Figure 20-1).
3. Reinstall the lower two sheet metal screws (see Figure 20-1)

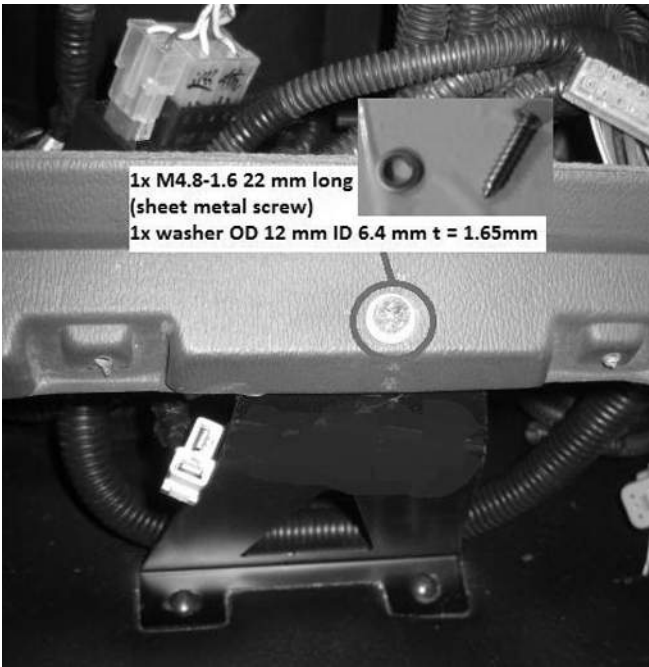
Figure 21-1

1. Reinstall the screw and washer (see Figure 21-1).

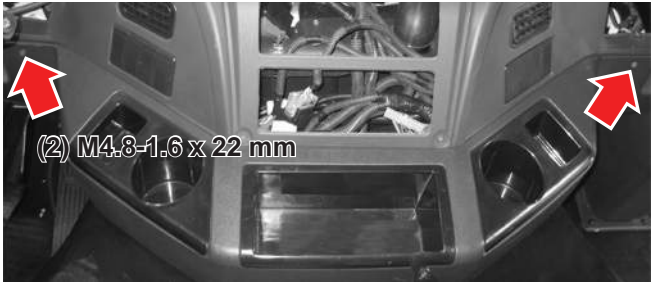
Figure 22-1

1. Reinstall the five screws securing the lower instrument panel skirt (see Figure 22-1).
2. Reinstall the cup holders and the center storage bin/cover, if equipped (see Figure 22-2).

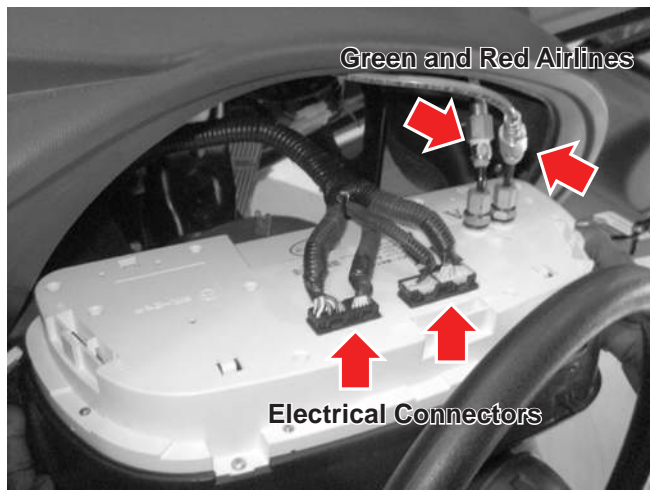
Figure 23-1

1. Reconnect the four electrical connectors (see *Figure 23-1*).
2. Reconnect the airlines, green to the RH port, red to the LH port (see *Figure 23-1*).

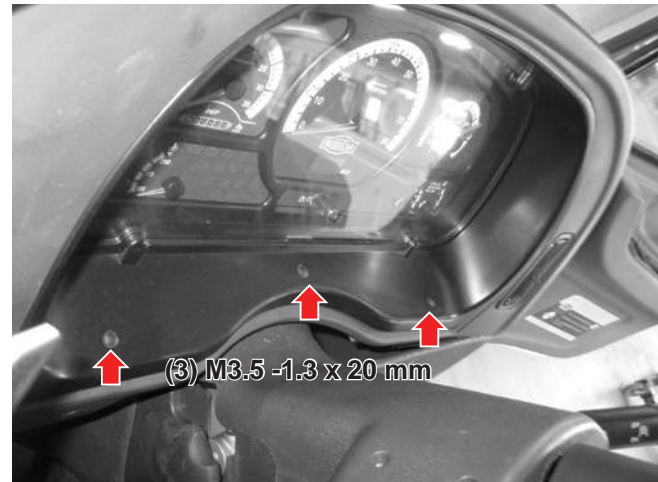
Figure 23-2

6. Reinstall the three screw plugs (see *Figure 23-2*).

3. Hook the upper tabs under the upper perimeter of the cluster cut-out in the instrument panel (see *Figure 23-2*).
4. Push the lower portion of the cluster forward, ensuring the cluster bezel locates securely in the cluster cut-out in the instrument panel (see *Figure 23-2*).
5. Reinstall the three screws, ensuring that they are aligned with the spring nuts (see *Figure 23-2*).

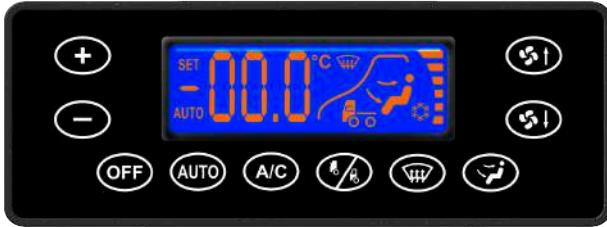
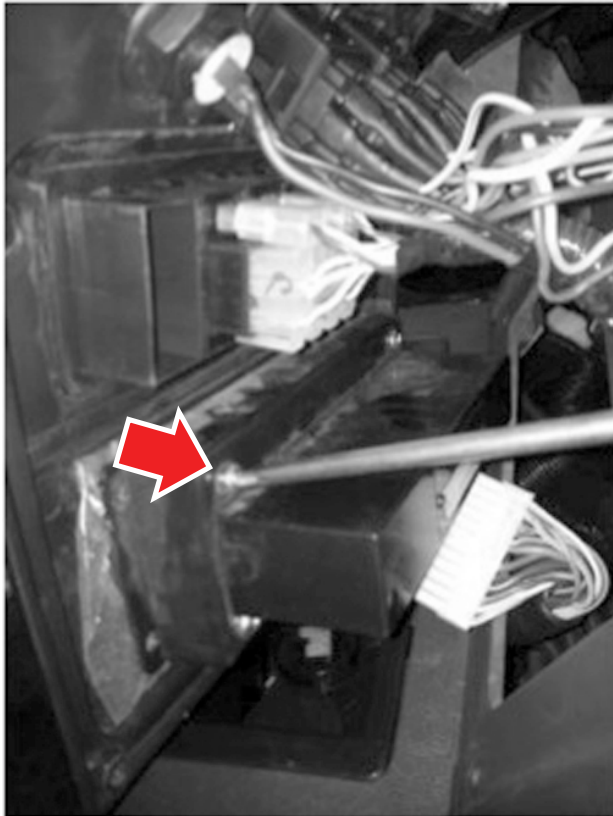
Figure 24-1

1. Remove the four screws affixing the clamp bracket to the rear of the HVAC controller (see *Figure 24-1*).

3. Install the new controller (A6030018-001) by reversing steps 24-3 to 24-1.

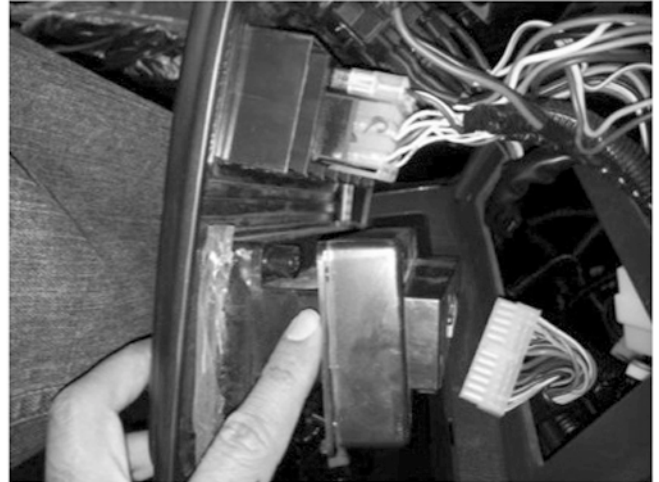
Figure 24-2

2. Remove the clamp bracket (see *Figure 24-2*).

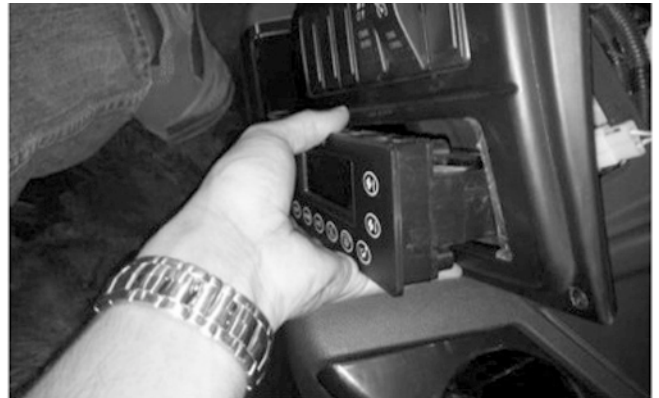
Figure 24-3

2. Slide the old controller out (see *Figure 24-3*).

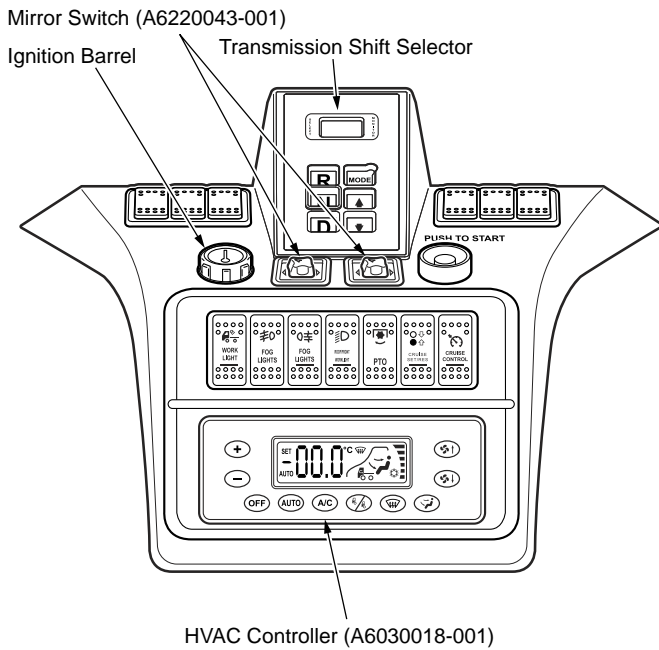
Figure 25-1

1. Reconnect the transmission shift selector connectors (see *Figure 25-1*).
2. Reconnect the mirror switch (A6220043-001) connectors (see *Figure 25-1*).
3. Reconnect the ignition barrel connector and the HVAC controller (A6030018-001) connector (see *Figure 25-1*).

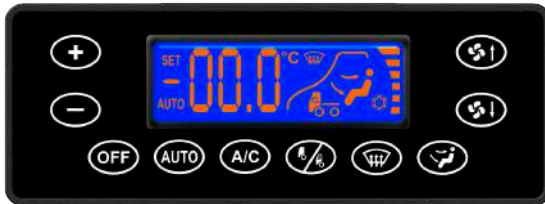
1. Start the engine and let it warm up.
2. Turn on the HVAC system by pressing the increase fan speed button.
3. Test the fan at all speeds.
4. While fan is at max speed, cycle through the 4 vent modes and ensure air is coming out of all the correct vents: panel, floor, windshield, floor and windshield (allow at least 5 seconds for vent selection valve to adjust between modes).

5. Drop the set temp to 64°F and turn on air-conditioning compressor (press frost symbol button). Ensure air becomes cool.
6. Increase set temp to HI while compressor is still running. Ensure that heater core is able to overcome the cooling effect of the evaporator core.

7. While the set temp is at any setting other than “HI” or “LO”, press the defrost button, and ensure the following occur:
 - Only windshield vents should be open.

- Fan speed should set to highest setting.
 - Air source should be set to fresh air.
 - Pressing the defrost button again should resume previous settings.

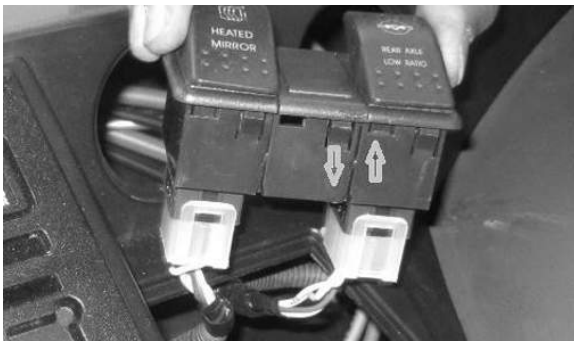
Figure 28-1

1. Route the switches through the slots in the center console panel in their original locations (see *Figure 28-1*).
2. Reassemble the switch banks in the same configuration that they were before breaking apart in step 8-3 (see *Figure 28-1*).
3. Push the switches through the slots in the center console until they snap into place (see *Figure 28-2*).

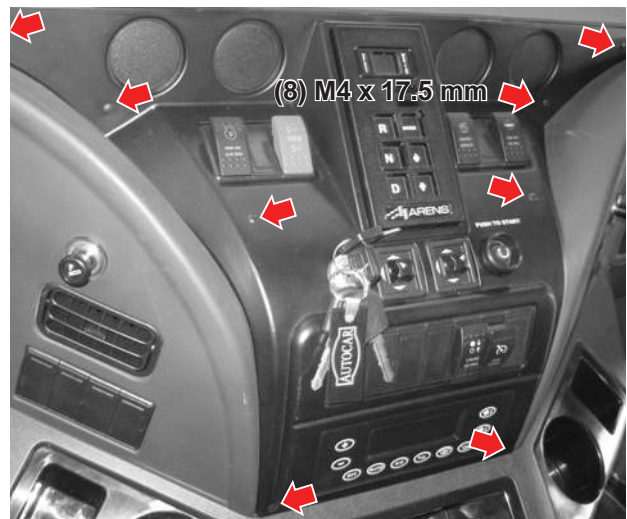
Figure 29-1

1. Reinstall the eight M4 screws (do not tighten until all the screws have been located and the panel aligned correctly) (see *Figure 29-1*).
2. Reinstall the eight screw caps (see *Figure 29-1*).
3. Reinstall gage panel caps (see *Figure 29-1*).
4. Push switches into their locating slots (see *Figure 29-1*).
