SERVICE BULLETIN

SB-10056651-1786

SUBJECT : Vent Hose Installation

SUMMARY : This bulletin explains the vent hose installation.

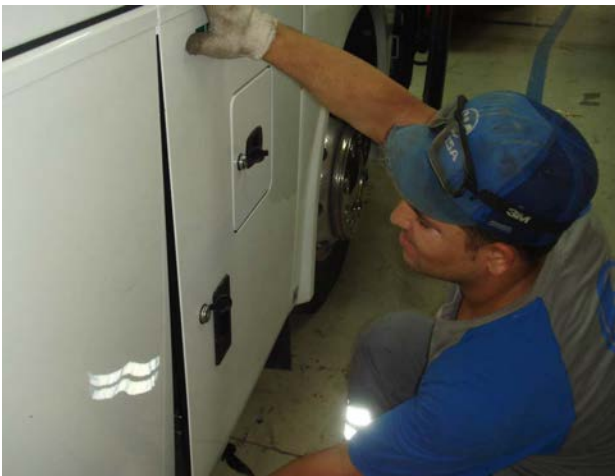
1. Open the fuel tank door to have the access the ventilation valves

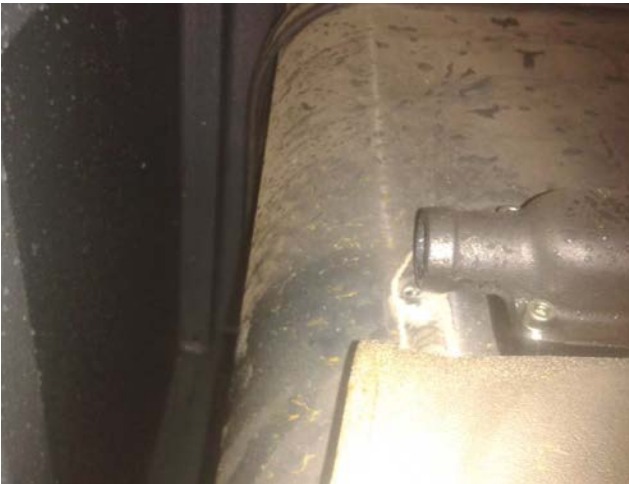
2. The hose will be connected to the ventilation valve outlet on the tank.

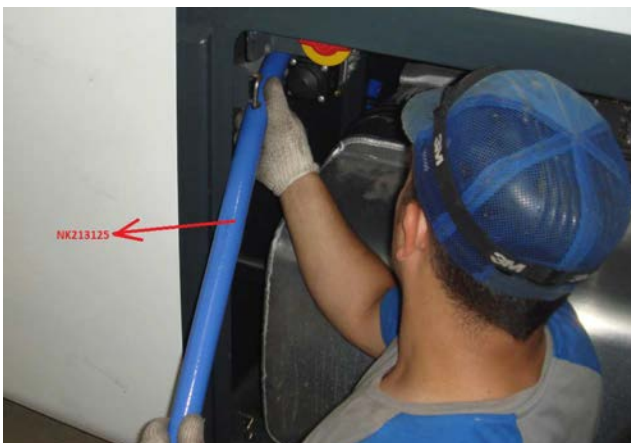
3. The hose, NK213125 will be used for this application. It will be directed as shown.

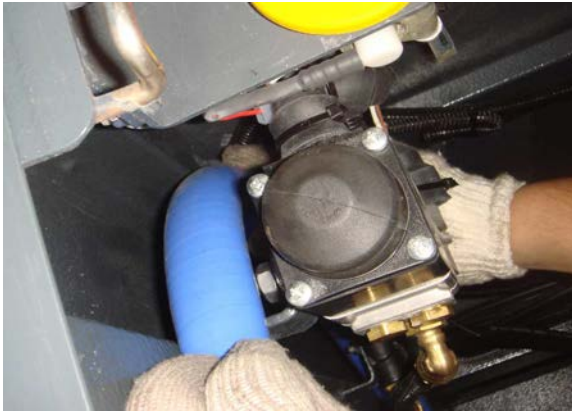
4. Note that , the hose should be routed always on the top level as much as possible.

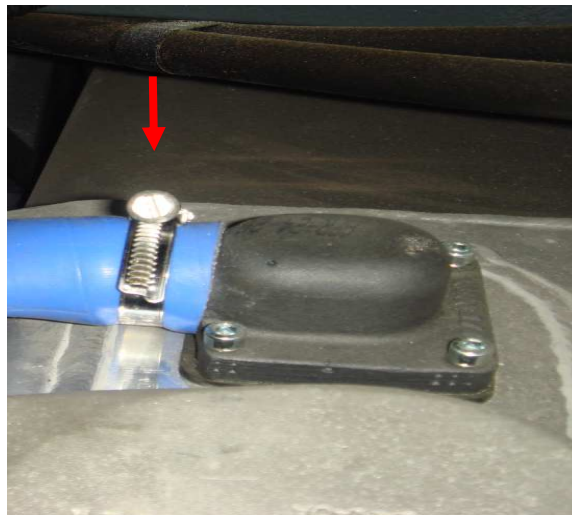
5. Mount the to the ventilation valve outlet on the tank by using clamp (BW302504009D).

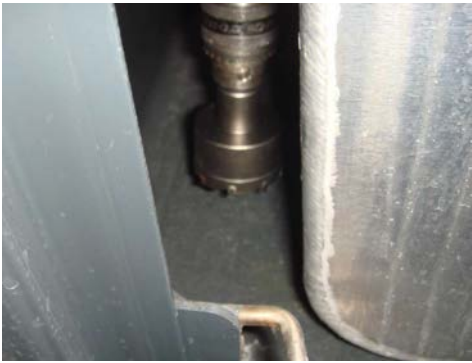
6. Hole cutting operation must be performed with the diameter 1,38".

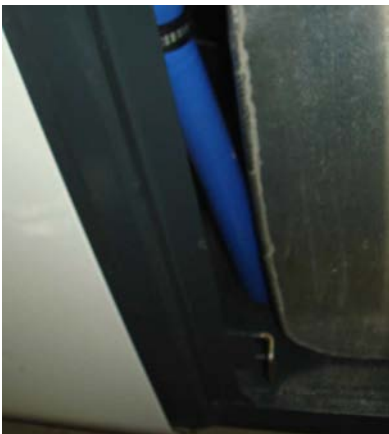
7. Hose should be clamped to the chassis wall as shown in the pictures.
