WARRANTY COVERAGE EXTENSION

Date: January 9, 2015
Order No.: P-B-47.10/63
Group: 47

**SUBJECT: Model 211, Model Years 2003- 2009 (AMG models not included at this time) and
Model 219, Model Years 2006- 2011 (AMG models not included at this time)
Fuel Odor In the Area of the Fuel Tank**

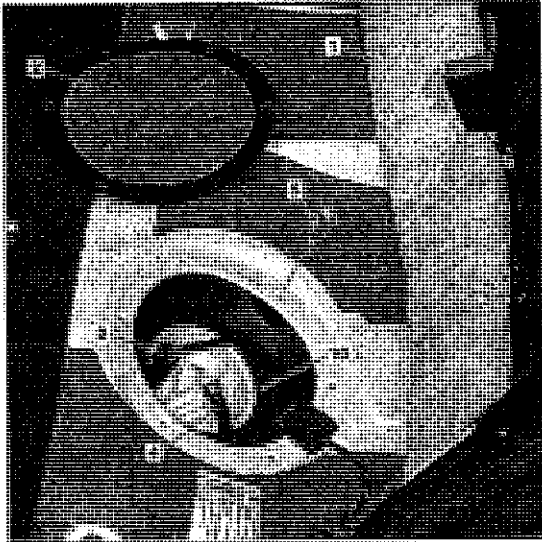
Figure 1

Remove screws (5, Figure 1) and take off both fuel tank access covers (2).

**Note:**
During assembly, do not install the covers (2) until after running engine and checking for fuel leaks.
