TECHNICAL SERVICE BULLETIN

Bulletin Number: **SLI-15-02**
Model Year(s): **2015**

SUBJECT: 2015 Slingshot / Slingshot SL – Steering Rack Replacement

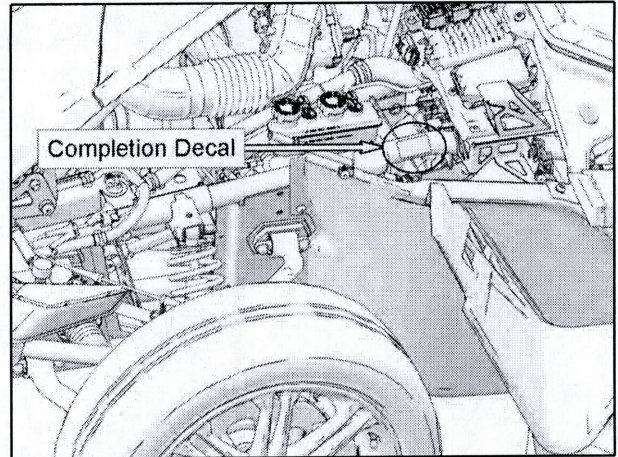
A Service Bulletin Completion Decal (PN 7170107) must be completed for this bulletin repair. Place the decal on the left side frame tube, near the brake master cylinder (as shown). If you require more decals, order them through normal Polaris parts ordering channels.

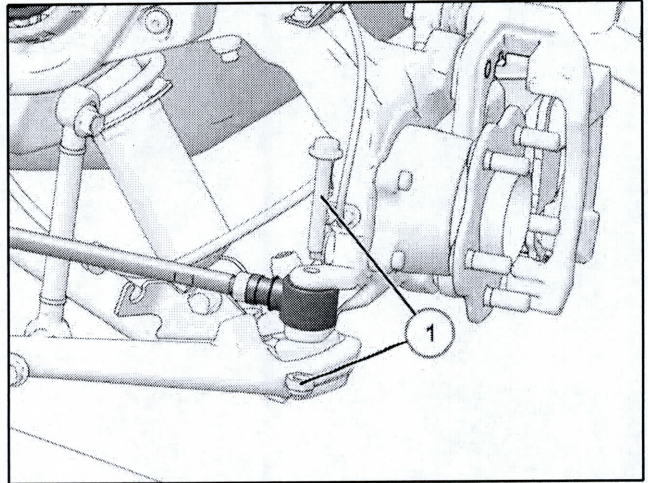
1. Disconnect the negative battery cable.
2. Open the vehicle hood.
3. Raise the vehicle using a suitable lift or jack and remove the front wheels. Refer to the 2015 Slingshot Service Manual for lift-point locations.
4. Remove both of the wheel speed sensors from the steering knuckles prior to removing outer tie rod bolts to gain clearance.
5. Remove the bolt and nut ① securing the outer tie rod end to the steering knuckle for each side of the vehicle and discard.

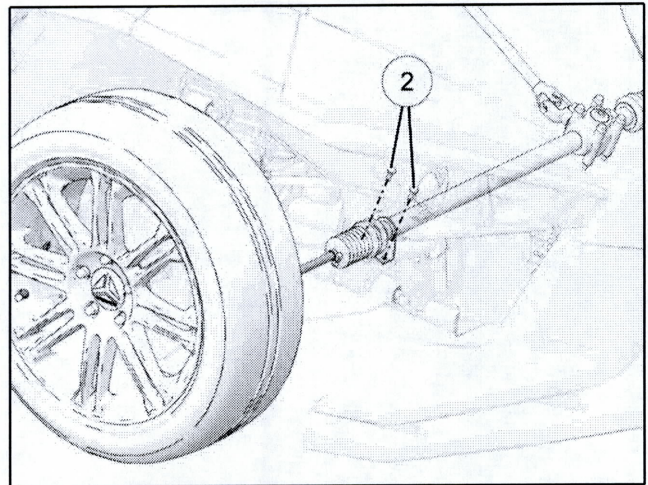
6. Remove the bolts ② from the passenger (right) side of the steering rack.

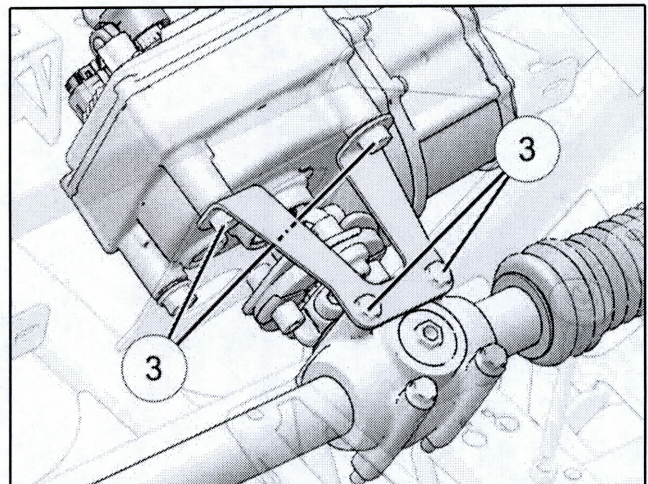
7. Remove the four steering rack bracket bolts ③ and remove bracket.

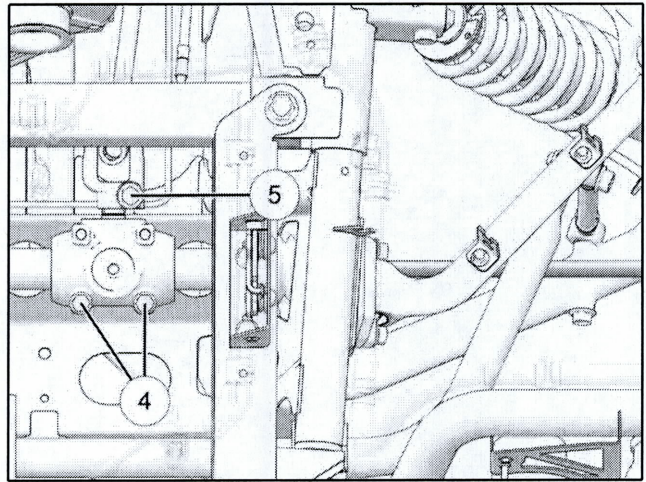
8. Remove the remaining two bolts ④ from the steering rack.
9. Remove the steering shaft coupler bolt ⑤.

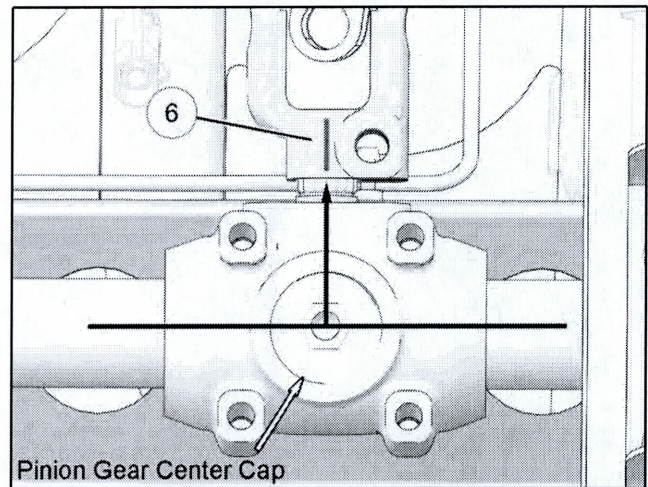
10. Using a grease / paint pen, place a mark on the steering shaft coupler ⑥ that is aligned with the pinion gear center cap and perpendicular to the steering rack. (To be used for reference later)

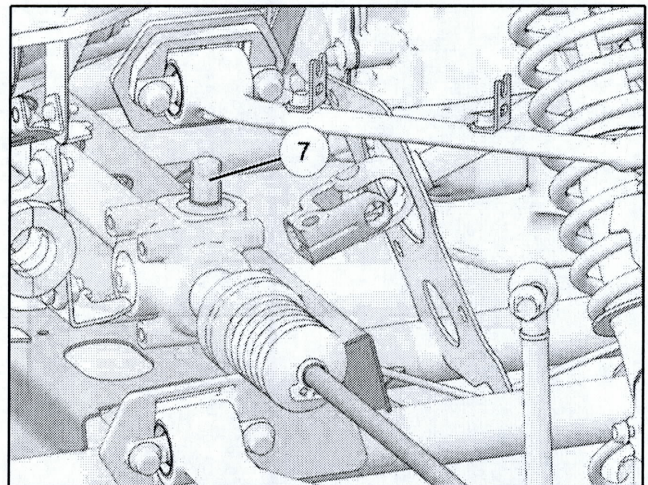
NOTE: Be careful not to damage the radiator, fan shroud or radiator hoses while moving the rack into position for removal.

11. Slide the rack assembly forward off of the steering shaft coupler and rotate so the input shaft ⑦ is pointing up as shown.

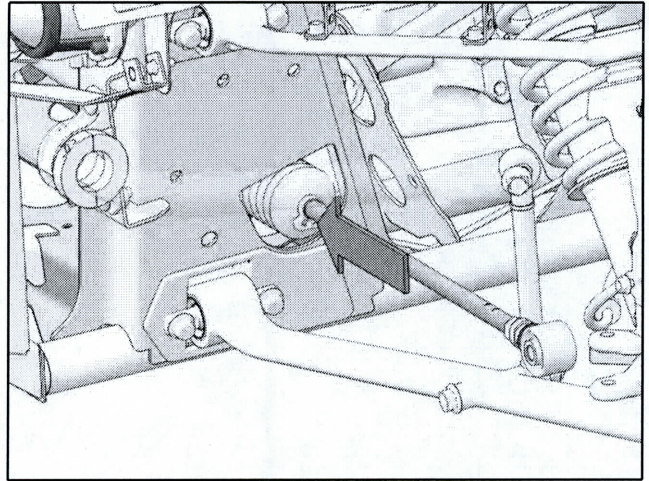
12. Slide the rack towards the passenger (right) side of the vehicle until the driver (left) side tie rod end clears the inside of the frame opening.

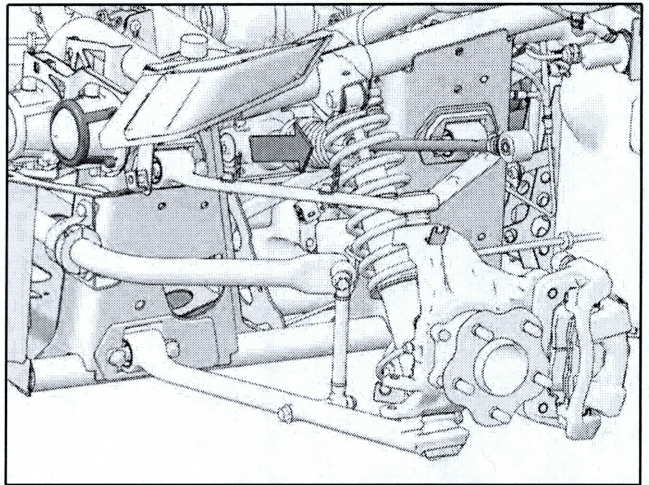
13. Move the rack to the rear of the shock assembly at the frame opening and remove the rack out of the driver (left) side of the vehicle as shown.

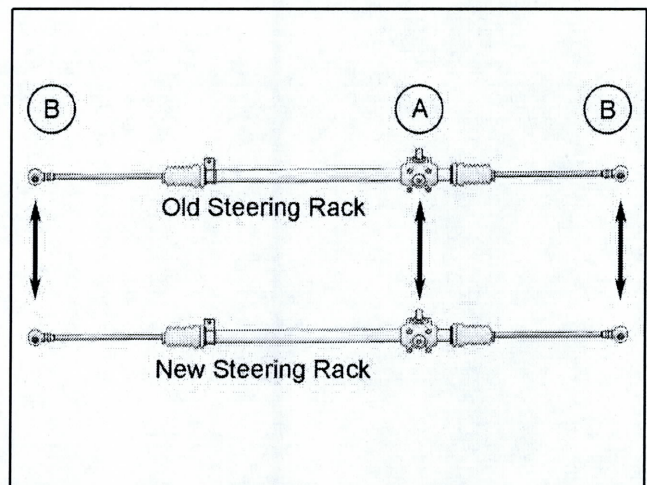
Lay the steering rack you removed on the ground in front of the new steering rack to verify that the new rack is centered:

- Align the pinion gear center caps from each rack (A)
- Verify that the outer tie rod ends (B) are in the same position.

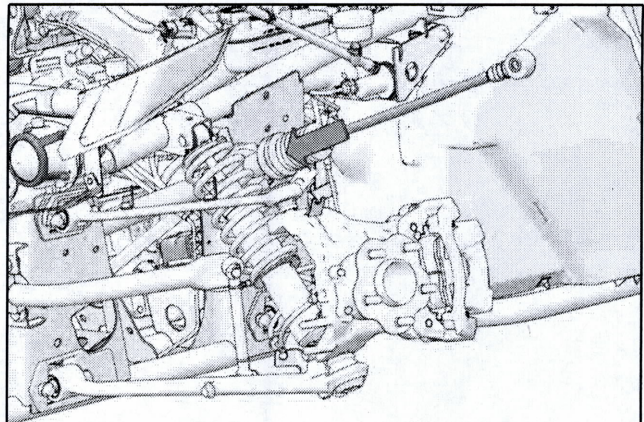
15. Install the new steering rack assembly by sliding it into position in the same order by which it was removed. See Figure 1 & Figure 2.
16. Apply a thin coat of grease to the input shaft splines and align the centering mark on the input shaft with the mark made in step 10, and slide the input shaft into the coupler joint.
17. Insert the coupler bolt and torque to specification.
18. Install the remaining bolts and torque to specification. Verify that steering rack boots were not torn / damaged during installation.

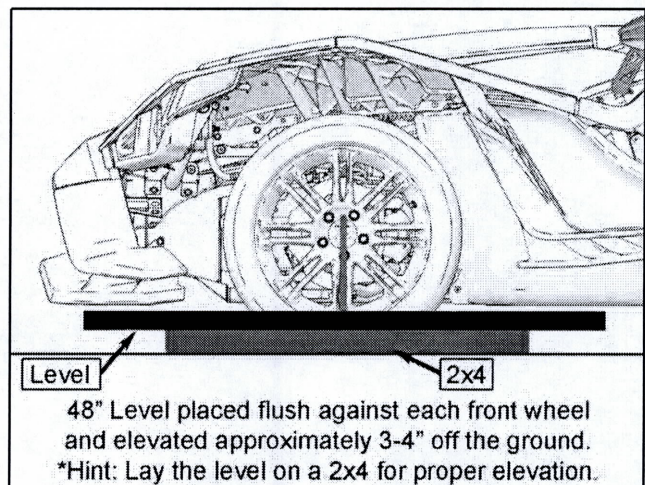
21. Lower the vehicle so it is resting on the ground.
22. Place a 48" level along the outer edge of each front wheel. The level must be elevated off the ground approximately 3-4" and flush against the tire sidewall. (A standard 2x4 will work)

NOTE: The center of the level must be aligned with the wheel center cap as shown.

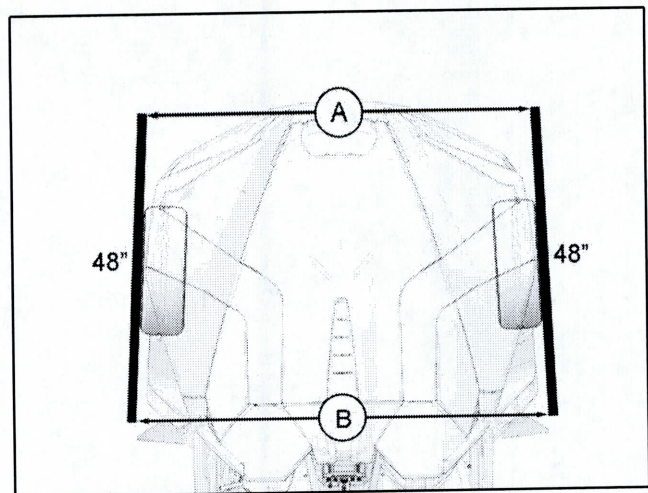
23. Measure the distance (A) between the forward, inside edges of both levels and record.

24. Measure the distance (B) between the rear, inside edges of both levels and record.

25. Subtract measurement A from measurement B and record:

Example 37" - 36" = 1" Toe-In

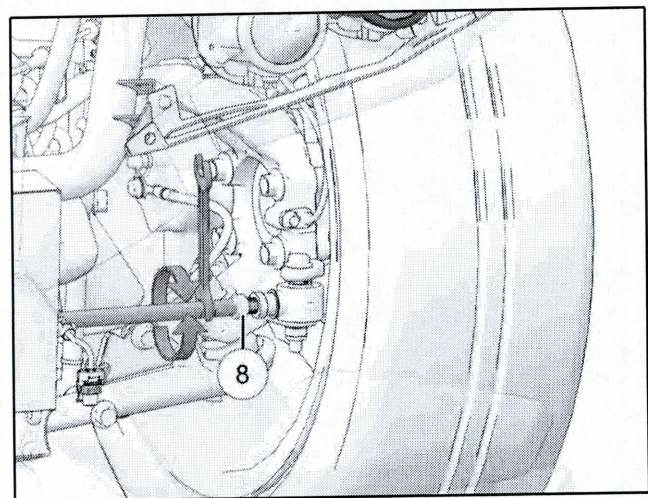
26. If the TOE measurement is not within specification, it will be necessary to loosen the tie rod jam nuts (8) and adjust tie rods **equally in small increments** until the correct TOE-IN specification is achieved.

27. Once the correct TOE specification has been achieved, torque the tie rod end jam nuts to specification.
