# HVAC Evaporator Drain Hose Clogged Due to Insect Intrusion

Service Category Vehicle Interior

Section Heating/Air Conditioning

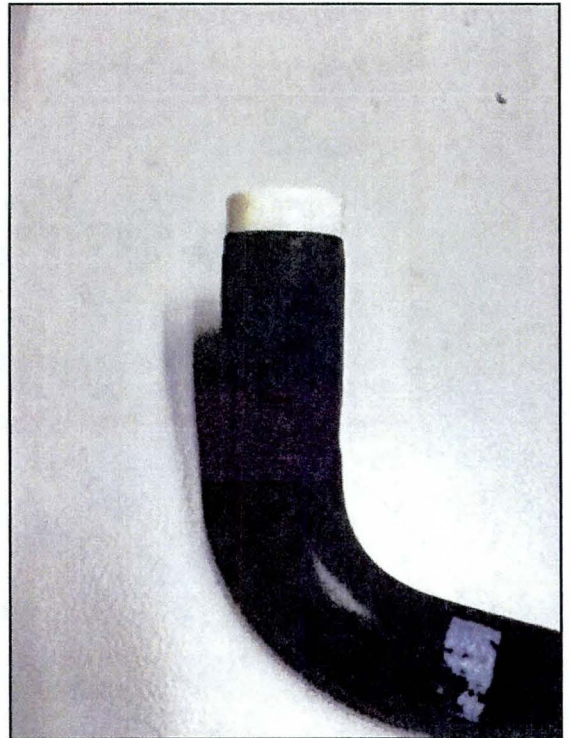
1. Follow the instructions provided in the Safety Requirements for Handling the ARINIX<sup>®</sup> Tip (Connector, Water Hose) section of this bulletin.
2. Locate the HVAC Evaporator Drain Hose.
3. Following the vehicle specific Repair Manual, remove the HVAC Evaporator Drain Hose.
4. Put on all necessary PPE and install the ARINIX<sup>®</sup> Tip (Connector, Water Hose) into the NEW HVAC Evaporator Drain Hose listed in the Parts Information section of this bulletin.
5. When installing the ARINIX<sup>®</sup> Tip, verify it is fully seated in the HVAC Evaporator Drain Hose as shown in Figure 1.
6. Following the vehicle specific Repair Manual, install the HVAC Evaporator Drain Hose.

1. Follow the instructions provided in the Safety Requirements for Handling the ARINIX<sup>®</sup> Tip (Connector, Water Hose) section of this bulletin.
2. Locate the HVAC Evaporator Drain Hose.
3. Following the vehicle specific Repair Manual, remove the HVAC Evaporator Drain Hose.
4. Put on all necessary PPE and install the ARINIX<sup>®</sup> Tip into the original HVAC Evaporator Drain Hose listed in the Parts Information section of this bulletin.
5. When installing the ARINIX<sup>®</sup> Tip, verify it is fully seated in the HVAC Evaporator Drain Hose as shown in Figure 1.
6. Following the vehicle specific Repair Manual, install the HVAC Evaporator Drain Hose.
