Subject 10-13 RX350 Exhaust Rattle from Manifold Heat Shield		Market USA
Service Category Engine/Hybrid System	Section Intake/Exhaust	
Applicability 2010-2013 RX350

10-13 RX350 Exhaust Rattle from Manifold Heat Shield

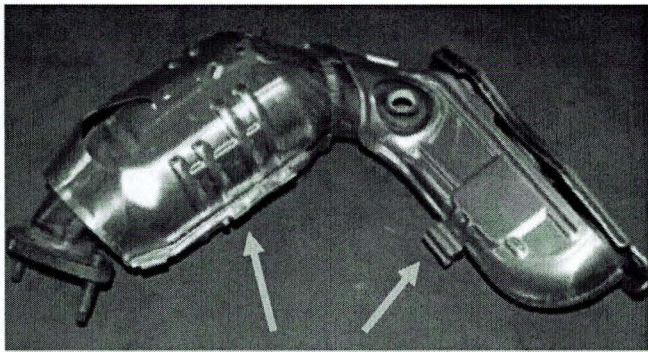
Some 2010-2013 RX350 vehicles may exhibit an exhaust “rattle” type noise from one or both of the two exhaust manifold heat shields pictured below:

Catalytic converter and exhaust manifold heat shields

1. Halt all diagnosis and repair. Open a Technical Assistance case (TAS) with all relevant details and call for diagnostic support. Be sure to:
 - a. Record specific details from the customer on the operating conditions when the concern occurred.
 - b. Record specific details about the characteristics of the noise, including which heat shield was the cause.
 - c. Perform a Techstream HealthCheck and record any stored Diagnostic Trouble Codes.
2. If the problem occurs outside of TAS operating hours, replace the affected exhaust manifold, do NOT alter it in any way, and submit a Dealer Product Report for this issue. Include information about which heat shield produced the noise, and a sound or video file if possible. Retain the manifold for recovery.
