Service Bulletin

Bulletin No.: PIP4765A

Subject: Engine Misfire and No Compression due to Piston Damage

Models: 2007-2014 Cadillac Escalade
2007-2014 Chevrolet Avalanche, Silverado, Suburban, Tahoe
2014 Chevrolet Silverado 1500
2007-2014 GMC Sierra, Yukon
2014 GMC Sierra 1500
2007-2010 Hummer H2
with Any of the Following V8 Engine RPO Codes:
L76, L77, L83, L86, L92, L94, L9H, LC9, LFA, LH6, LH8, LH9, LMG, LV3, LY2, LY5, LY6,
or LZ1

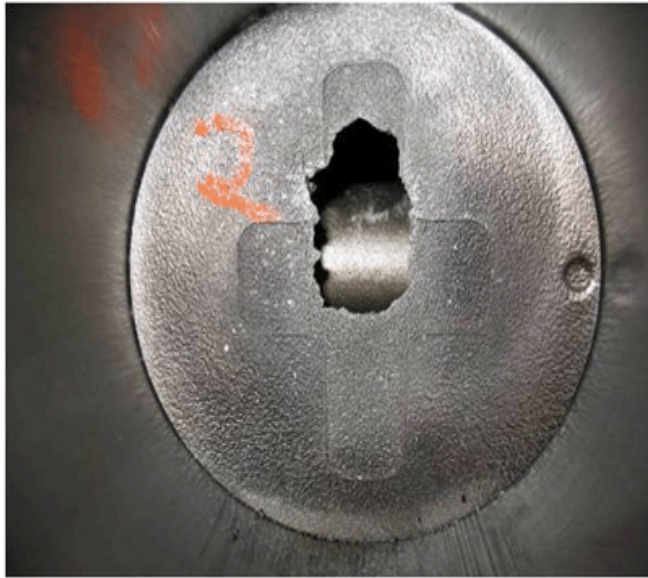
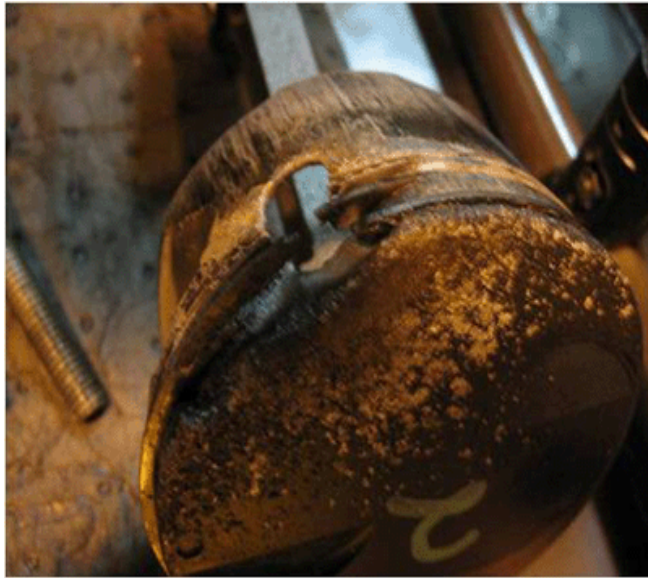
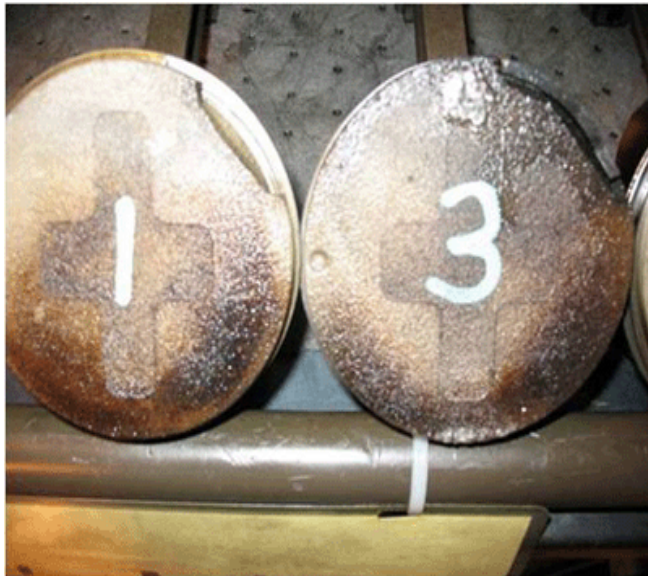
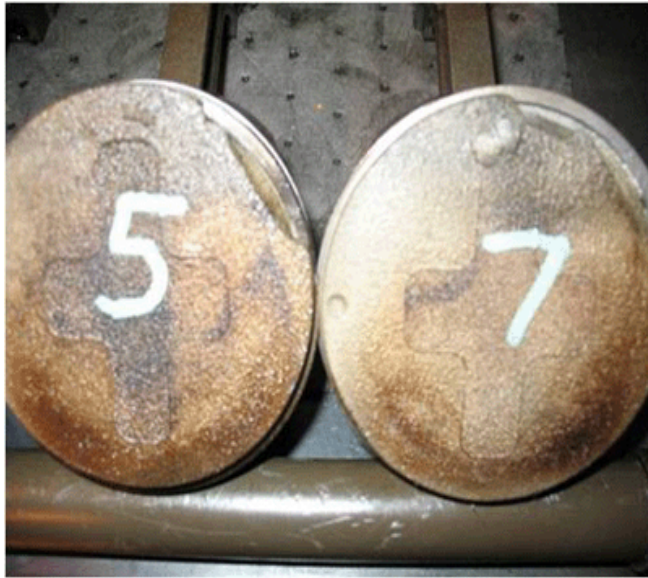
This may be the result of aftermarket ECM calibrations/components and detonation that lead to a melted piston.

1. If a lighted bore scope is available, inspect the top of the related piston(s) through the spark plug hole to determine if any of the pistons are melted as shown below. These photos all show examples of pistons that were damaged/melted due to detonation that was induced from aftermarket calibrations and/or components. If this type of piston damage is noted, it is most likely the result of aftermarket ECM calibrations and/or components. Follow the remaining steps to determine if this is a warrantable repair. If this type of piston damage is present and aftermarket items are found during steps 2 or 3, this should not be considered a warrantable repair.

2. Inspect for aftermarket components, such as an exhaust, ignition, high performance air filter (K&N style), or air intake system. Take photos and document accordingly if anything is found.

3. Determine if factory ECM calibration numbers and CVNs are present by following the latest version of 09-06-04-026.
