SERVICE BULLETIN

APPLICABILITY: 2014MY Forester

NUMBER: 12-163-14

SUBJECT: Revised Sunroof Deflector for Rattling Sound

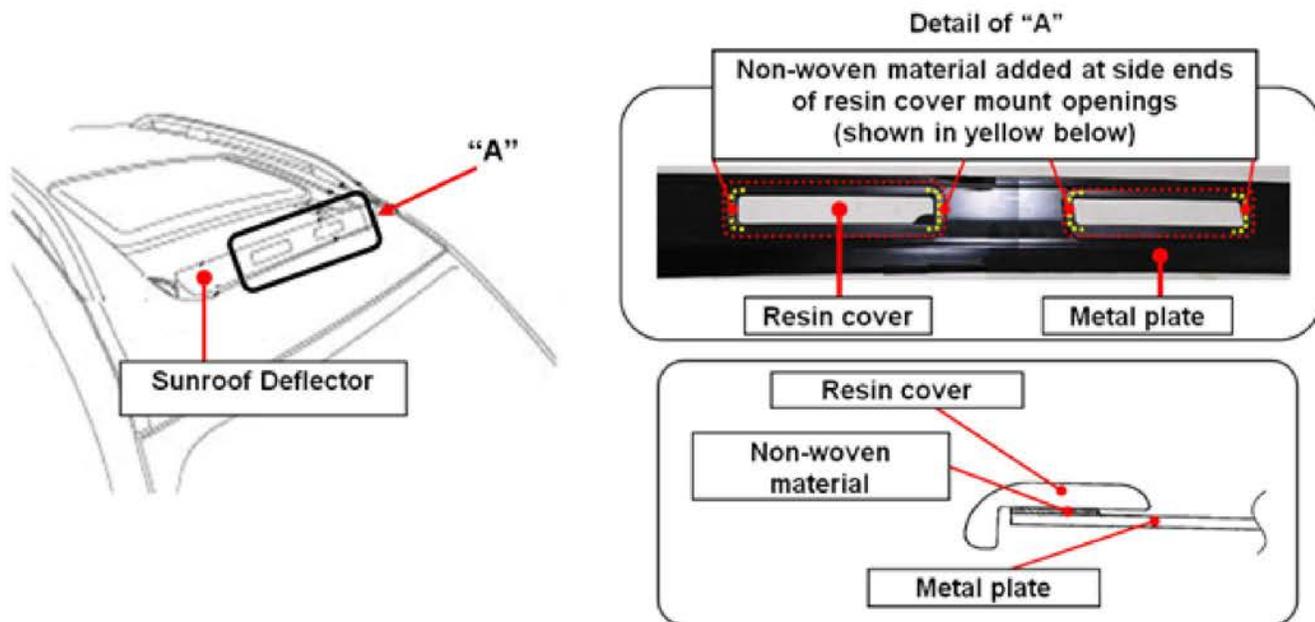
If you receive a customer concern of a rattling sound from the sunroof air deflector while driving with the roof panel closed, a countermeasure part has been developed to eliminate it. Non-woven material has been added to the resin cover portions of the air deflector as shown in the illustration below.

Once the condition has been confirmed, replace the sunroof air deflector following the procedure outlined in the applicable Service Manual.
