Tech Tips

TT 28-08-02

2005> Jetta A5, - Key Cannot Be Removed from the Ignition when the Transmission is in PARK

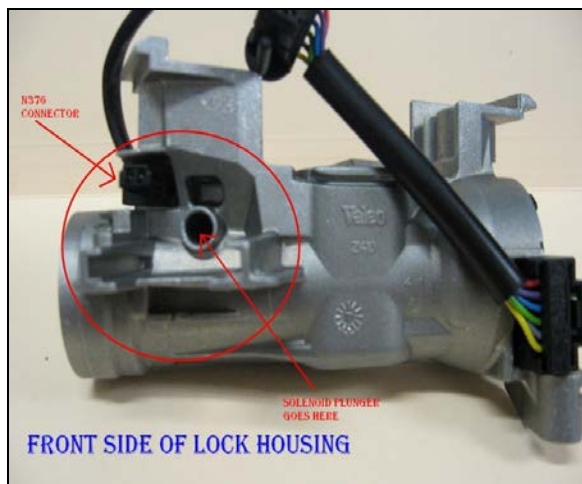
If a customer comments that the key **cannot** be removed from the ignition when the transmission is in PARK or that the PRND12 is not reading correctly in the MFI, DO NOT replace the ignition switch, lock cylinder, or lock housing assembly. Instead, be sure the Ignition lock solenoid is working properly and/or check that the N376 (**called the "catch"**), is connected to the lock housing. In some cases you may get a fault code 00194 009 Ignition key removal from lock open circuit/ short to earth. Use MVB 5 in address word 16-Steering Column Electronics for an aid in diagnosis. **Please be certain to use the VIN in ETKA to obtain the latest part number(s) available.**
