Service Bulletin

Bulletin No.: PI0296

Subject: Malfunction Indicator Lamp (MIL) Illuminated, DTC P0201, P0300 and/or P0301 Set, Engine Misfire (Inspect Wiring Harness Insulation of Fuel Injector #1 for Chafing, Repair as Outlined)

Models: 2008-2011 Chevrolet Cobalt, HHR, Malibu
2008-2010 Pontiac G5, G6
Equipped with 2.4L Engine RPO LE5 or LE9

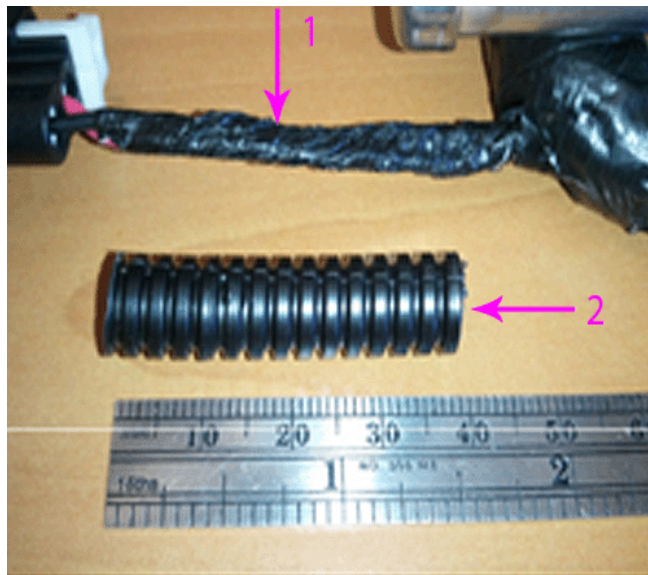
Some customers may comment that the malfunction indicator lamp (MIL) is illuminated and the engine has a misfire. The technician may observe on a scan tool DTC P0201, P0300 and/or DTC P0301 set as Current or in History. This condition may be caused by chafing of the wiring harness insulation for fuel injector #1.

1. Perform the Diagnostic System Check - Vehicle.
 - ⇒ If DTC P0201, P0300 and/or P0301 are set as Current or in History, proceed to Step 2.
 - ⇒ If DTC P0201, P0300 and/or P0301 are not set as Current or in History, refer to > Symptoms - Vehicle > Symptoms - Engine Controls in SI.
2. Turn OFF the ignition.
3. Inspect the wiring harness insulation of fuel injector #1 for chafing in the area of the alternator and the upper radiator cooling hose at the engine.
 - ⇒ If the wiring harness insulation of fuel injector #1 has chafing, then repair as needed. Refer to Power and Signal Distribution > Wiring Systems and Power Management > Diagnostic Information and Procedures > Repairing Damaged Wire Insulation in SI.
 - ⇒ If the wiring harness insulation of fuel injector #1 does not have chafing, then refer to Diagnostic Trouble Code (DTC) List - Vehicle in SI.

4. Cut a piece of plastic convoluted tube (2), approximately 38 mm (1.5 in) in length to install on the wiring harness (1) of fuel injector #1.
