Service Bulletin

Bulletin No.: PI0572B

Subject: Information on COAX Repair Kit Availability

Models: 2006-2014 GM Passenger Cars and Light Duty Trucks

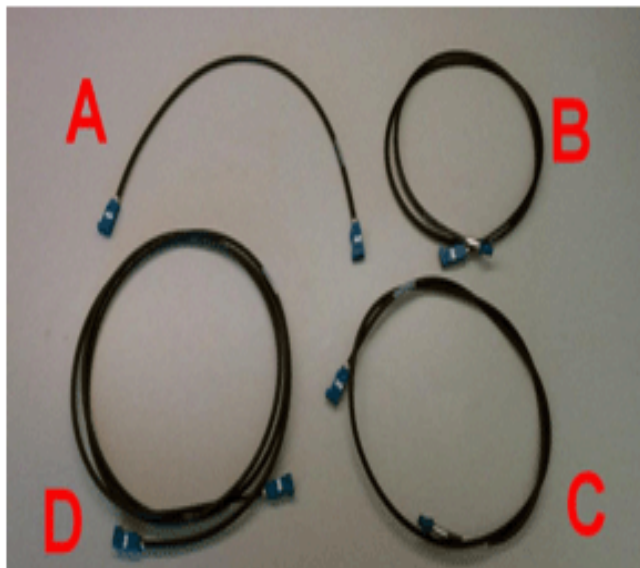
2706799

Communication Interface Module Antenna Cable Kit (part number 13581174)

Consists of four different RG56 cables in lengths of 18 inches (A), 3.5 feet (B), 5 feet (C) and 7 feet (D). This kit is used to replace the cables for carrying a cellular signal or a combined cellular and GPS signal. It is also referred to as the long run cellular kit.

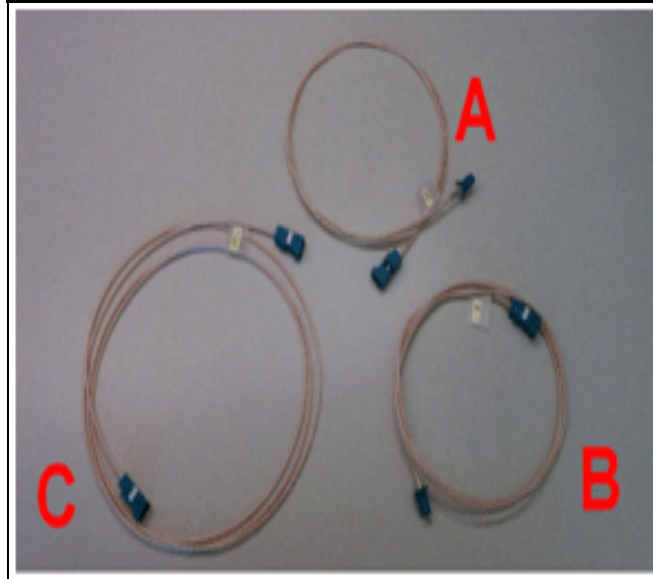
2706807

Digital Radio and Vehicle Locator Antenna Coaxial Cable Kit (part number 13581173)

Consists of three different RG316 cables in lengths of 3.5 feet (A), 5 feet (B) and 7 feet (C) and is used to replace the satellite radio and GPS cables. It is also referred to as the long run XM/GPS kit.

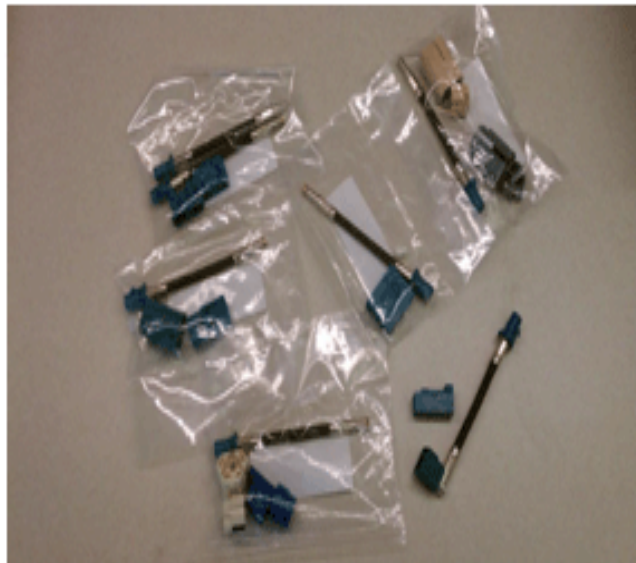
2706814

Digital Radio and Mobile Telephone and Vehicle Locator Antenna Coaxial Cable Kit (part number 19119056)

Consists of many different connectors, housings and jumpers to mate into the connector housings. This kit may be used by itself to repair a connector or in conjunction with either of the long run kits to change the connector ends. It is also referred to as the connections kit.

If an in-vehicle connector is damaged, it may be possible to replace it with a new service connector housing from the Digital Radio and Mobile Telephone and Vehicle Locator Antenna Coaxial Cable Kit. The kit will have mostly non-keyed water blue connectors for 1-way and 2-way styles. The 3-way connectors are color coded. In some cases, it will not be possible to replace only a connector. For these cases, run a long run cable and bypass the non-replaceable connector.

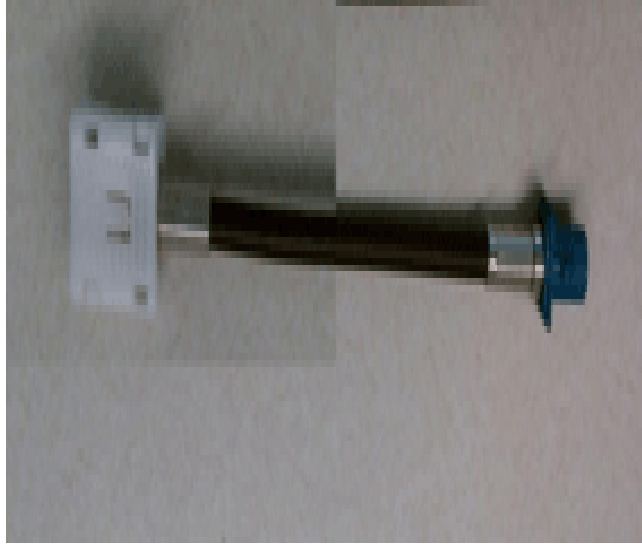
2706816

Communication Interface Module Antenna Cable Kit (part number 22803854)

Consists of a 4-inch jumper for the mini-UHF connector that was used on several OnStar modules before the 2011 model year.
